Report on the Preliminary Air Leakage Testing of two maisonettes in Erneley Close, Manchester, being refurbished to the EnerPHit standard, in compliance with ATTMA TSL1 (2010)

Site address: Erneley Close, Longsight, Manchester M12 5RB

JALDAS5084/R1

14th & 15th January 2014

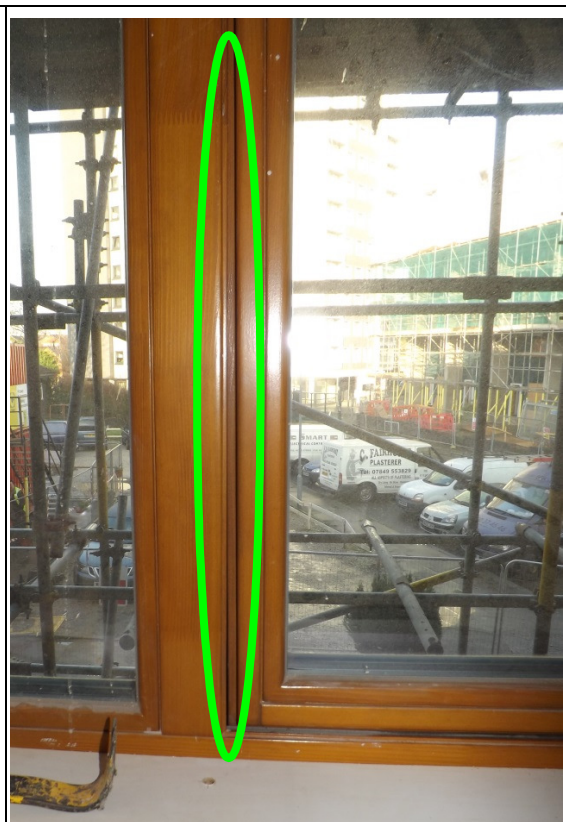
P4) Damaged window in No. 3 was sealed for test

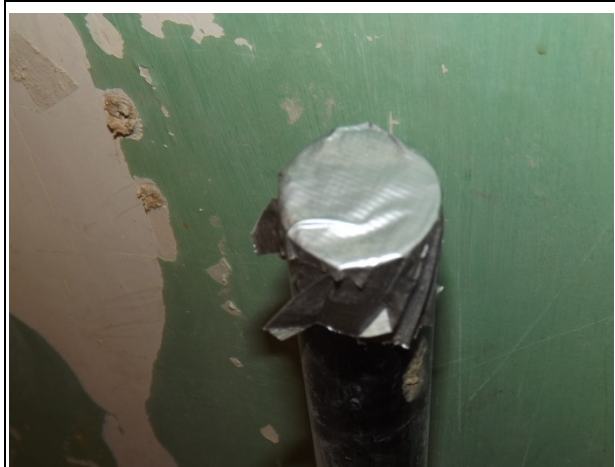
P5) Top of incomplete pipe sealed for test

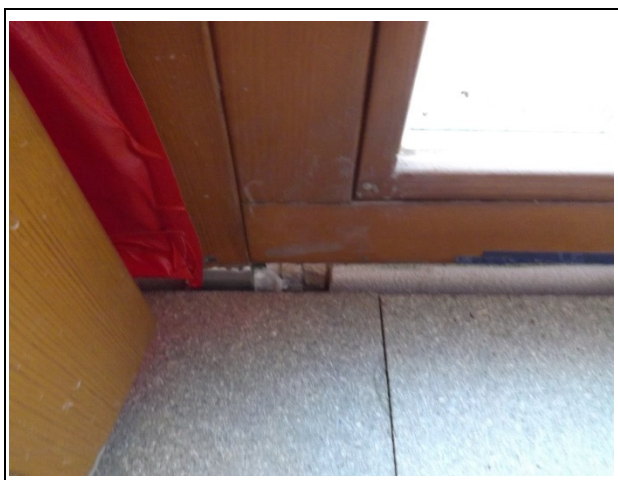
- 1) Associated with the thresholds beneath both the front and back doors, where the sealing between the structural foam and the adjacent surfaces appears to be problematic;

<p>P6) Substantial leakage at edge of finished floor in No. 3, beside front door threshold (Items 1 & 6)</p>	<p>P7) Concreting around base of soil vent pipe in No. 3 did not eliminate leakage (item 3)</p>

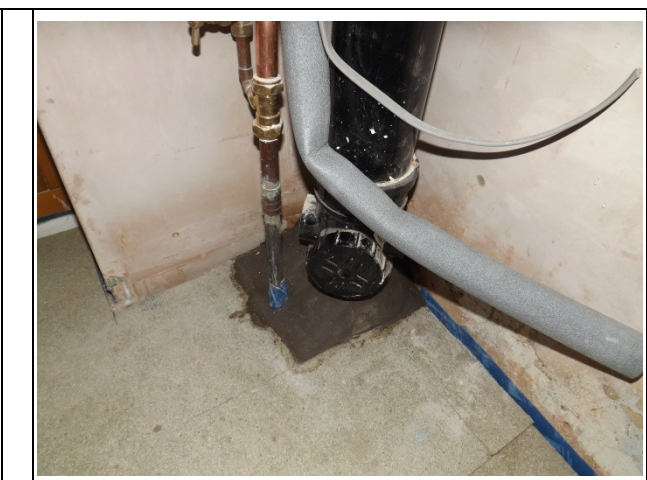
- 3) At the bottom of the soil vent pipe where it passes through the ground floor (lower maisonettes) or the concrete slab beneath the upper maisonettes. Using a wet concrete mix has not proved completely effective with residual leakage still being found. Some leakage was also identified on joints in the soil vent pipe itself;

- 4) The top and bottom of the soil vent pipes are clear weak points from a leakage perspective, made even worse by the leakage identified from actual joints on the soil vent pipe in No. 3. Attempting to seal the leakage around the bottom of the soil vent pipe with concrete proved ineffective, hence we suggest consideration be given to using some self-levelling compound at this location, which could then be painted over with liquid latex to ensure an effective seal before the soil vent pipe is boxed. Similarly at the top of the soil vent pipe, the timber pattress has proved to be very vulnerable to being disrupted by further works and localised movement. Hence care needs to be taken to ensure this location is effectively sealed, perhaps with self-levelling compound and liquid latex from above, before the soil vent pipes are boxed in. We are particularly concerned about the effectiveness of the seal around the soil vent pipe through the roof of the upper maisonettes;

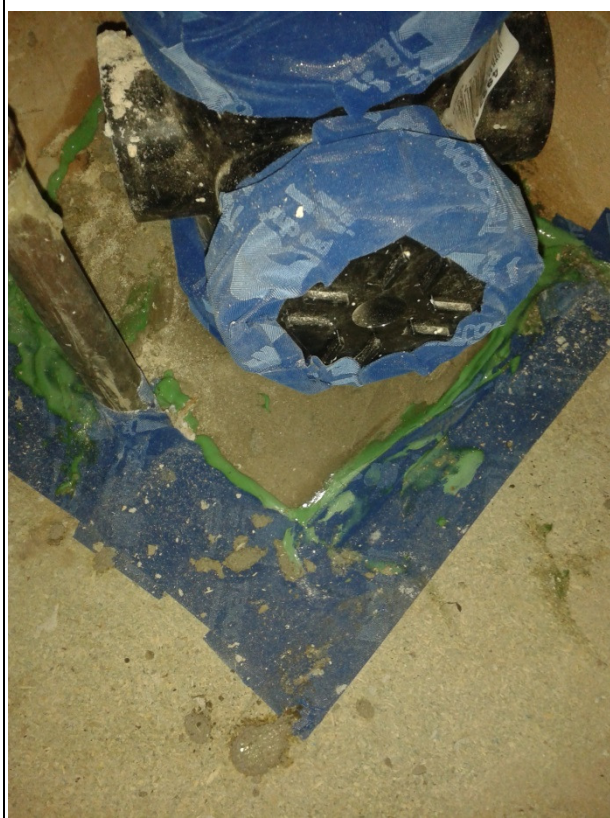
P8) Partially effective sealing at base of soil vent pipe, also tape seal over joints (item 3)

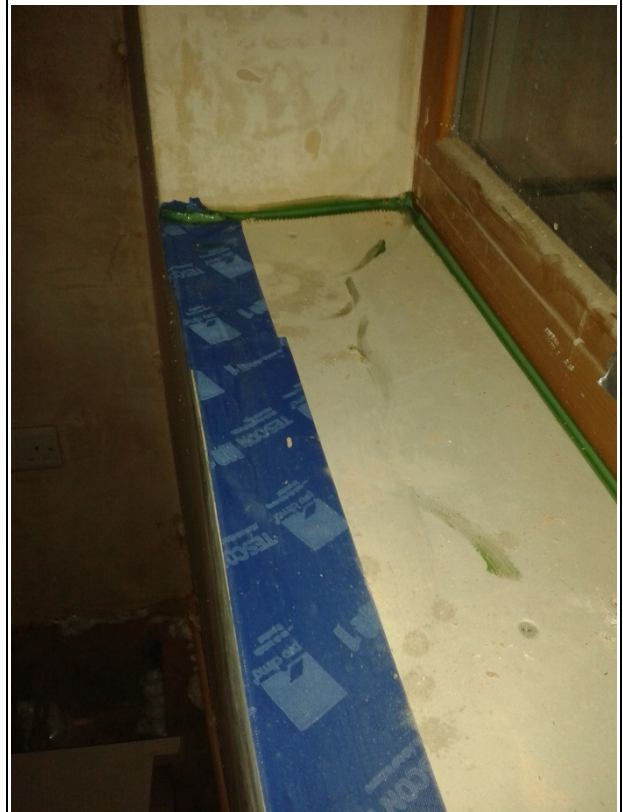
- 8) Leakage found around the window sills of various windows, at front, back and edges (although typically not all of these on any one window);
- 9) Penetrations through the internal party walls, in particular some 2" square cable trunking typically located in the intermediate floor void. This is another leakage site that has often been found to require resealing after ongoing installation works between airtightness tests;

P9) Tape along front edge of window sill to stop leakage at corner joint in plasterboard (item 8)

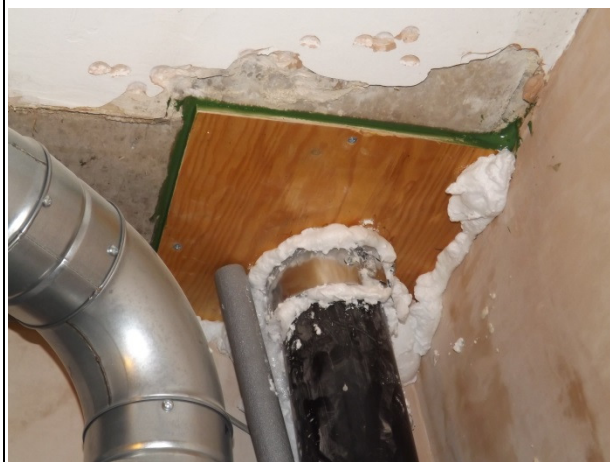
- 4) At the top of the soil vent pipe, which is fitted with a timber pattress sealed back to adjacent surfaces with foam and mastic. This seal has been found to be damaged on several occasions, so it is clearly vulnerable and must be robustly sealed. This may require some sort of wet concrete or levelling screed being applied from above once the timber pattress has been secured from below. At the very least the efficacy of the sealing must be checked before the soil vent pipe is boxed in;

P10) The timber battress at the top of the soil vent pipe in both No's 3 (shown) & 18 has had to be resealed more than once (item 4)

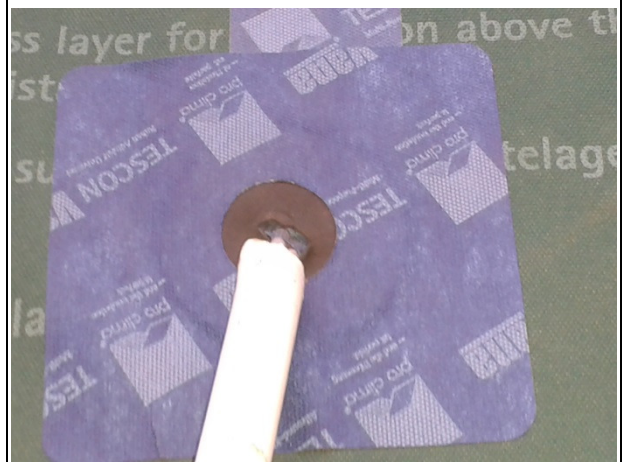
- 5) Cable penetrations through the front and rear facades, for example to connect to external lights, door bells and entry systems;
- 6) Leakage through the new ground floors, which essentially are sealed using a subfloor membrane tapes and sealed to both perimeter walls and internal partition walls;

P11) Ineffective seal where cable penetrates front façade (item 5)

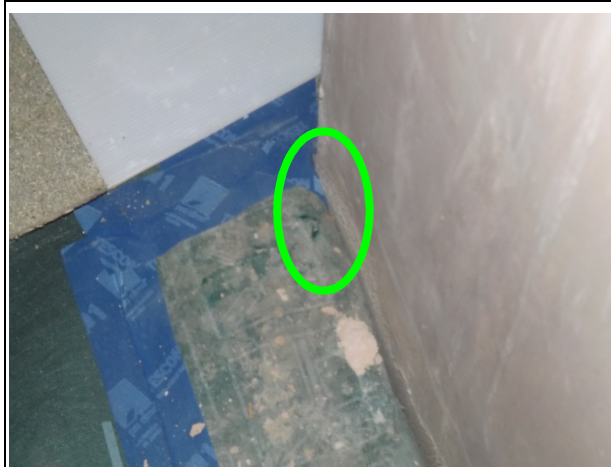
P12) Damage to subfloor membrane identified & then repaired before Vacupor insulation and floating floor installed (item 6)

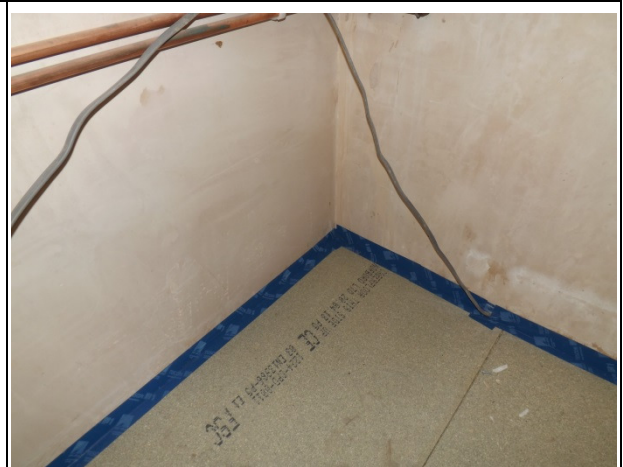
P13) Edge of floating floor sealing with Tescon tape to eliminate edge leakage (item 6)

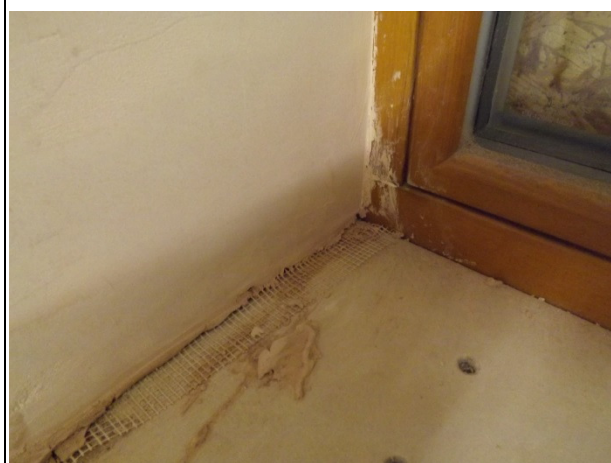
P14) Leakage along unfinished edge of window reveal (item 8)

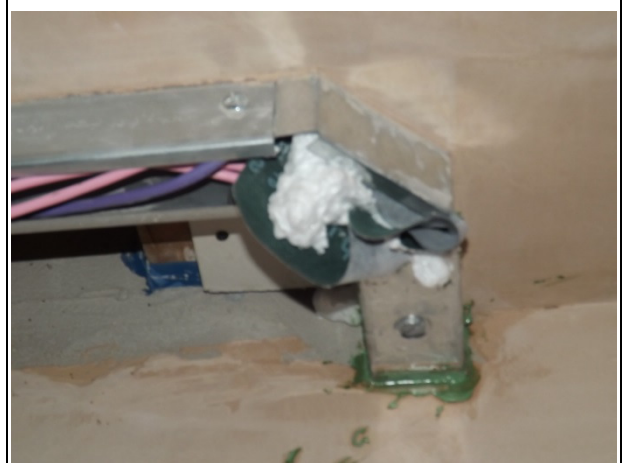
P15) 2" trunking sealed with foam and around with mastic – more than once (item 9)

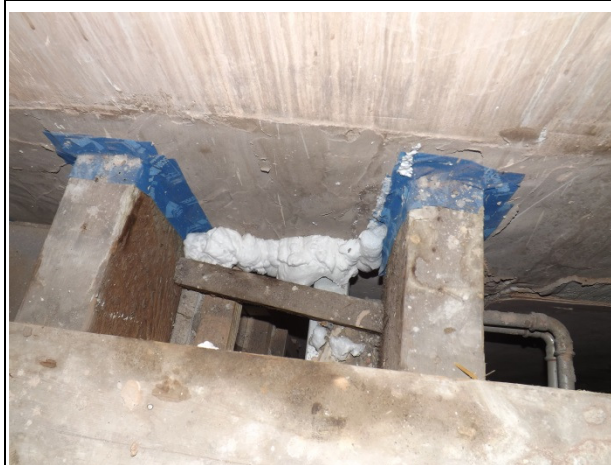
- 10) Leakage around floor joists embedded in the brickwork party walls and gable end walls. This is particularly an issue when there are cable penetrations close to the joist ends. Comparative testing in No. 3 suggested that sealing these leakage sites on both sides of a midblock dwelling could contribute as much as 0.2 ACH^{-1} of the reduction in the air change rate achieved. Hence it is clearly essential that this measure is effectively undertaken throughout the Erneley Close maisonettes;

P16) Tape and some foam sealing around floor joists into party wall (item 10)

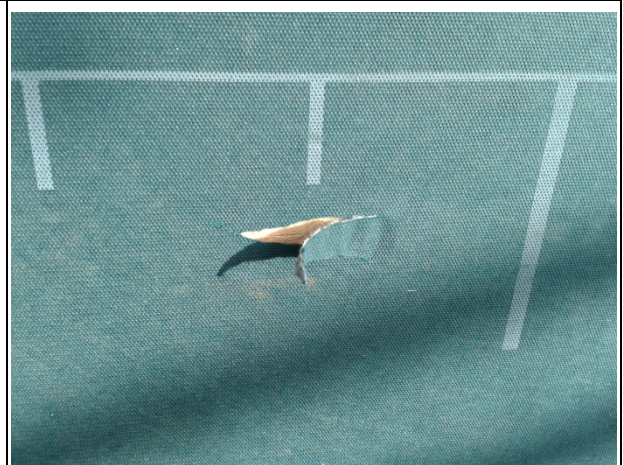
- 13) The DA membrane used to provide airtightness on the front and back facades, over new OSB, has been damaged and repaired in many places, and additional sealing has been carried out around the resin-anchored bolts by which the steelwork supporting the external insulation is secured. We suggest that it is advisable to carry out a pressurisation leakage check and inspect externally each dwelling once the steelwork is fitted but before the insulation is fitted, this should ensure that the DA membrane is fully sealed;

P17) Torn DA membrane, viewed externally (item 13)
