## Common Leakage Sites no.1

**Around the ends of floor joists built into the external wall, and to a lesser extent around joist hangers.**

**Building Fabric Leakage 1:- Around the ends of floor joists or hangers**

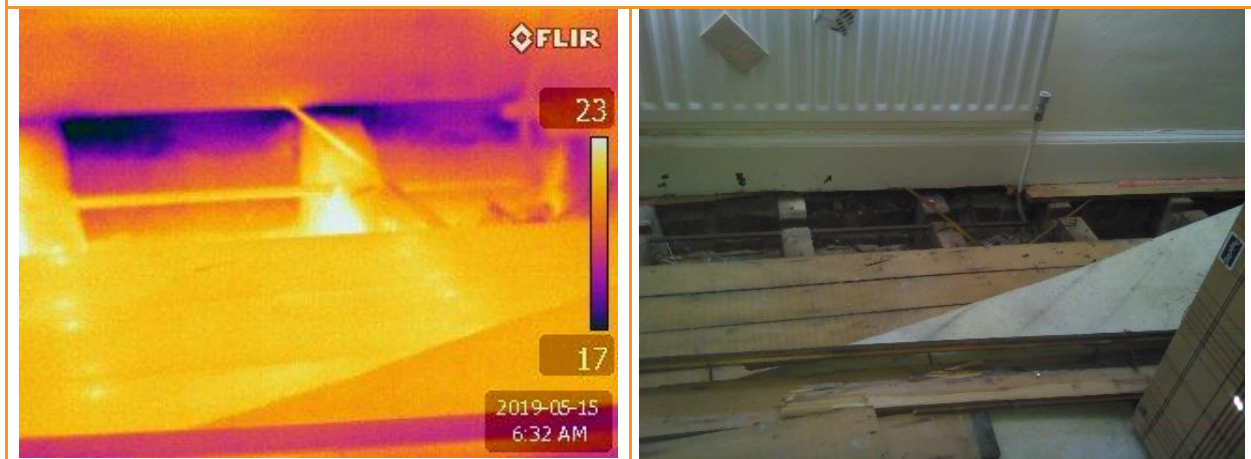
**1.05: Internal thermographic image with house depressurised, showing substantial leakage around perimeter of intermediate floor where floorboards lifted in bedroom to side of house**

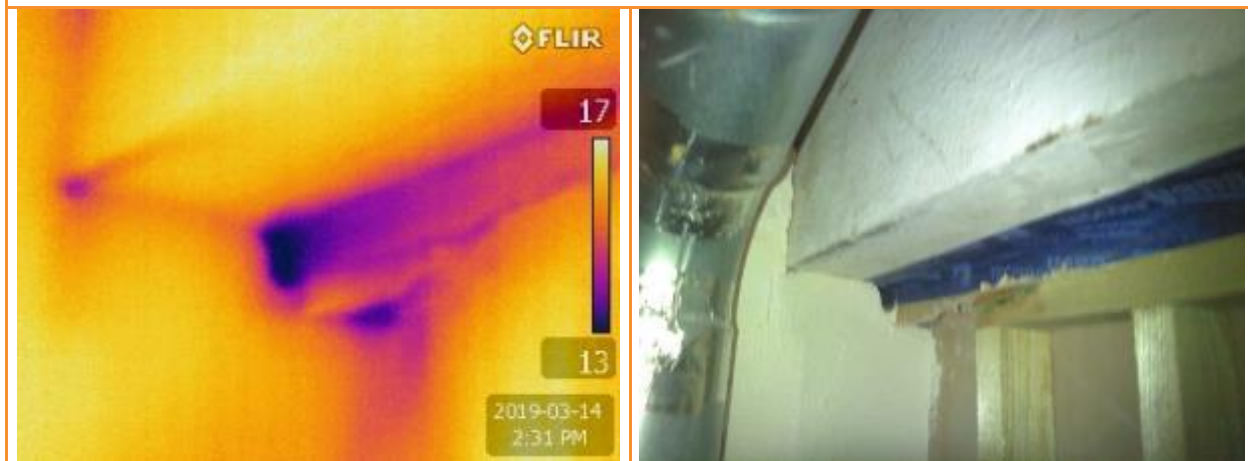
**1.08: Internal thermographic image whilst house depressurised, showing major leakage around roof joist in corner of single-storey section off kitchen**

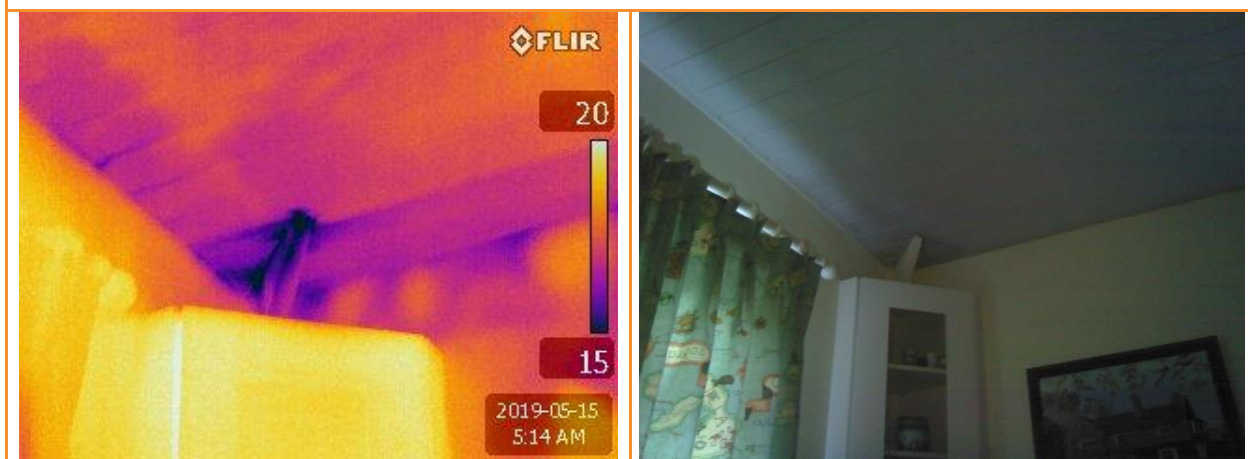
**1.09: Internal thermographic image whilst house is depressurised showing leakage beneath roof joist.**
