Common Leakage Sites No.12

Building Fabric Leakage 12: Through masonry walls

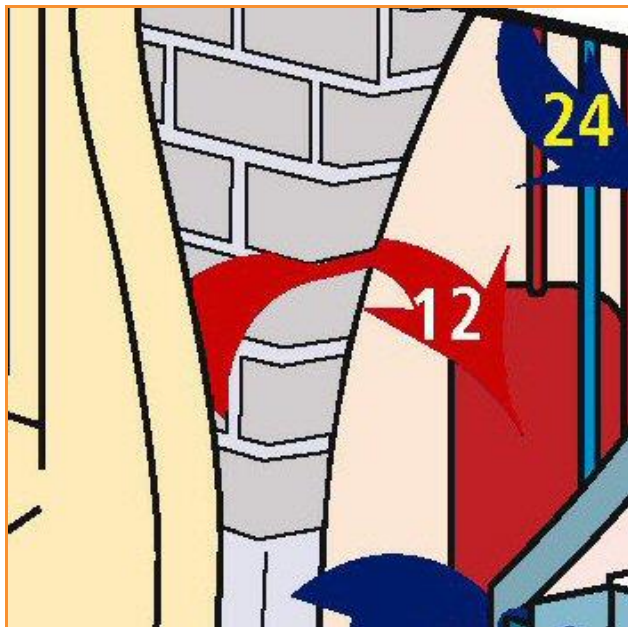
Through a porous masonry inner leaf, particularly with blockwork containing fuel ash from power stations.

Air is leaking from the wall cavity into a room through porous blockwork, which has been noted as an issue with blocks made using fuel ash from power stations. It can also apply in reverse where the external sealing of the wall, such as a render coat, is cracked and allows warm air from the room to escape to the outside.

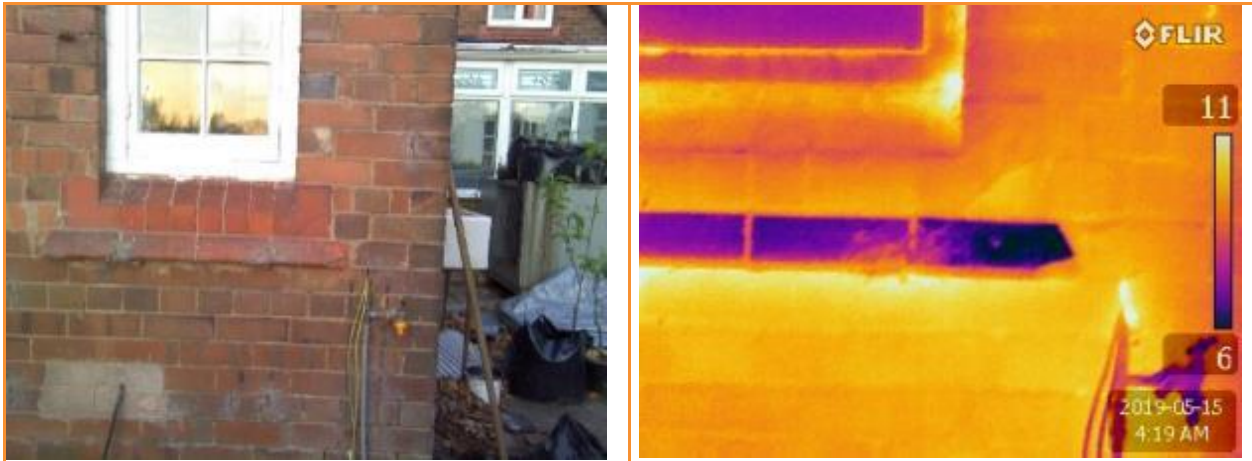
12.01: External thermographic image whilst house is pressurised showing heat escaping through crack in render, also underlying block pattern visible.

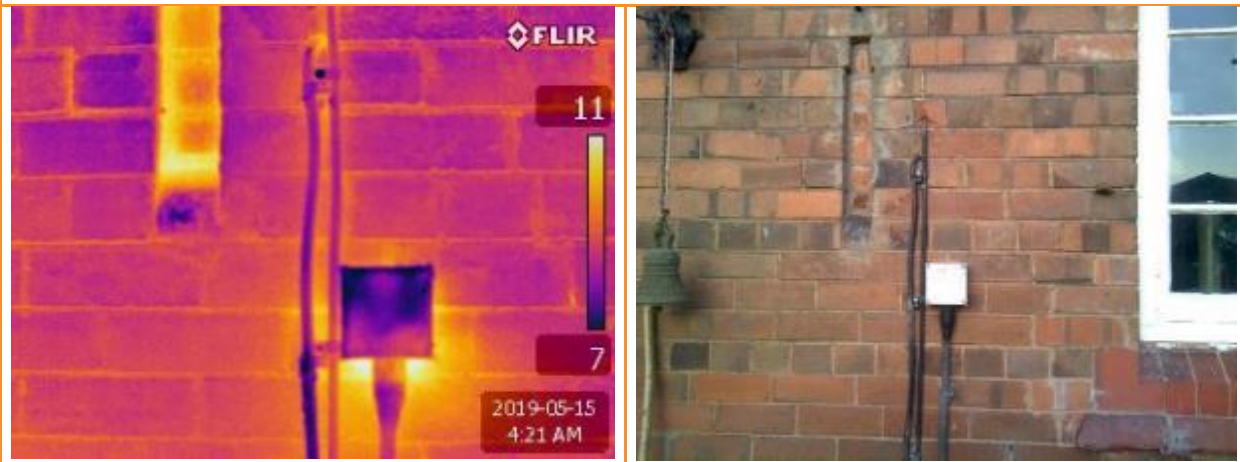
12.02: External thermographic image whilst house is pressurised showing leakage along the underside of a row of projecting bricks.

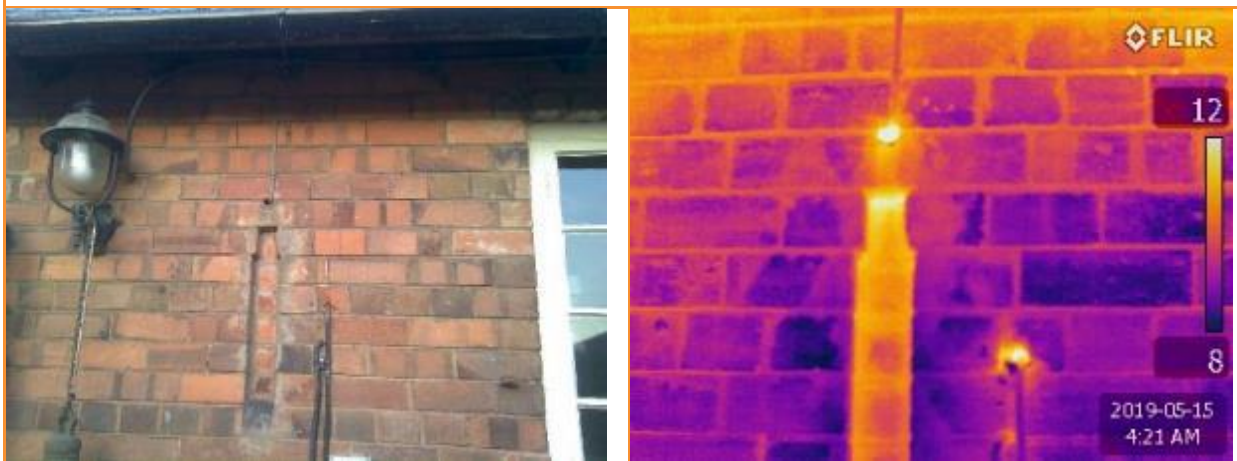
12.03: External thermographic image whilst house is pressurised showing leakage at base and side of brick alcove.

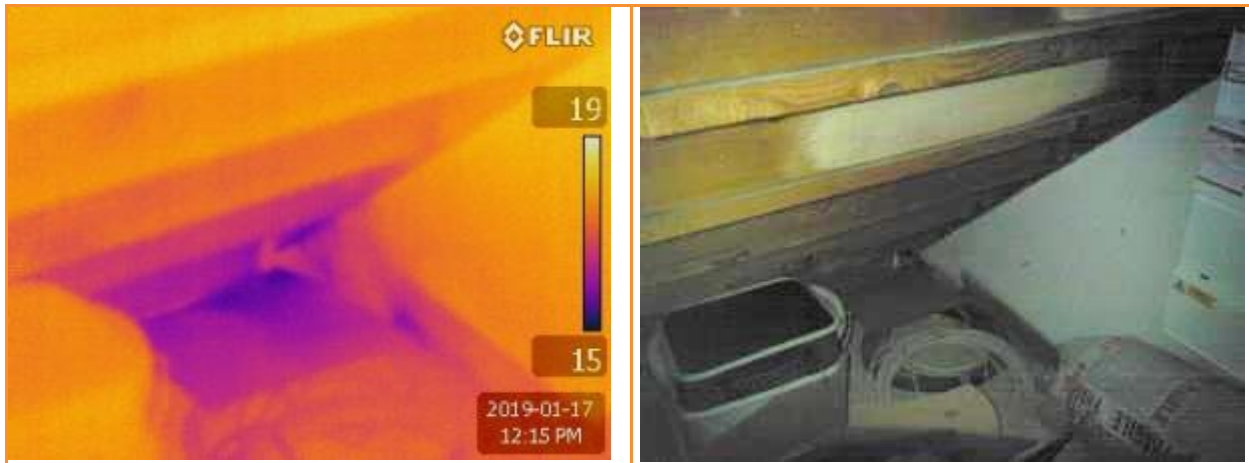
12.04: External thermographic image whilst house is pressurised showing leakage at top of brick alcove.

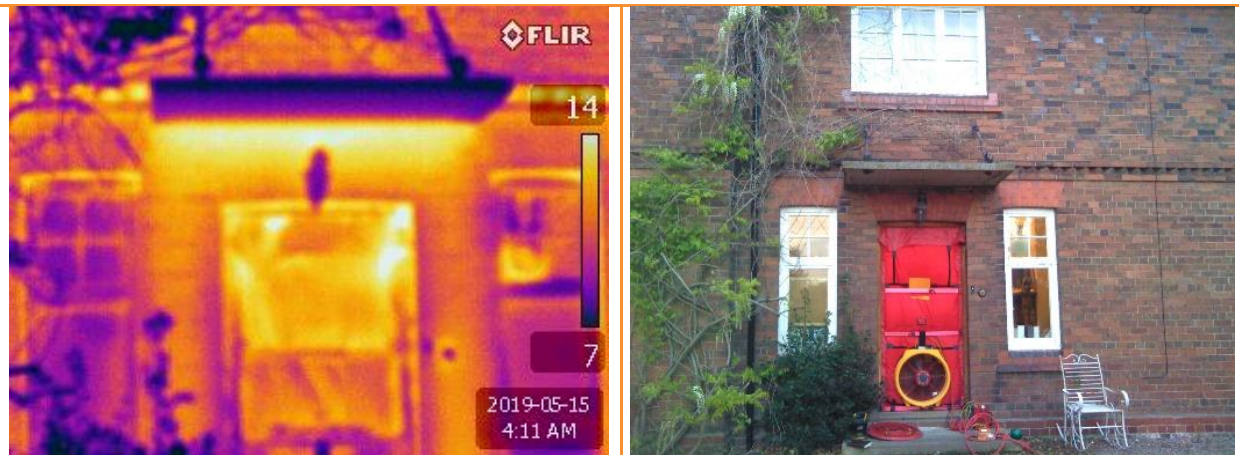
12.05: Internal thermographic image whilst house is depressurised showing leakage occurring beneath bottom of stairs, adjacent to wall to extension.

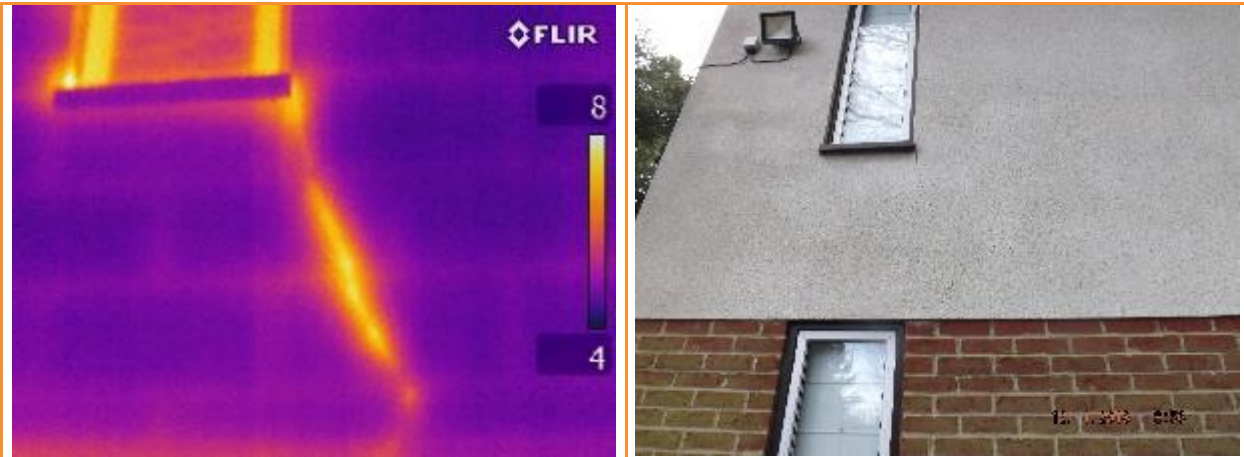
12.07: External thermographic image whilst house pressurised, showing heat loss along underside of projecting brickwork detail beneath side window

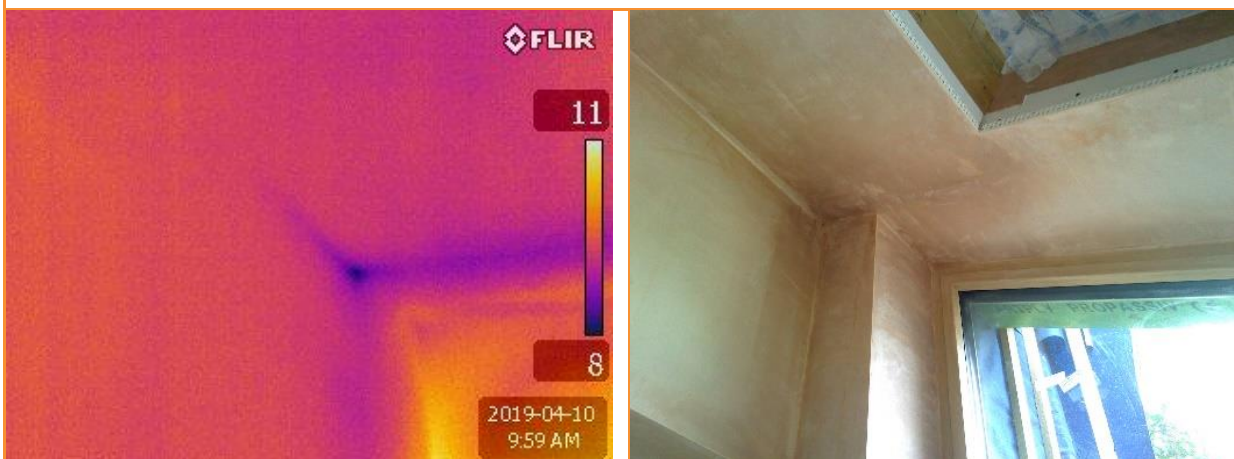
12.09: Thermographic image showing no discernable leakage around cable through the ceiling, but clearly a cold spot in corner where the external walls meet

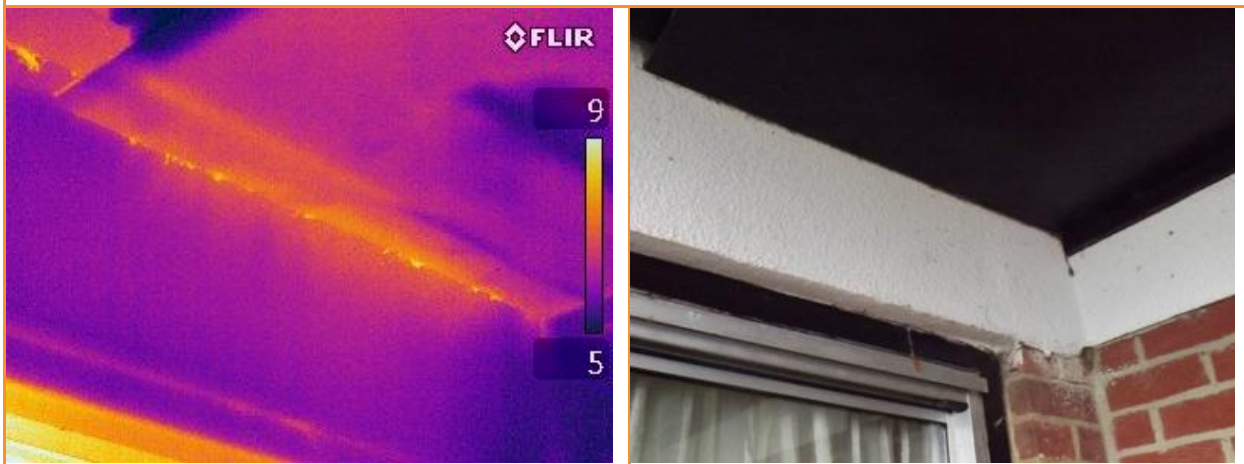
12.11: Thermographic image showing major leaks along the wall to balcony interface
