## Common Leakage Sites no.2

### **Beneath inner window sills and around window frames.**

**Building Fabric Leakage 2: Beneath window cills and around window frames**

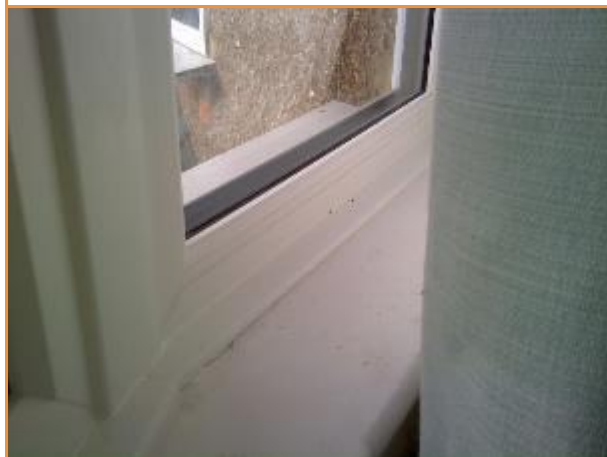
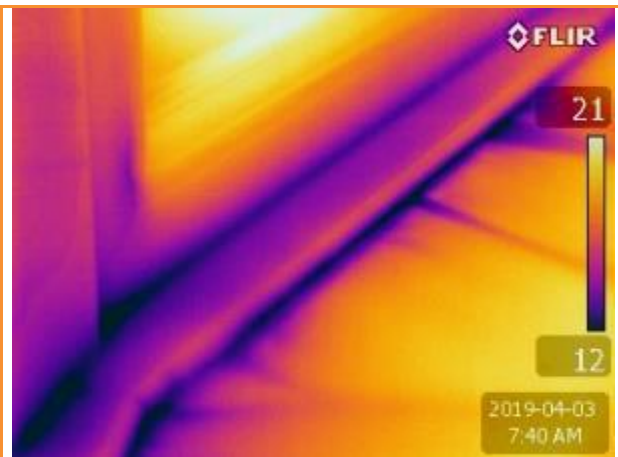
**2.01: Internal thermographic image whilst house is depressurised showing leakage across base of windows, also between back edge of sill and bottom of frame.**

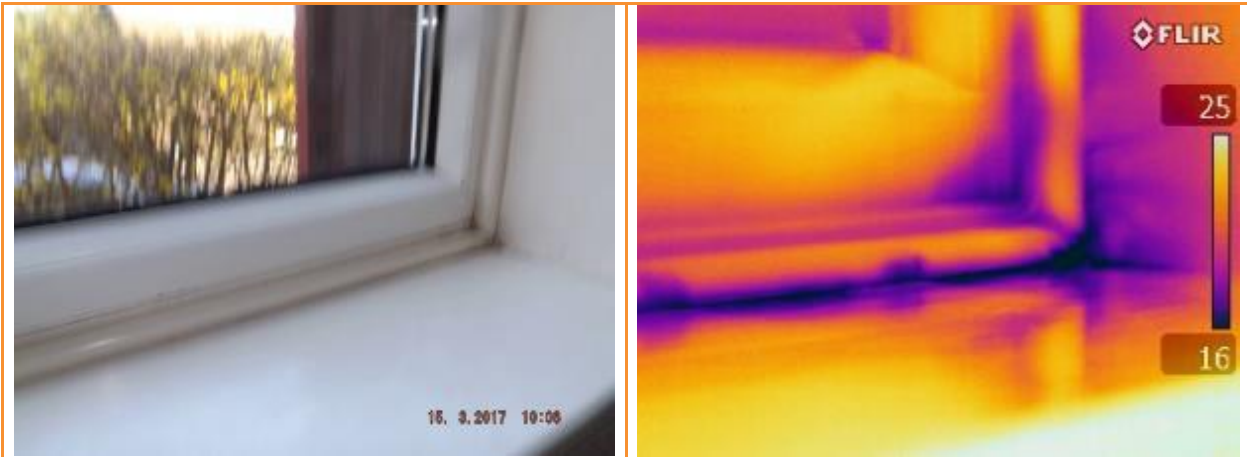
**2.02: Internal thermographic image whilst house is depressurised showing leakage around existing window.**

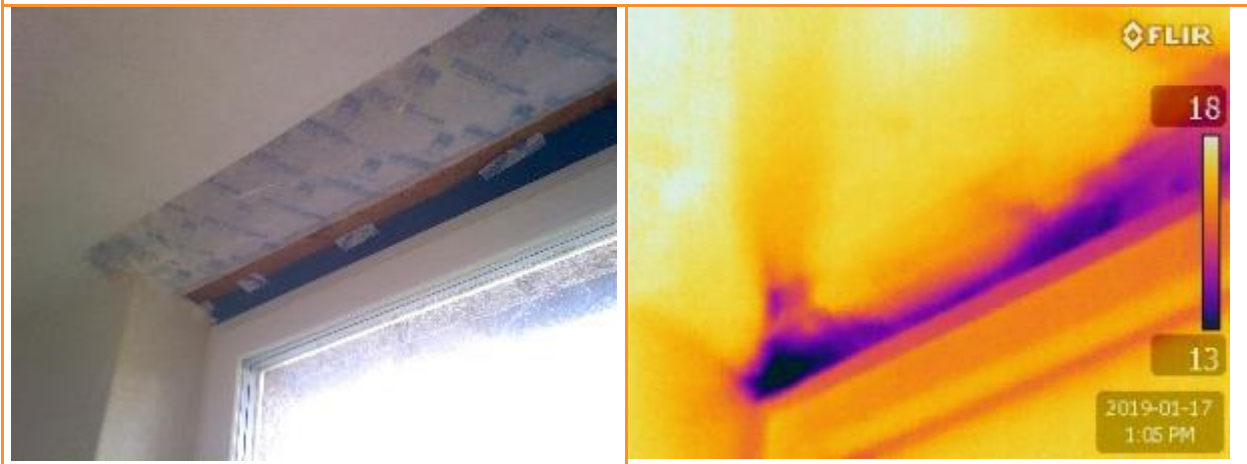
**2.03: Internal thermographic image whilst house being renovated is depressurised, showing leakage at top of bedroom window where sealing is unfinished.**

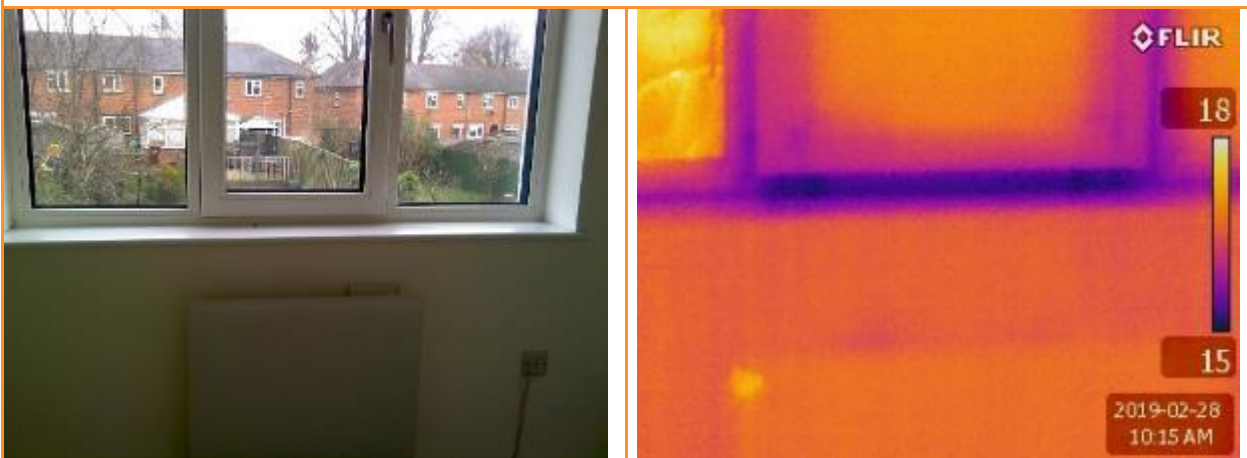
**2.04: Internal thermographic image whilst house is depressurised showing leakage across base of opening light in bedroom window.**

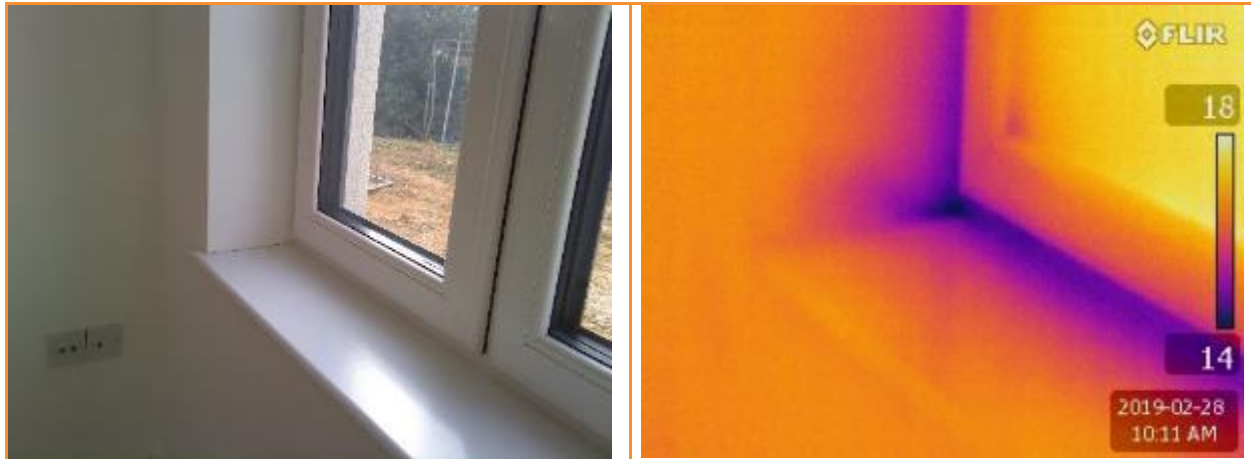
**2.05: Internal thermographic image whilst house is depressurised showing leakage at bottom corner of first floor window.**

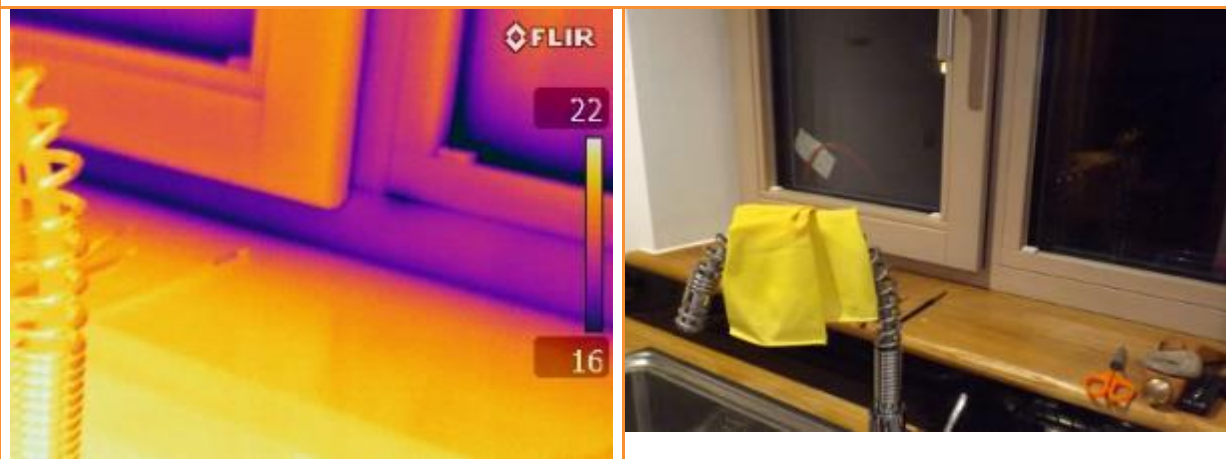
**2.06: Internal thermographic image whilst dwelling is depressurised showing leakage along back edge of window sill in kitchen.**

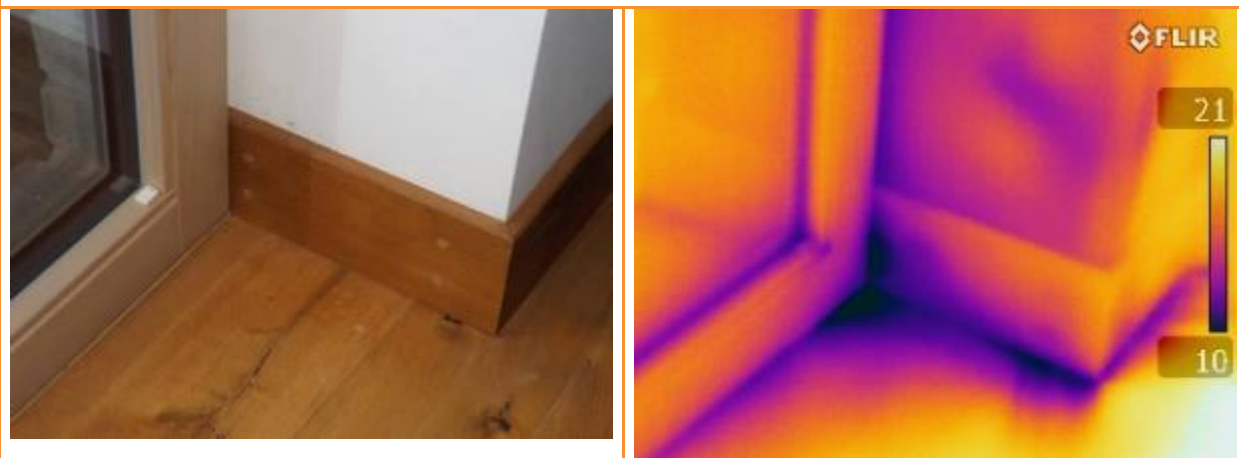
**2.07: Internal thermographic image whilst dwelling is depressurised showing leakage at lower corner of opening.**

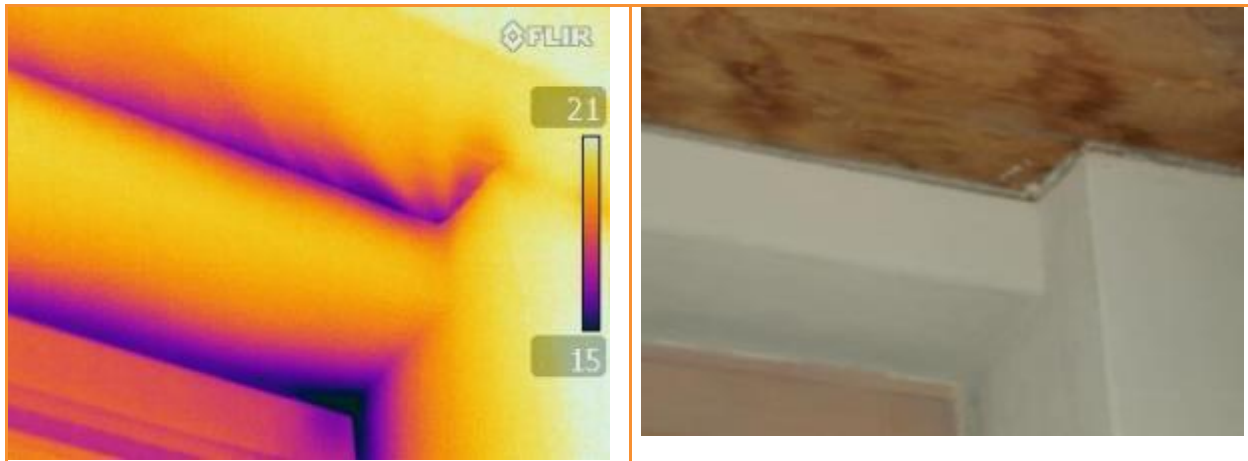
2.08: Internal thermographic image whilst dwelling is depressurised showing leakage around window.

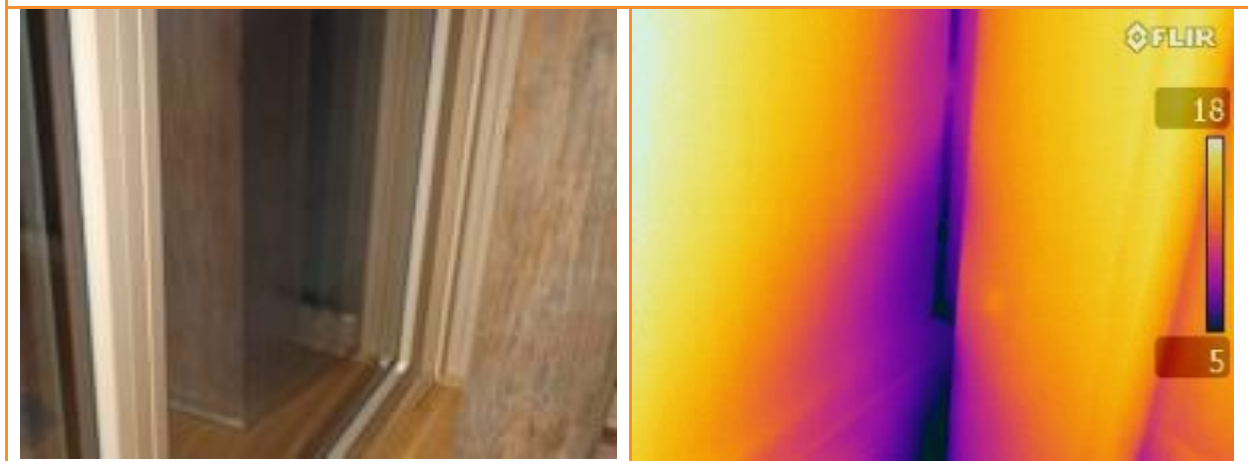
2.09: Internal thermographic image whilst dwelling is depressurised showing leakage down the side of a window frame.

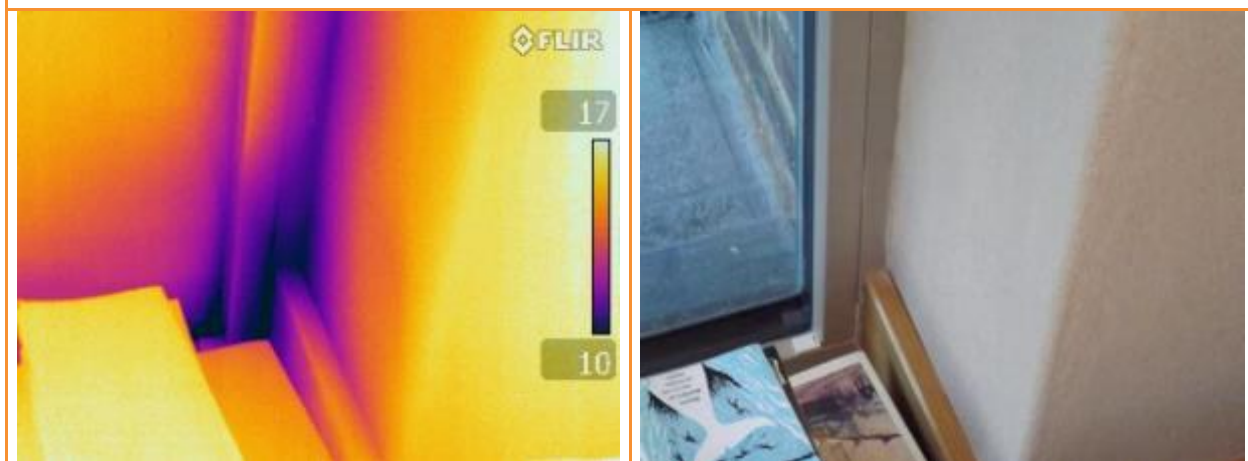
2.10: Internal thermographic image whilst dwelling is depressurised showing leakage showing leakage around skirting board at side of window.

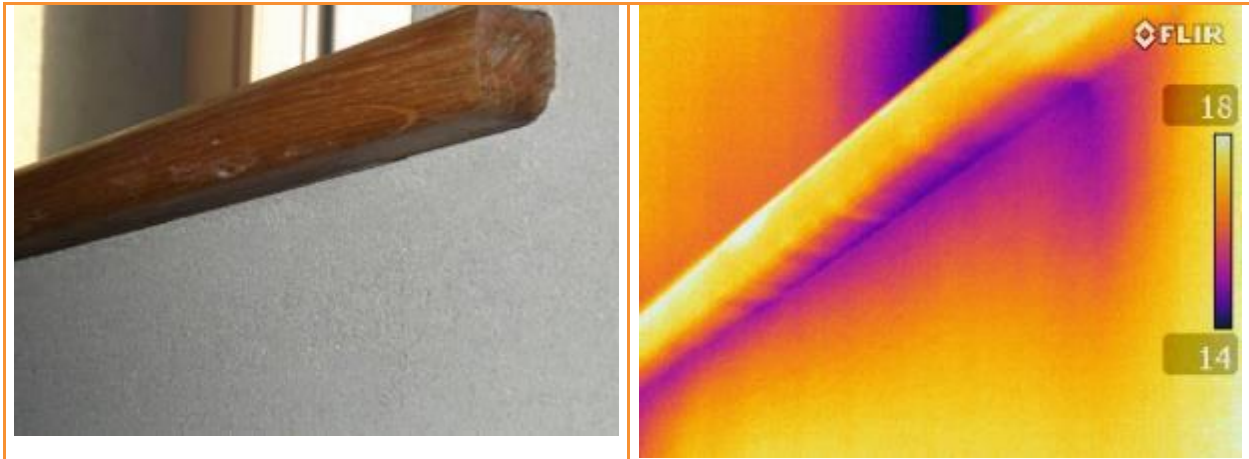
**2.11: Internal thermographic image whilst dwelling is depressurised showing leakage along underside of window sill.**

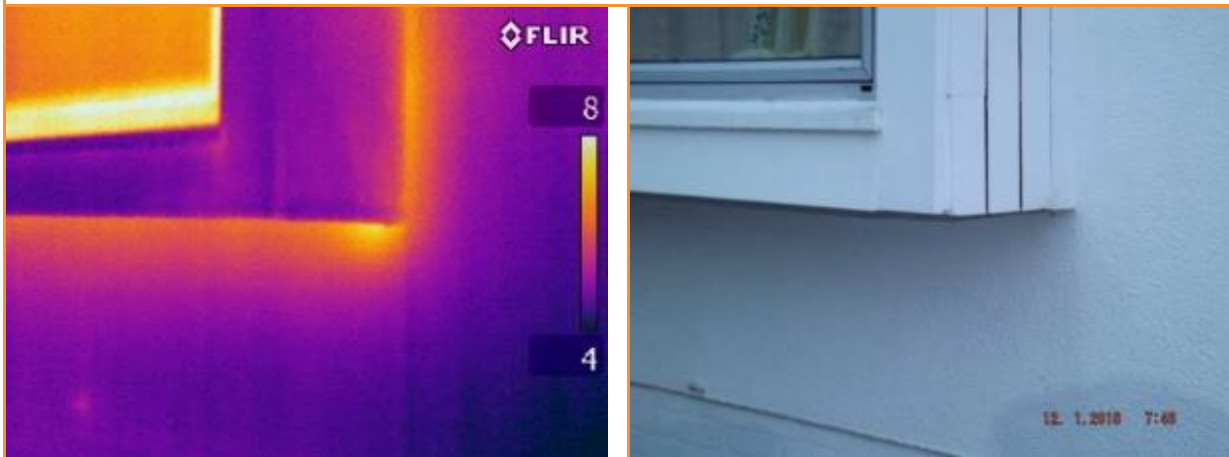
**2.12: External thermographic image whilst house is pressurised showing leakage around projecting window, particularly at bottom corner.**

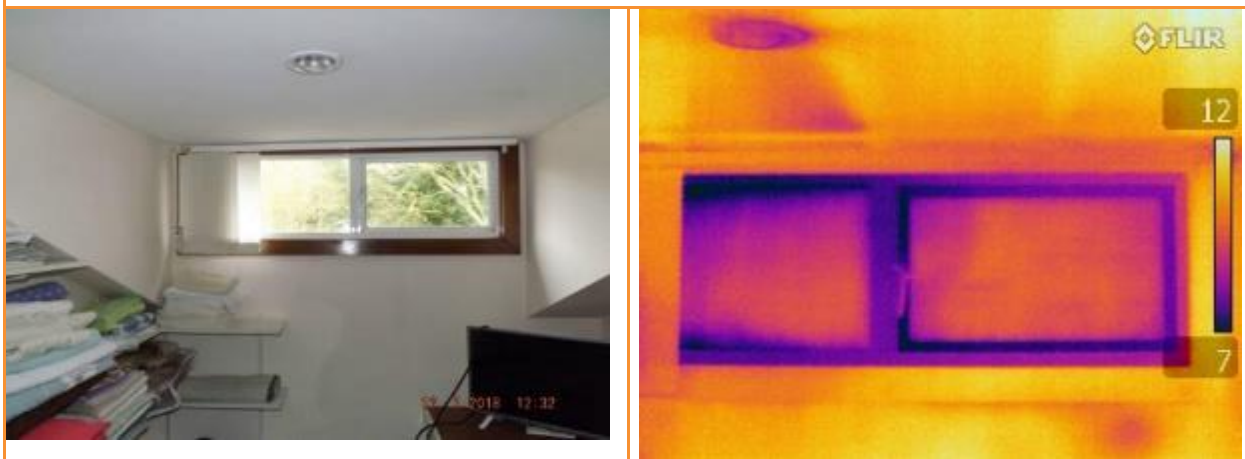
**2.13: Internal thermographic image whilst house is depressurised showing leakage around top floor dormer window.**

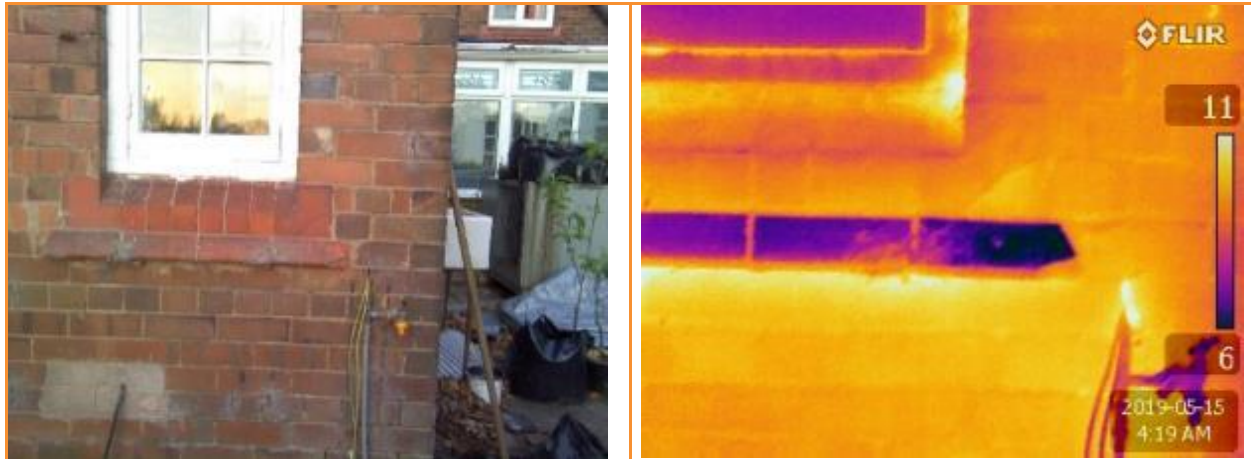
**2.14: External thermographic image whilst house is pressurised showing leakage at bottom corner of window opening.**

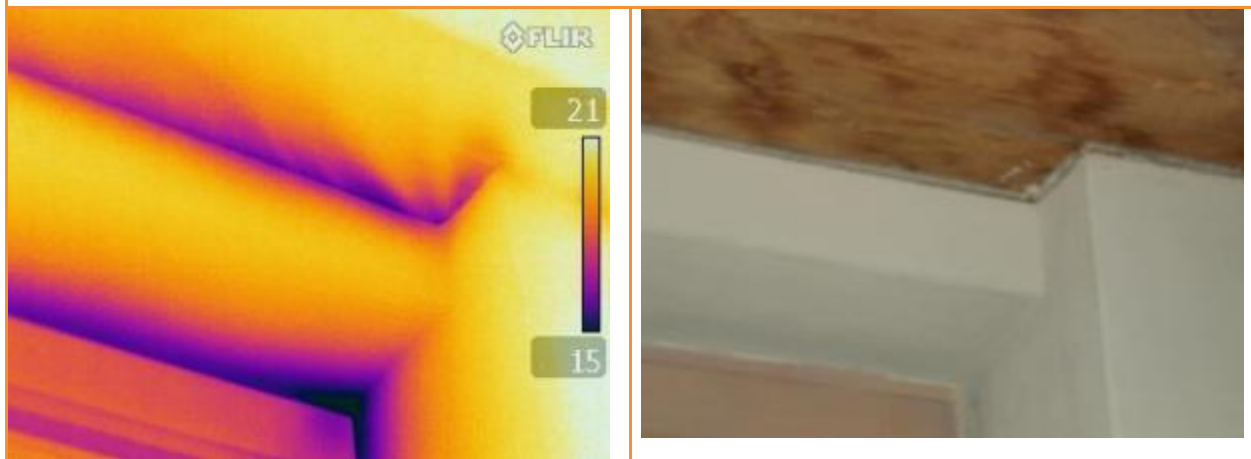
**2.15: Internal thermographic image whilst dwelling is depressurised showing leakage around window opening.**

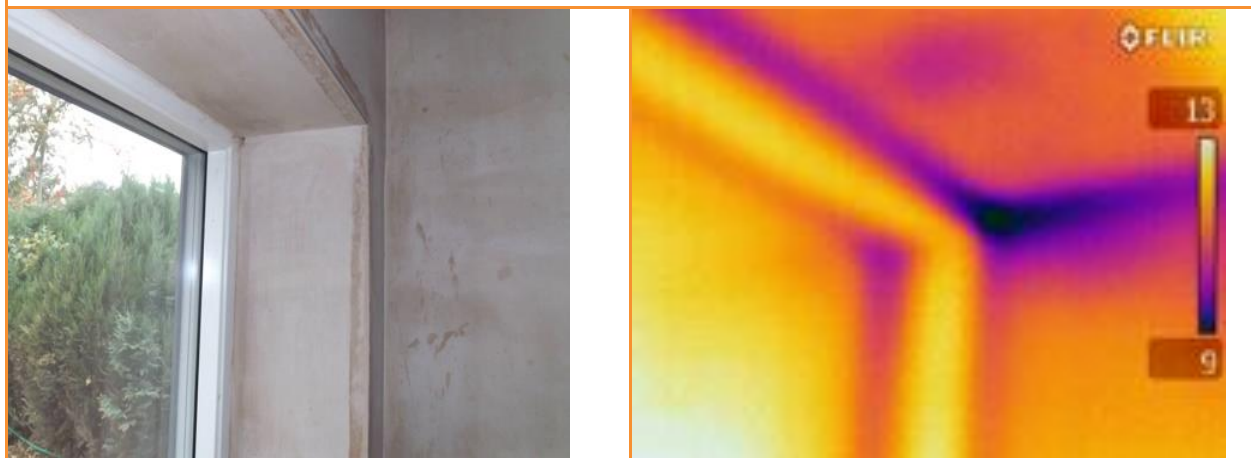
**2.16: Internal thermographic image whilst dwelling is depressurised showing leakage at top corner of window opening.**

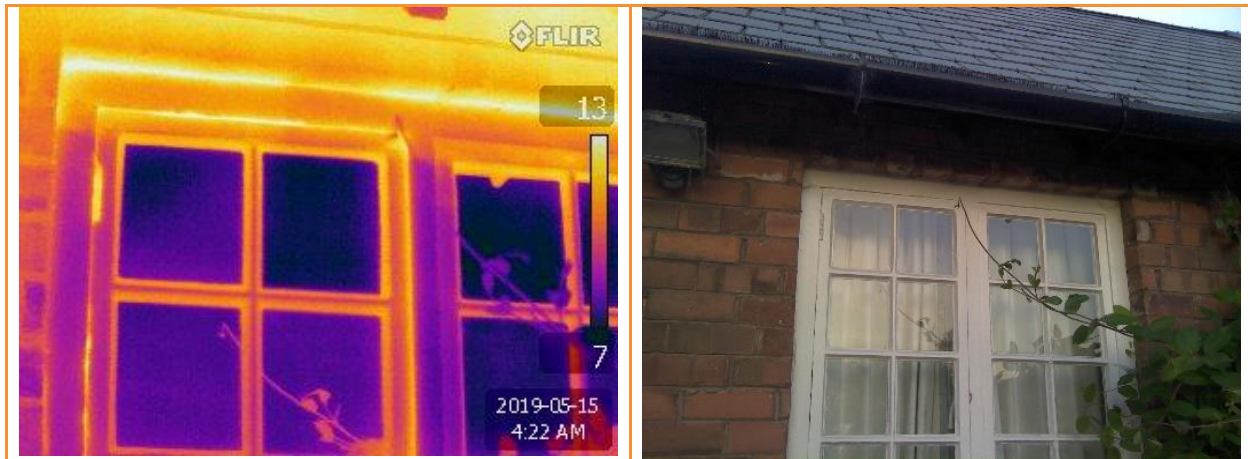
**2.17: External thermographic image whilst house pressurised showing leakage around the opening window but also between the window frame and the wall above**

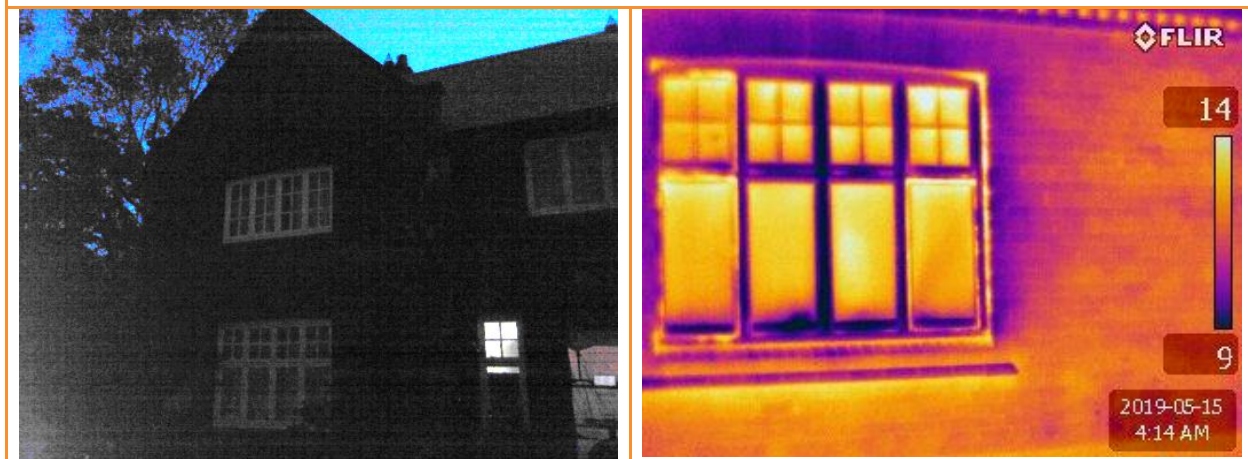
**2.18 External thermographic image whilst house is pressurised showing leakage around the lower window frame in numerous different places**

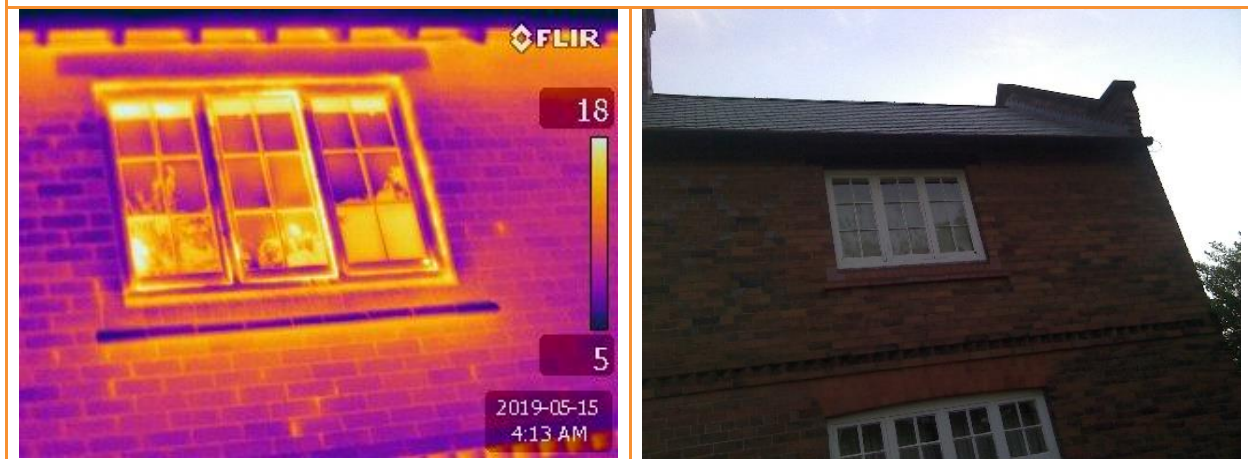
**2.19: External thermographic image whilst house pressurised, showing leakage around upper right front window. Also, eaves leakage and leakage under brick detail visible**

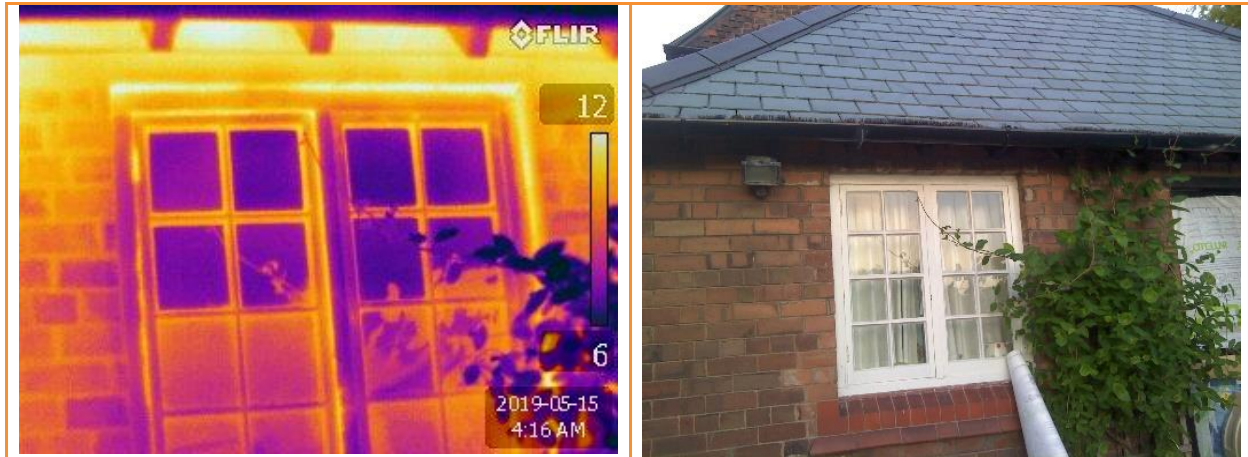
**2.20: External thermographic image whilst house pressurised, showing leakage around rear window. Also, substantial eaves leakage visible**

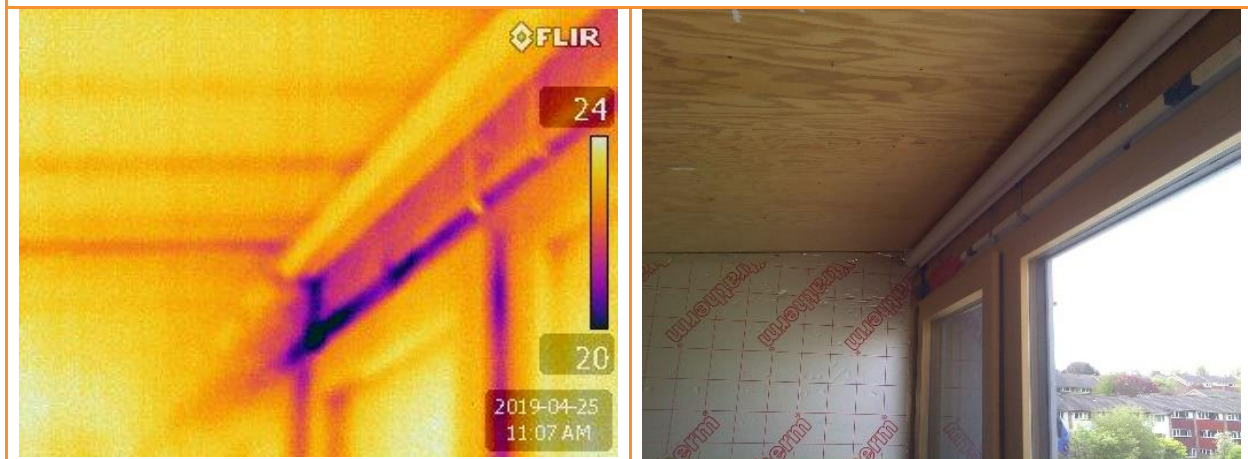
**2.21: Thermographic image whilst house depressurised, showing substantial leakage across top of upper opening, also apparent between windows and in the corner where the external wall meets the return**

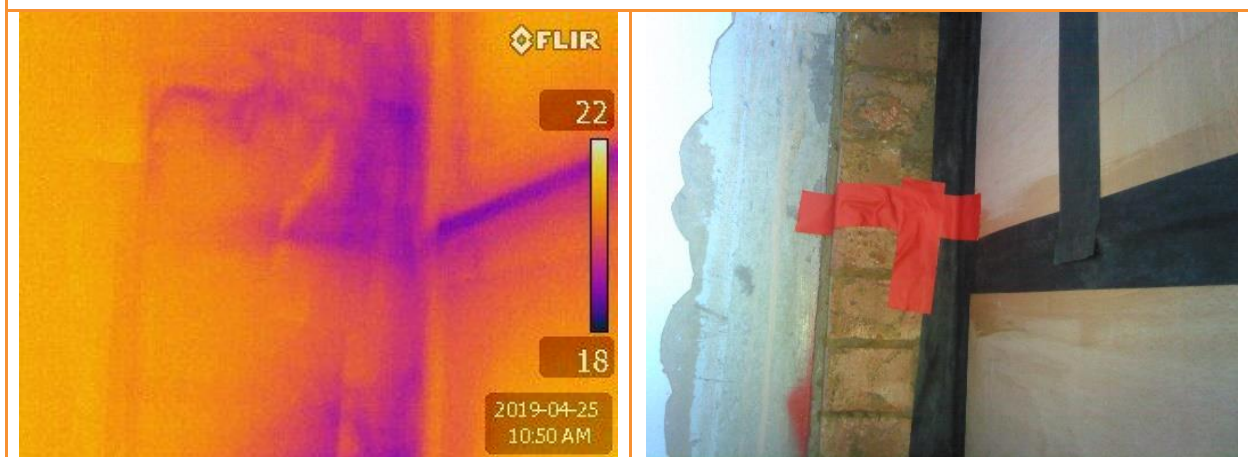
**2.22: Thermographic image showing leakage both at the side of and beneath the window frame**

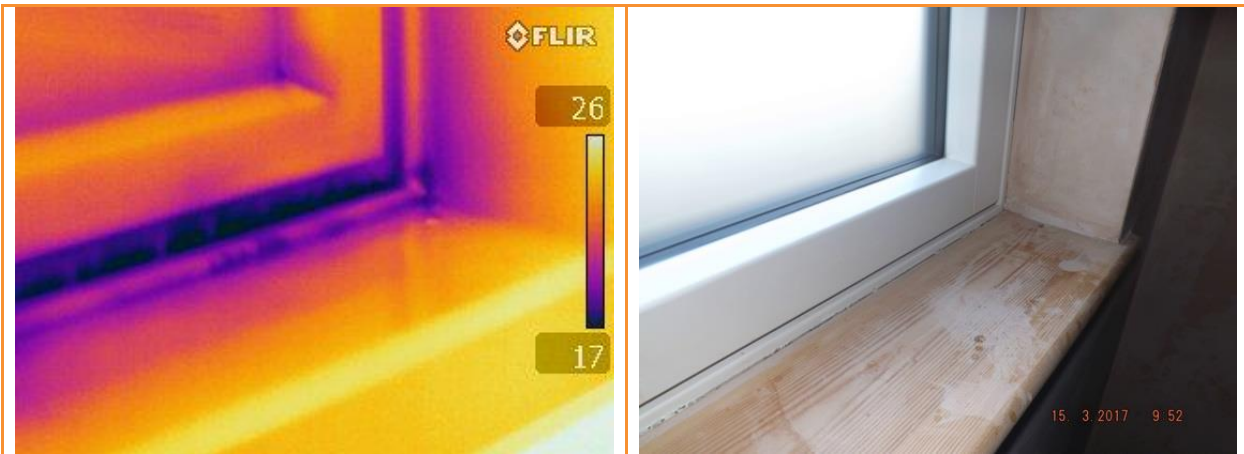
**2.23: Thermographic image of leakage across back edge of window sill and where window leaking along bottom draughtseals**

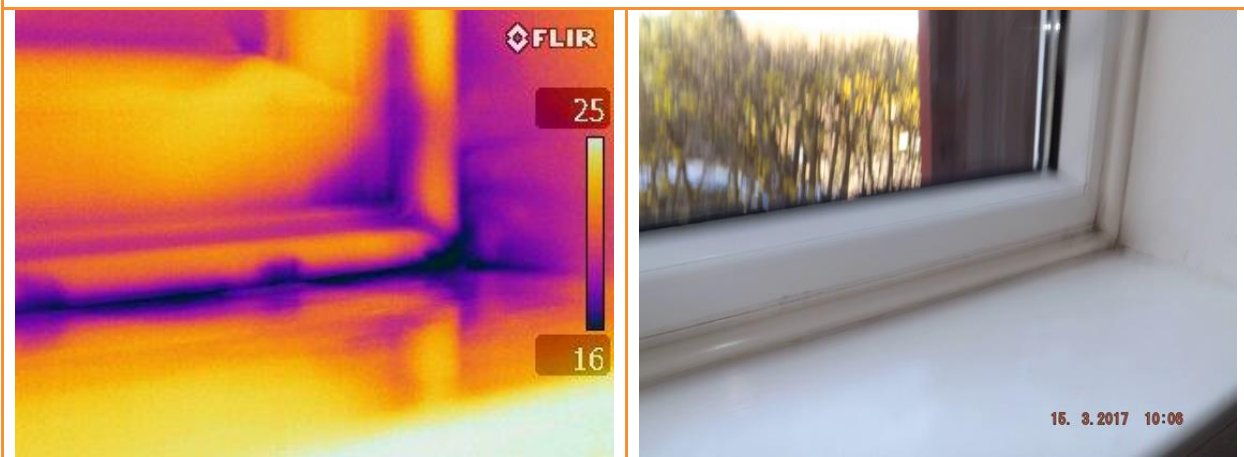
**2.24: Thermographic image illustrating leakage along bottom edge of older windows**

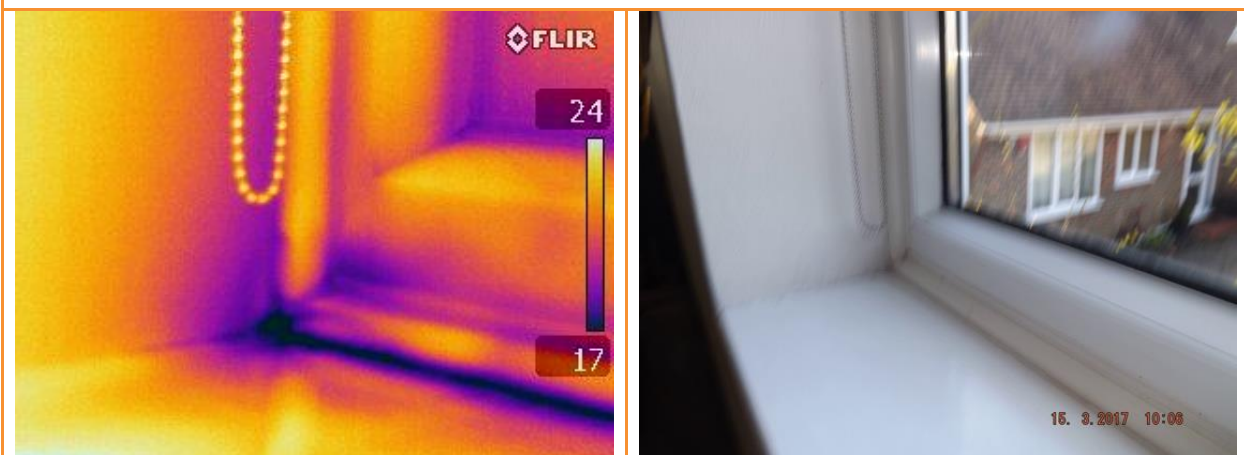
**2.25: Thermographic image of leakage along bottom edge of older windows**

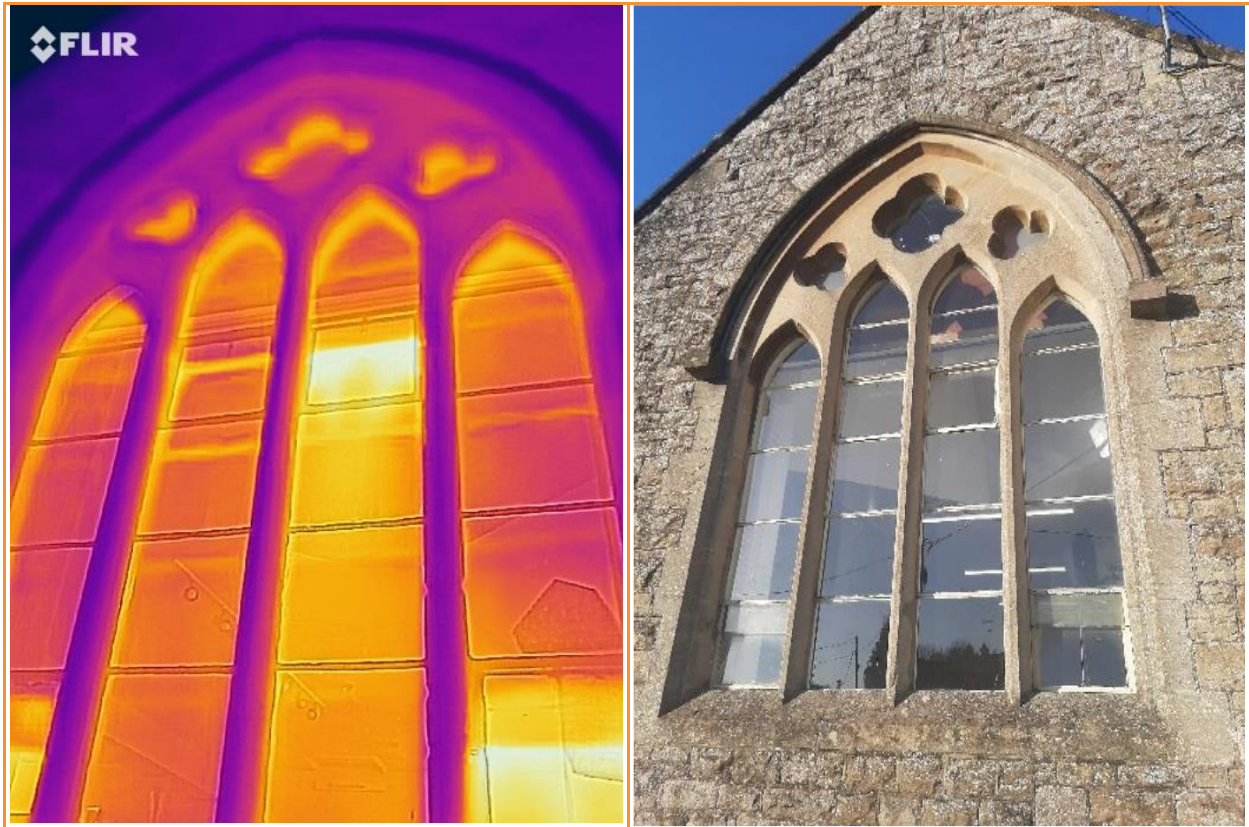
**2.26: External thermographic image whilst building pressurised, showing substantial warm air (white/yellow) escaping the building through two windows that don't close properly. Yellow line around the outside of the windows also suggests leakage between the windows and the adjoining stonework, particularly at the top**

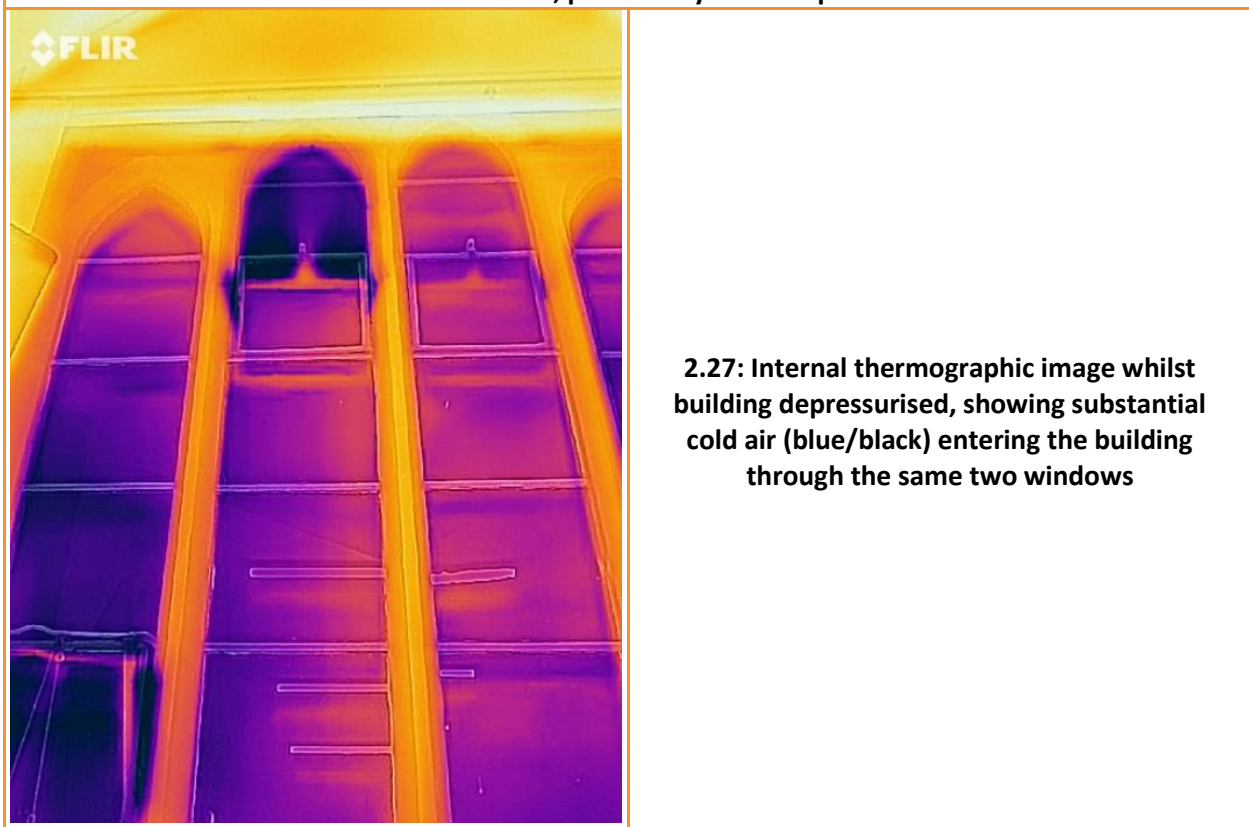
**2.27: Internal thermographic image whilst building depressurised, showing substantial cold air (blue/black) entering the building through the same two windows**

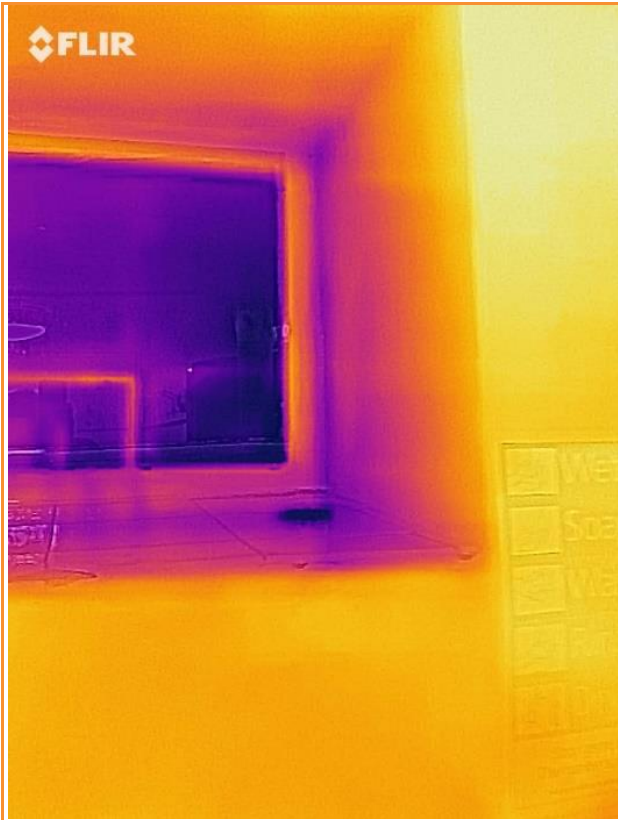
**2.28: Internal thermographic image while building depressurised showing leakage of cold air (blue/black) around window in ladies' toilet. Particular leakage visible through a hole beneath the bottom right of the frame**

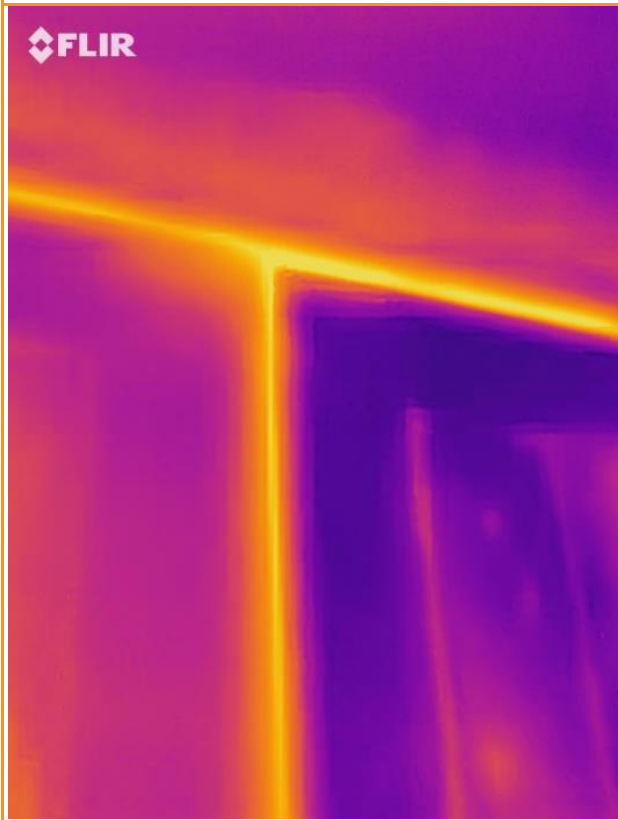
**2.29: External thermographic image while building is pressurised showing leakage of warm air (yellow) at side and top of window in gents' toilet.**

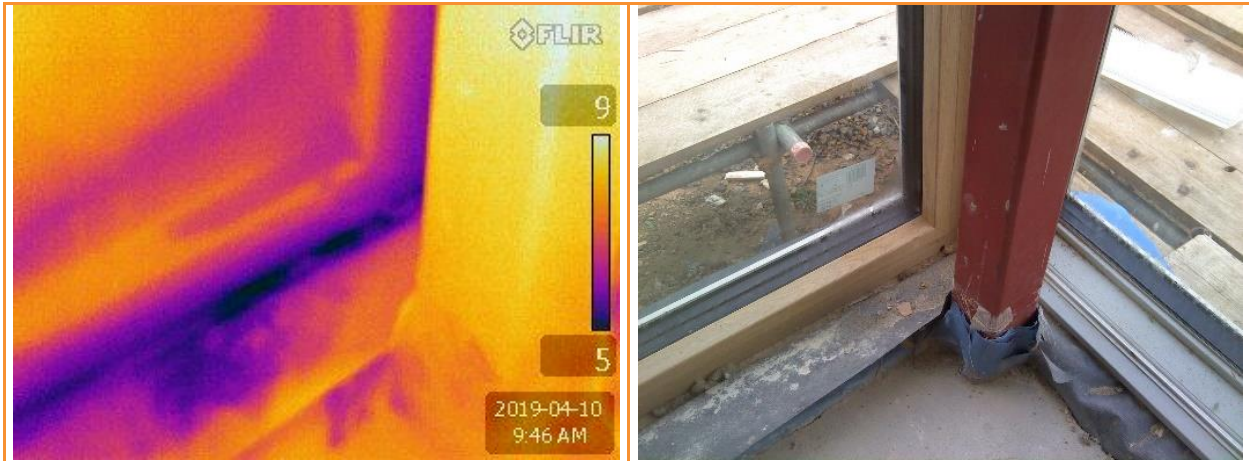
**2.30: Thermographic image showing substantial leakage under base of window in corner of lounge**

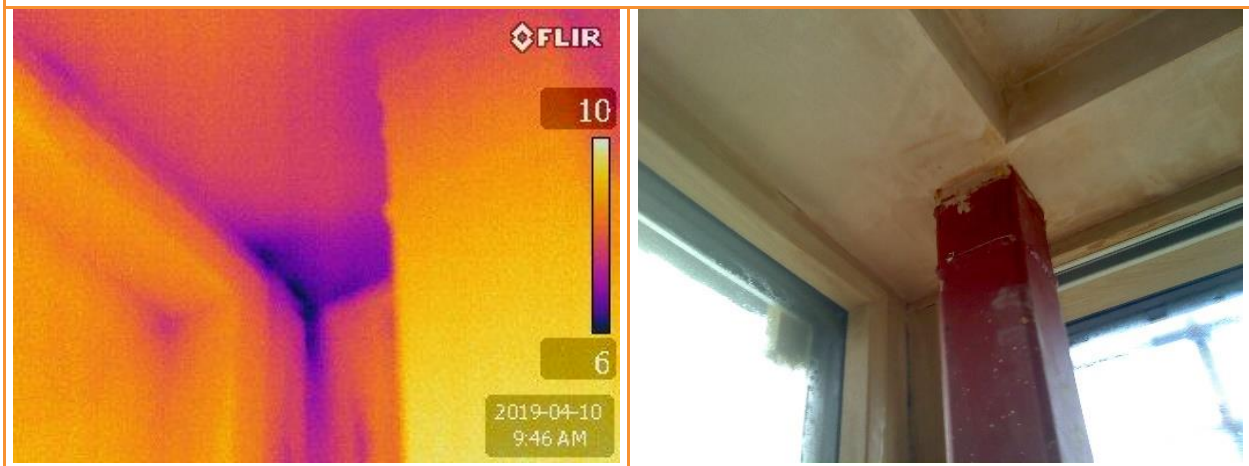
**2.31: Thermographic image showing significant leakage at top of corner window in lounge**

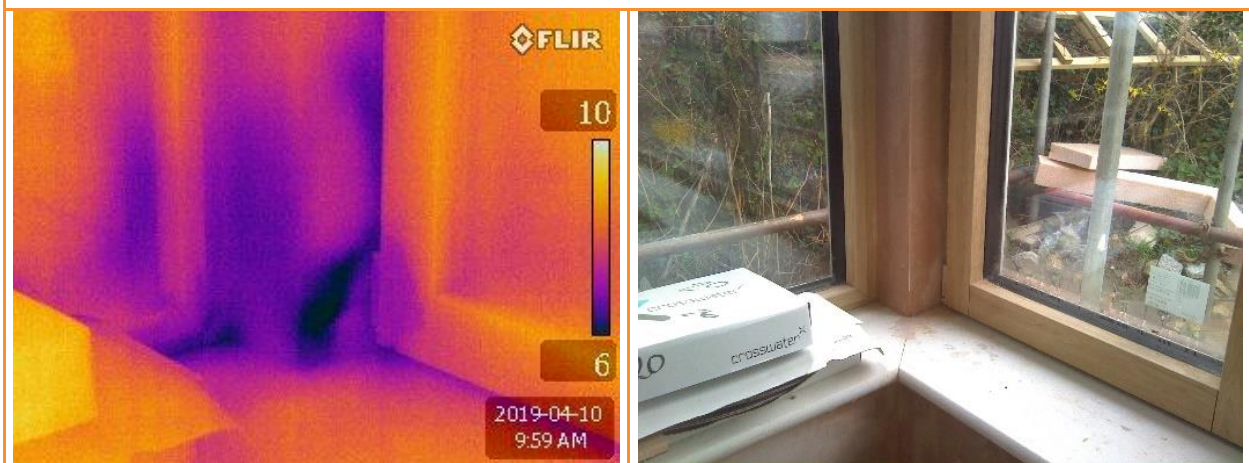
**2.32: Thermographic image showing substantial leakage at corner joint between windows in the first floor bedroom**

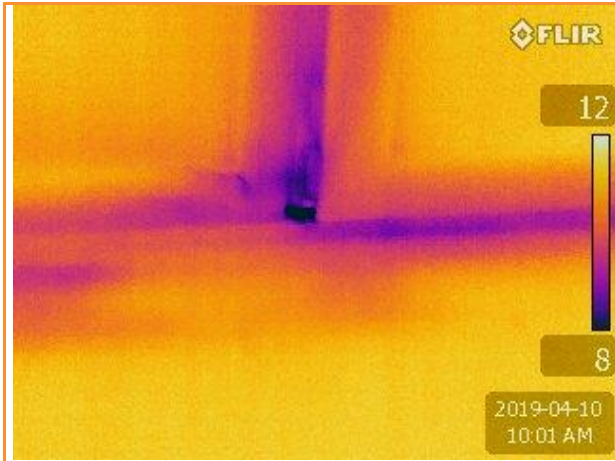
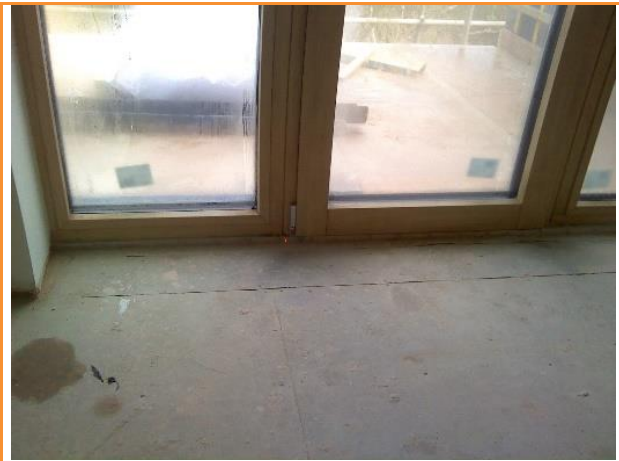
**2.33: Thermographic image showing leakage through hole at base of joint between sections of window, first floor rear**

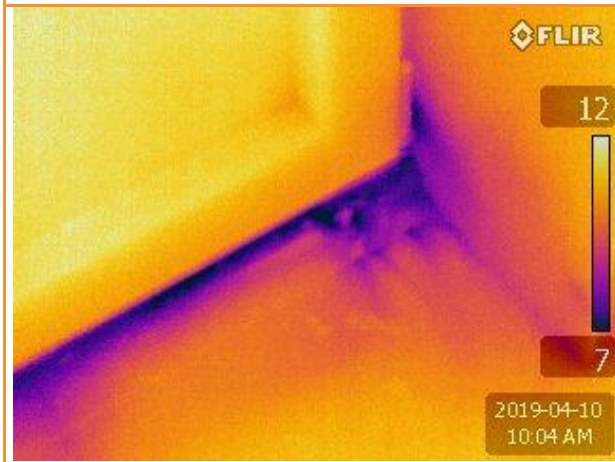
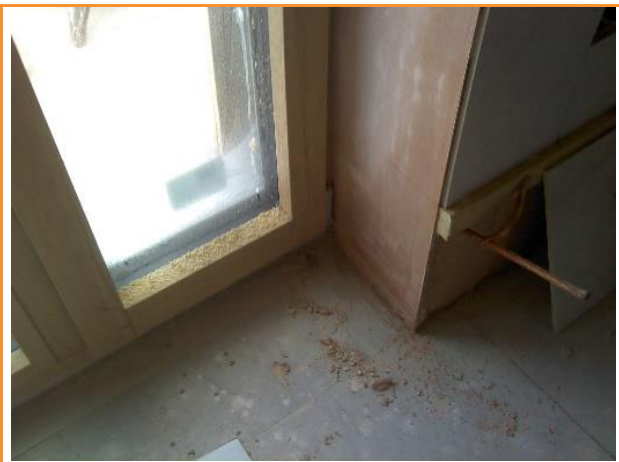
**2.34: Thermographic image showing leakage occurring near the bottom left corner of the rear bedroom windows, first floor**

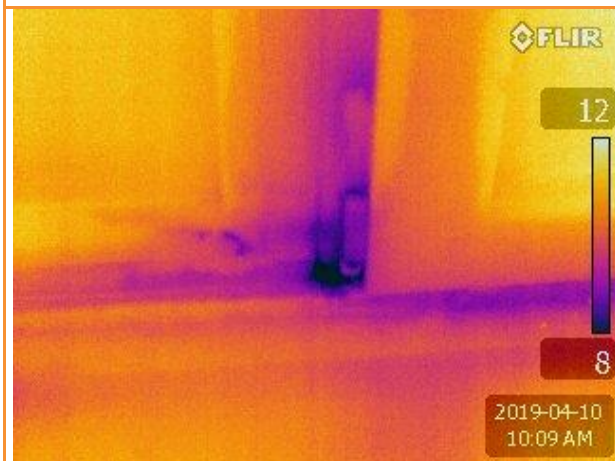
**2.35: Thermographic image showing leakage around lower hinge of first floor window**

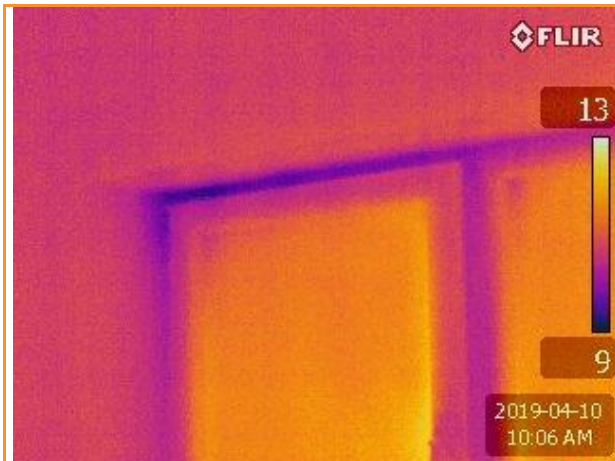
**2.36: Thermographic image showing leakage at head of first floor window**

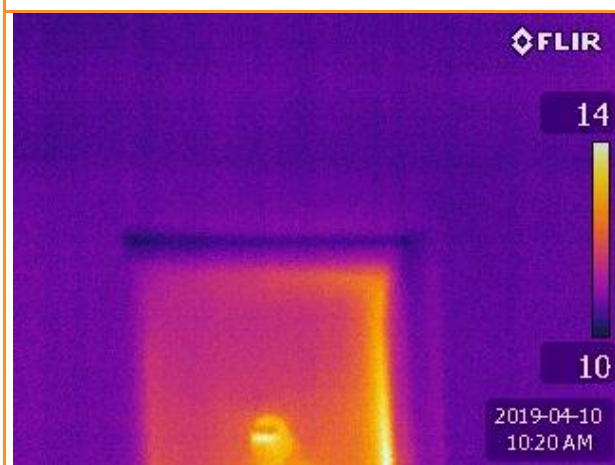
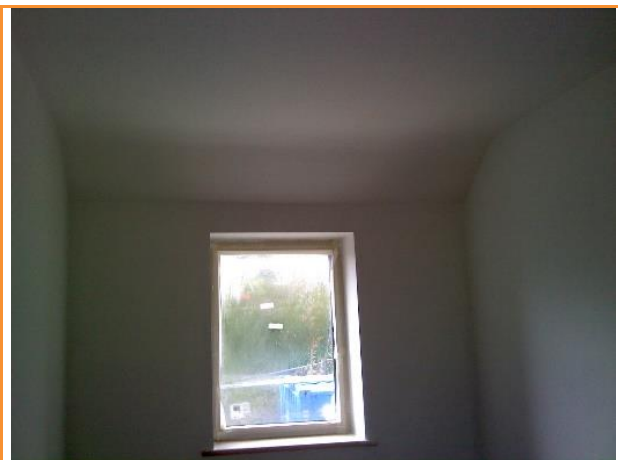
**2.37: Thermographic image showing leakage across top of stairwell window**

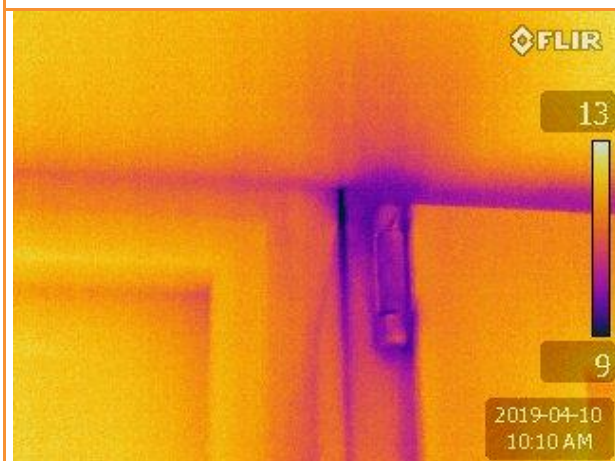
**2.38: Thermographic image showing leakage between sections of window just below the head, first floor bedroom, also around hinge**
