## Common Leakage Sites no.2

### **Beneath inner window sills and around window frames.**

**Building Fabric Leakage 2: Beneath window cills and around window frames**

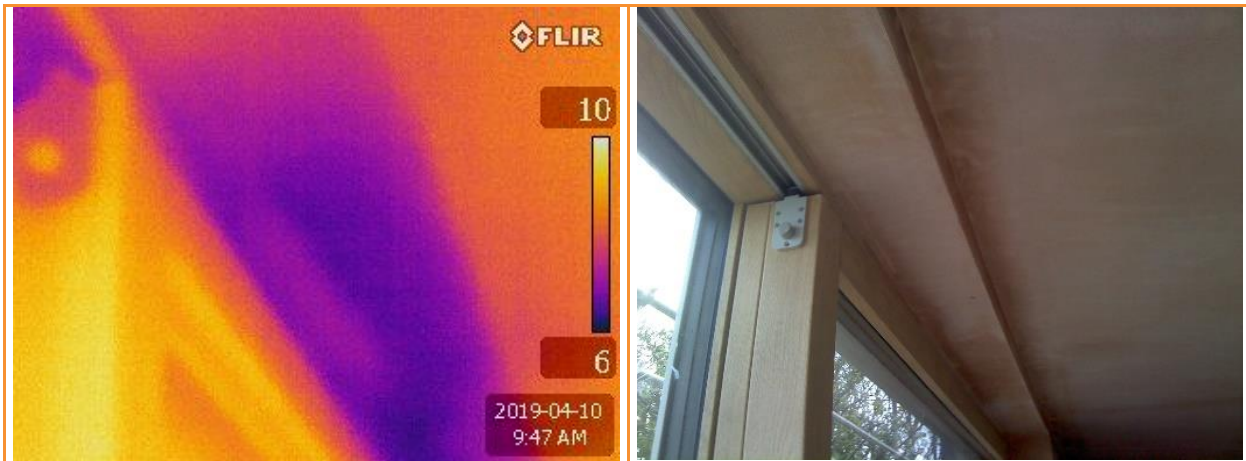
2.39: Thermographic image showing major cold area in ceiling of ground floor lounge. Suggests that leakage into the void above the plasterboard may be occurring around some or all of the steel beam above the window opening

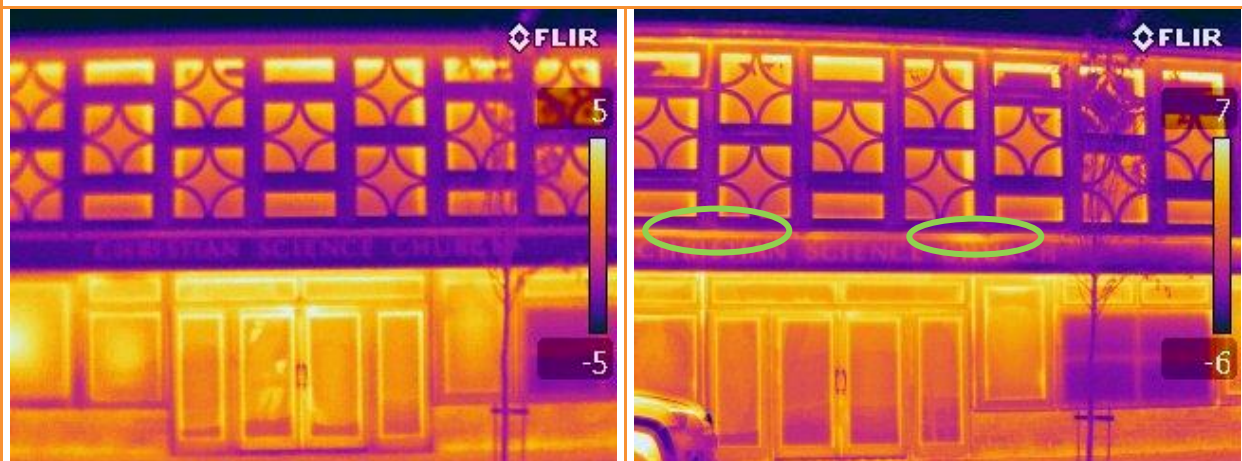
2.40: Thermographic image showing leakage along underside of balcony before building pressurised (left), then after building pressurised showing significant leakage along front edge of upper windows (right)

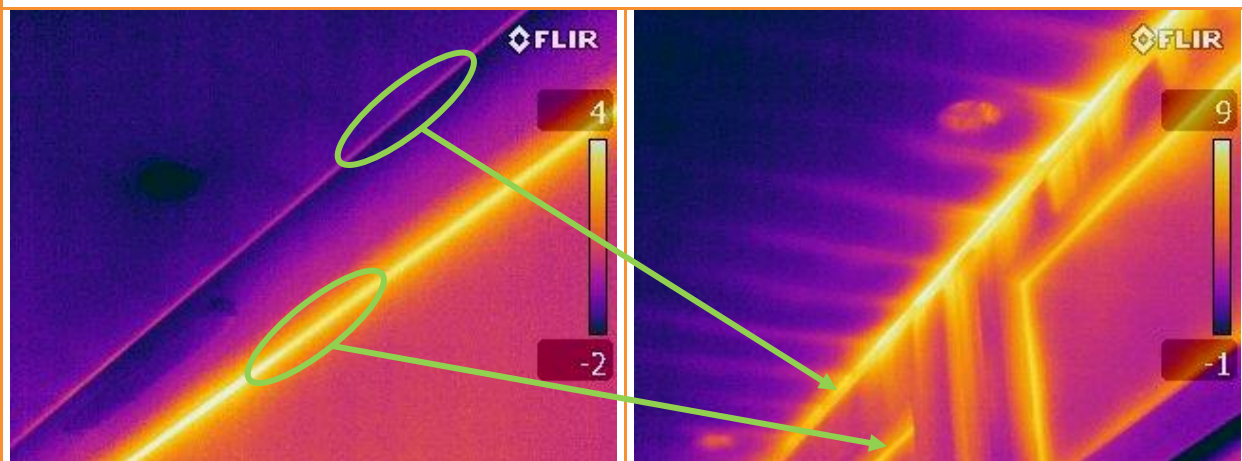
2.41: Thermographic image showing heat reflecting off metal spacer bar at window head before building pressurised, then more heat loss when pressurised: on window head, also along joints in timber under-cladding & through the vents

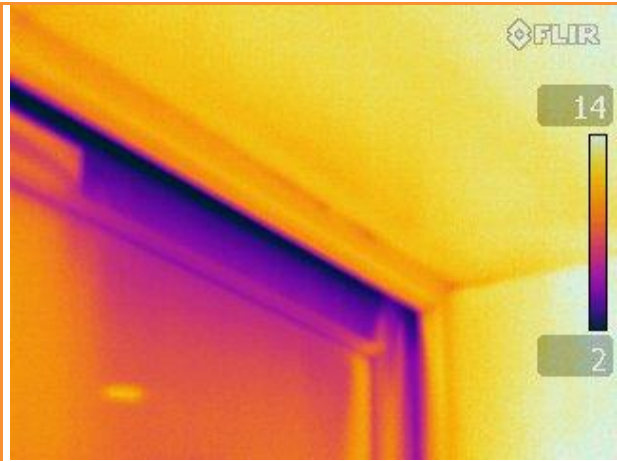
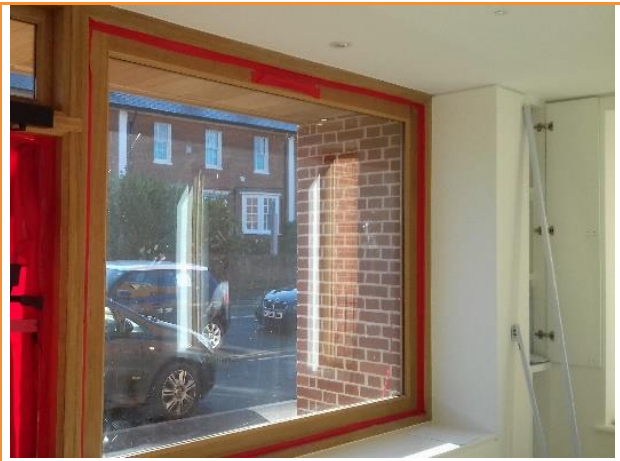
**2.42: Internal view of window whilst depressurised, external cold air clearly leaking significantly. Temporary sealing applied to quantify leakage from this source.**

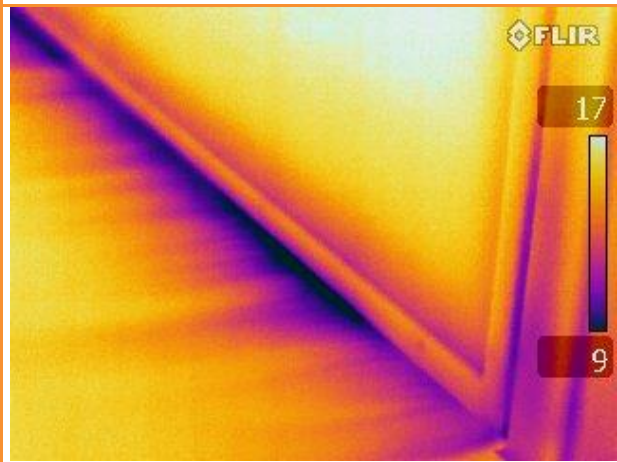
**2.43: Thermographic image whilst building depressurised showing substantial leakage along bottom edge of large window**

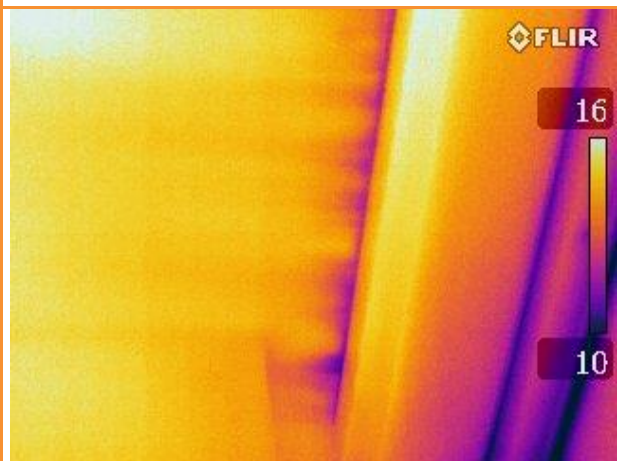
**2.44: Thermographic image whilst building depressurised showing substantial leakage along top edge of boxing inside large window**

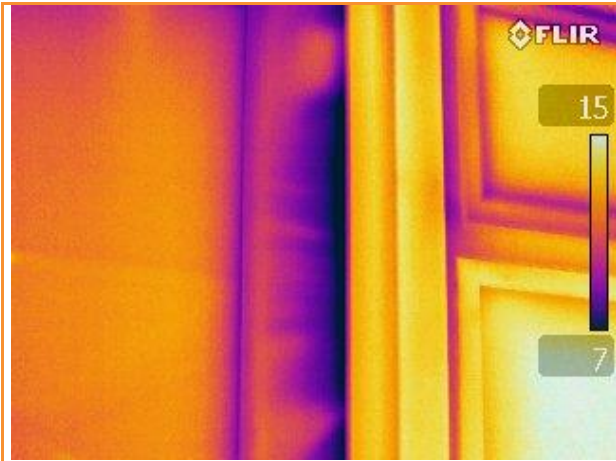
**2.45: Thermographic image of major leakage at side of window frame whilst depressurising**

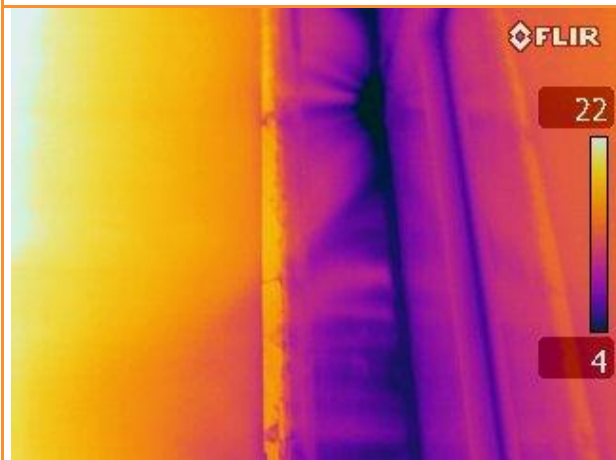
**2.46: Thermographic image of major leakage at side of window frame whilst depressurising**

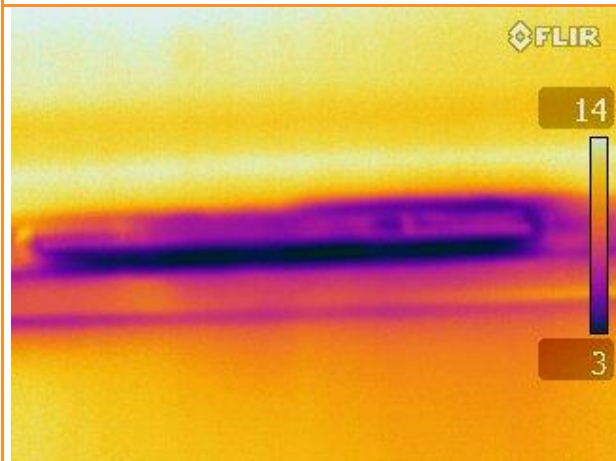
**2.47: Thermographic image of major leakage around closed trickle vent whilst depressurising**

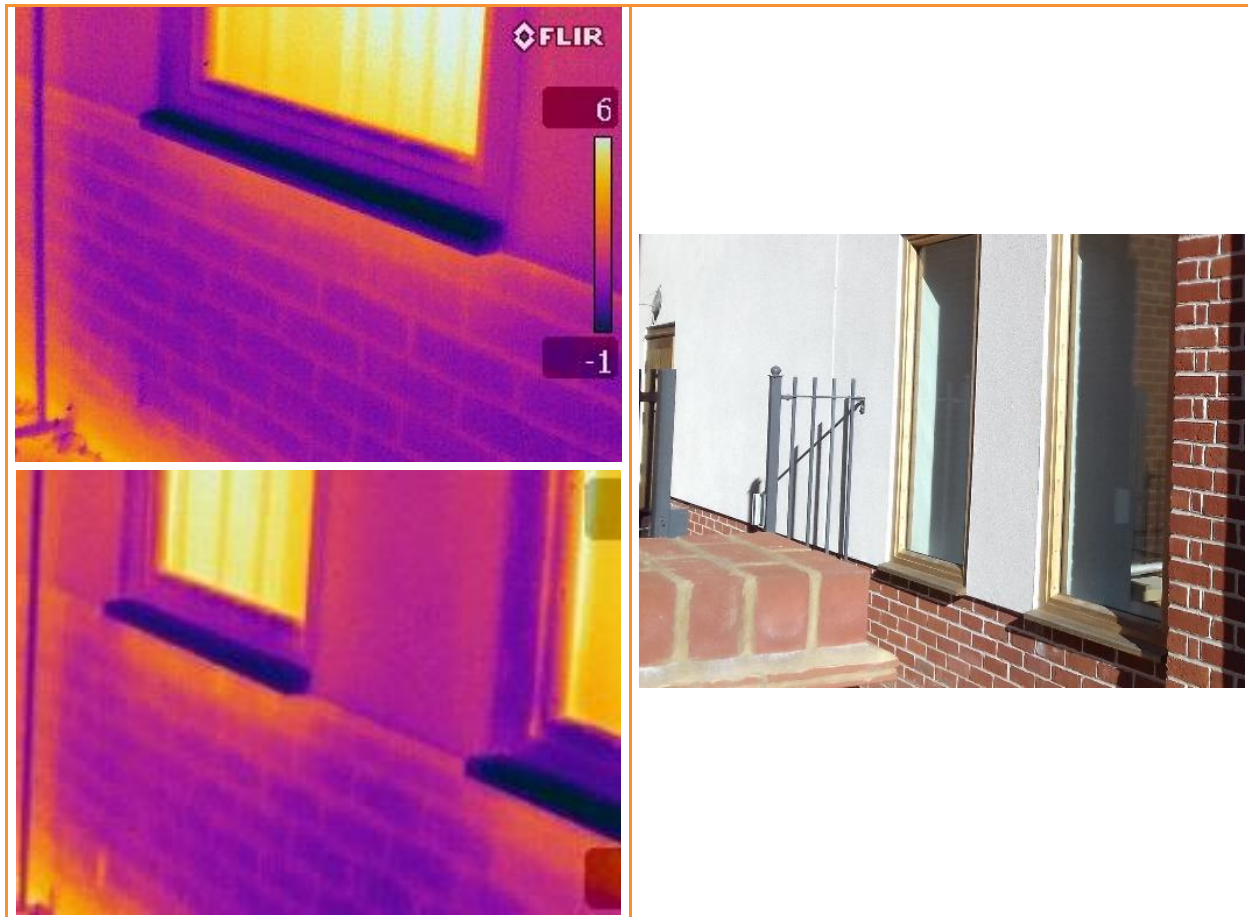
**2.48: Thermographic image showing some heat loss under window sill before pressure applied (top), then after building pressurised (bottom)**

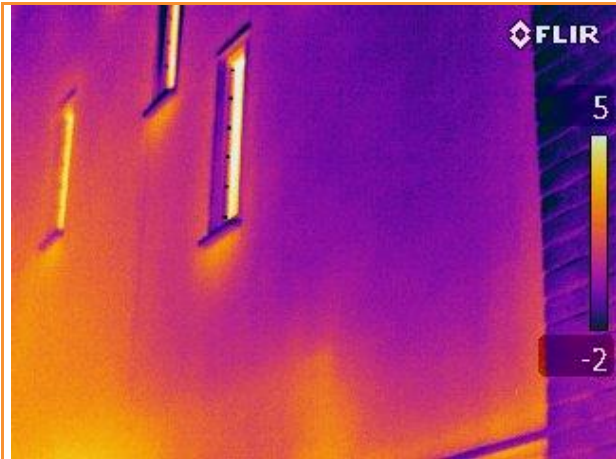
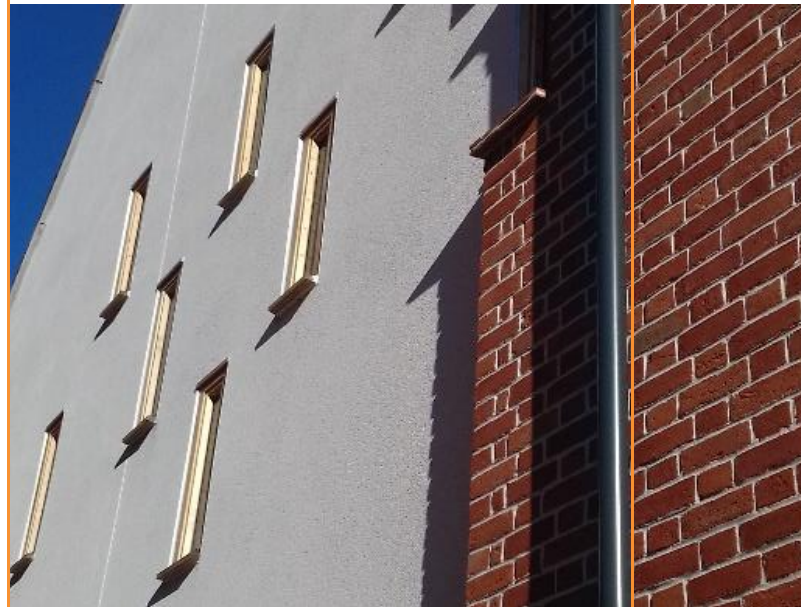
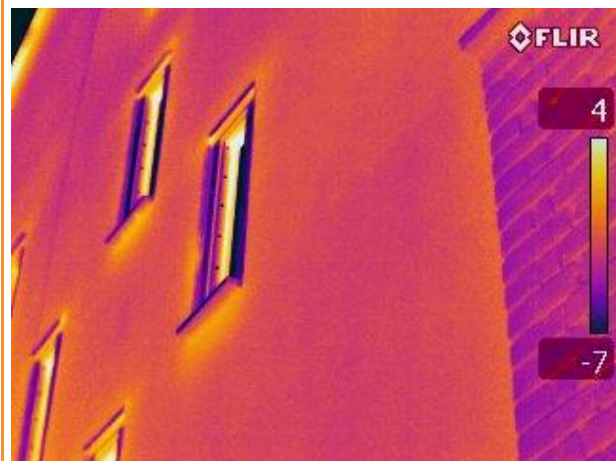
**2.49: Thermographic images of window sills at east end of building before pressure applied (top), then after pressure applied, showing noticeably more heat loss (bottom)**

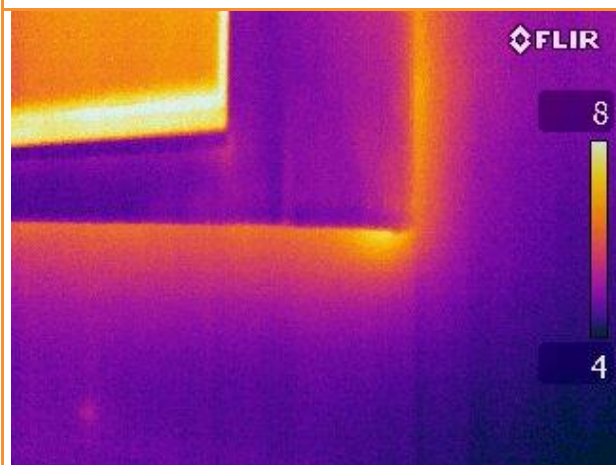
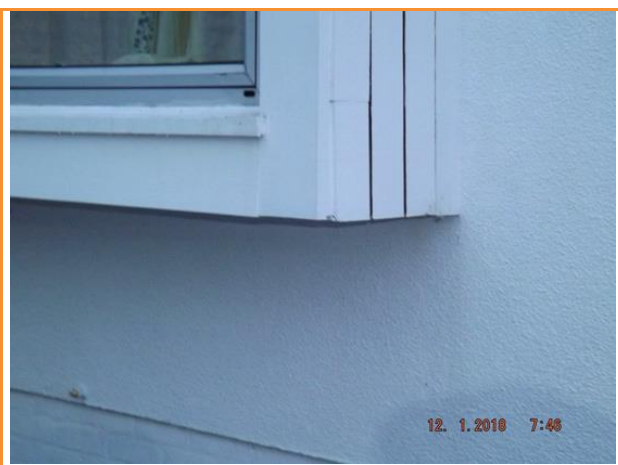
**2.50: Thermographic image showing leakage in specific location beneath base of projecting window, also general cold bridging**

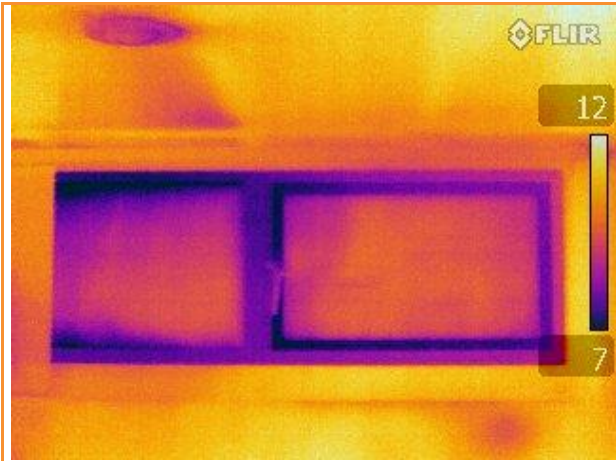
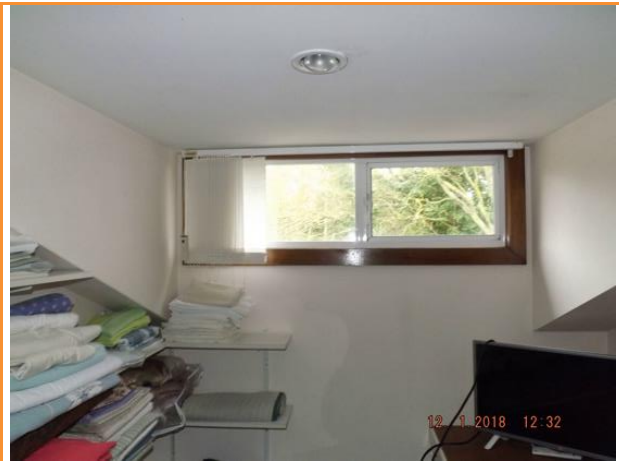
2.51: Thermographic image showing substantial leakage around dormer window on top floor

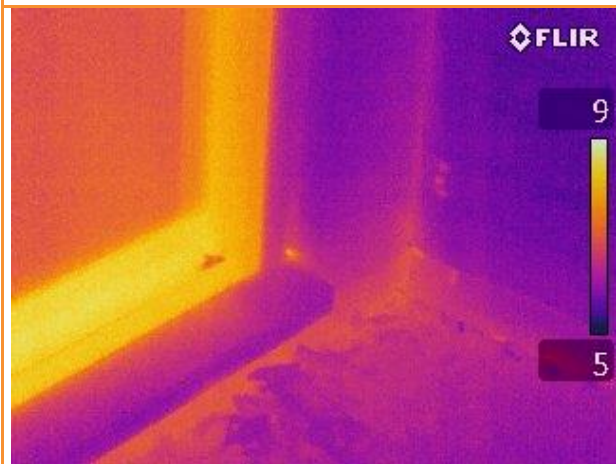
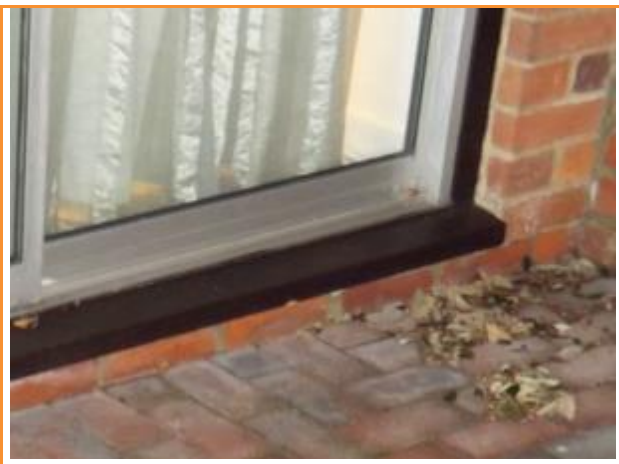
2.52: Thermographic image showing low level point leakage, also some threshold leakage

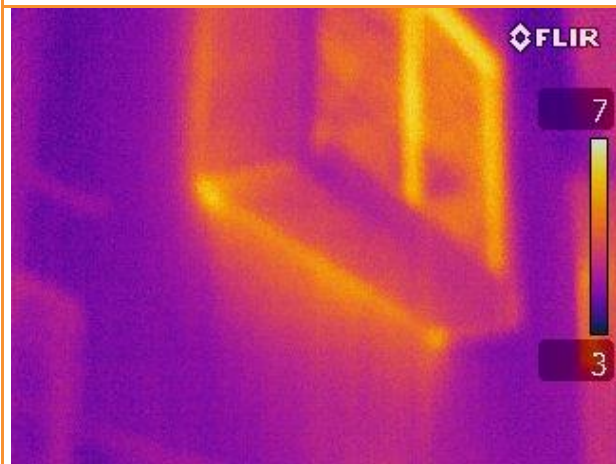
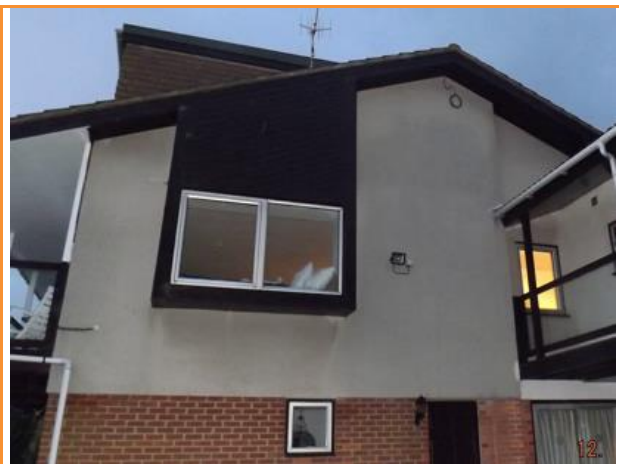
2.53: Thermographic image showing cold bridging and some leakage around projecting window at end of lounge

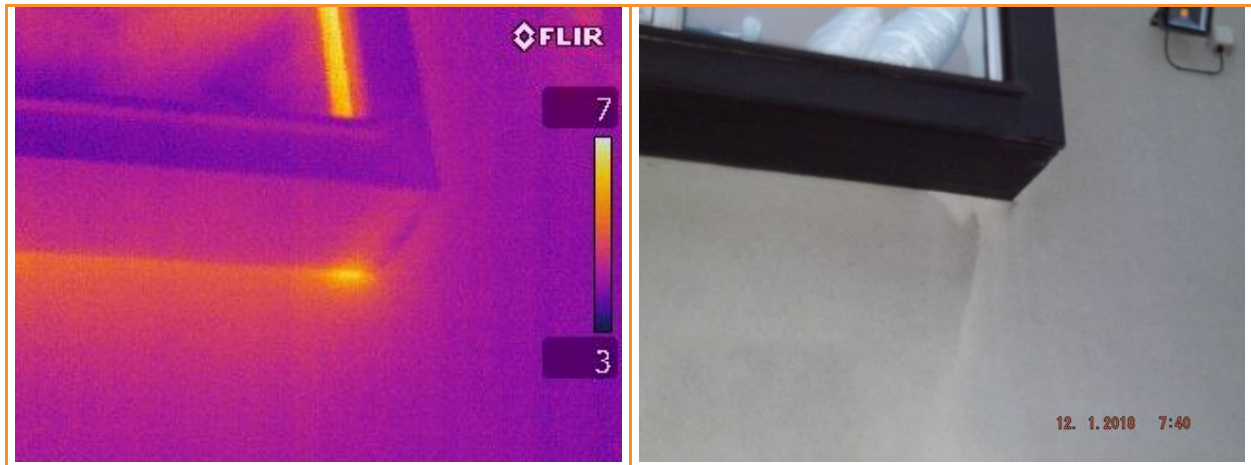
**2.54 Thermographic image showing hot spot beneath corner of projecting window – clear leakage**
