Common Leakage Sites no.3

Building Fabric Leakage 3: Through windows joints and/or hollow window frames

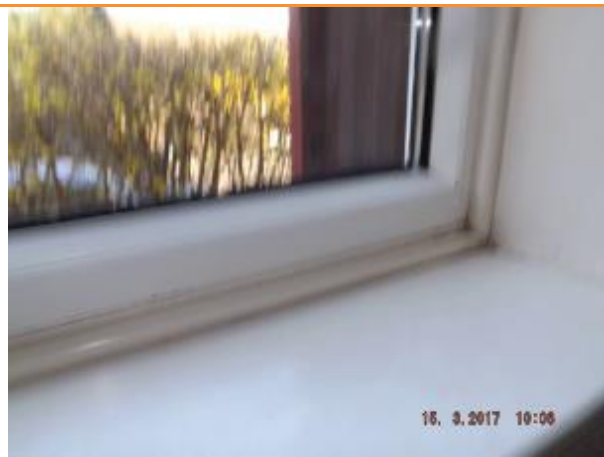
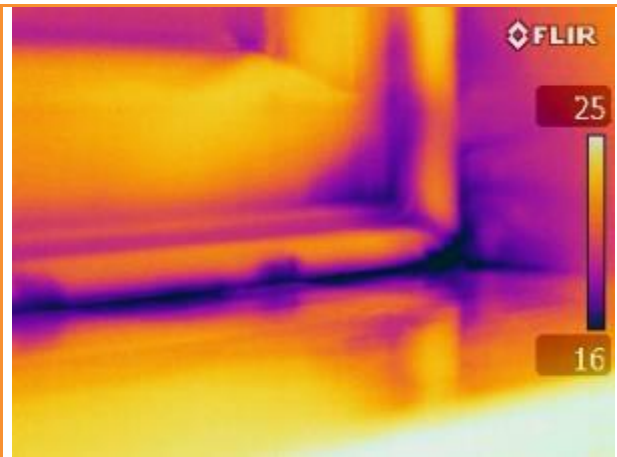
3.01: Internal thermographic image whilst house is depressurised showing leakage through existing window.

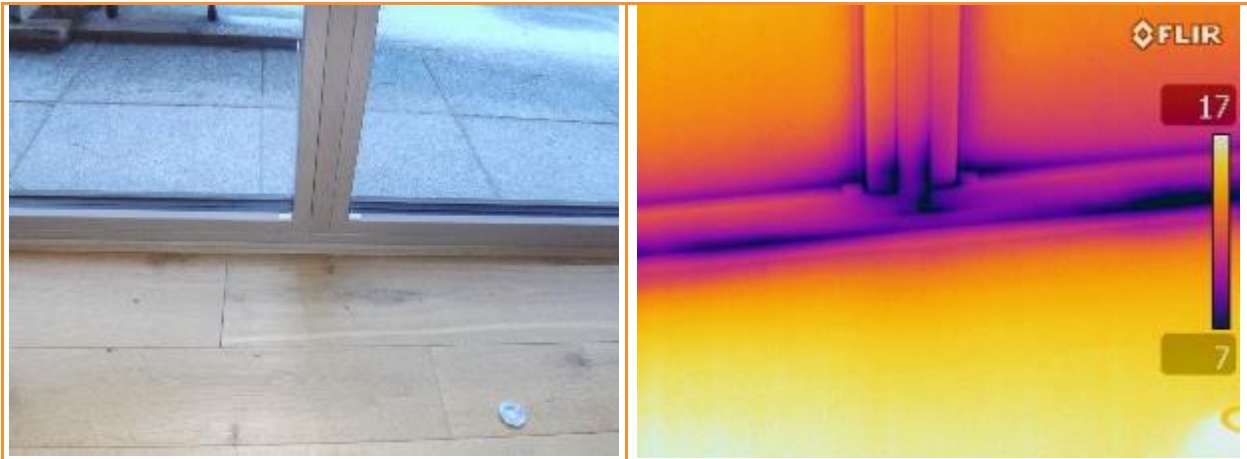
3.02: Internal thermographic image whilst existing house depressurised. Leakage occurring at joints in frame of glazed door in lounge.

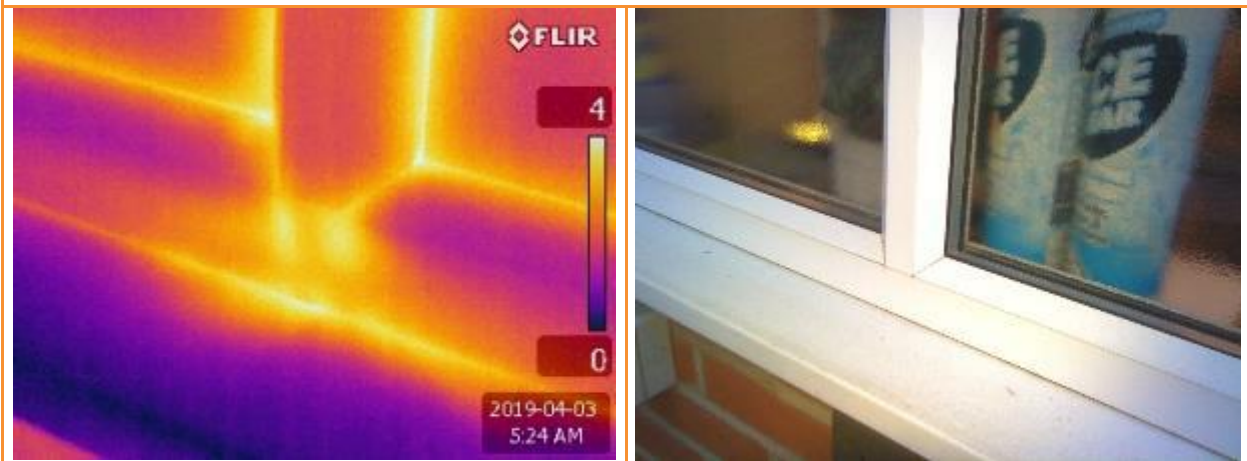
3.03: External thermographic image whilst house is pressurised showing leakage on joints in uPVC windows, also between frame and wall below.

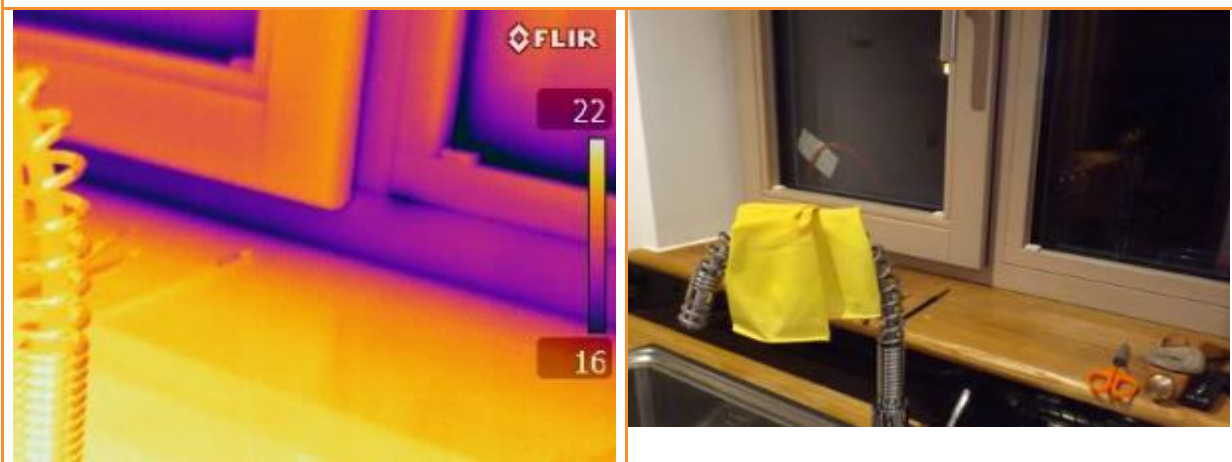
3.04: Internal thermographic image whilst dwelling is depressurised showing leakage at joint in frame of fixed light.

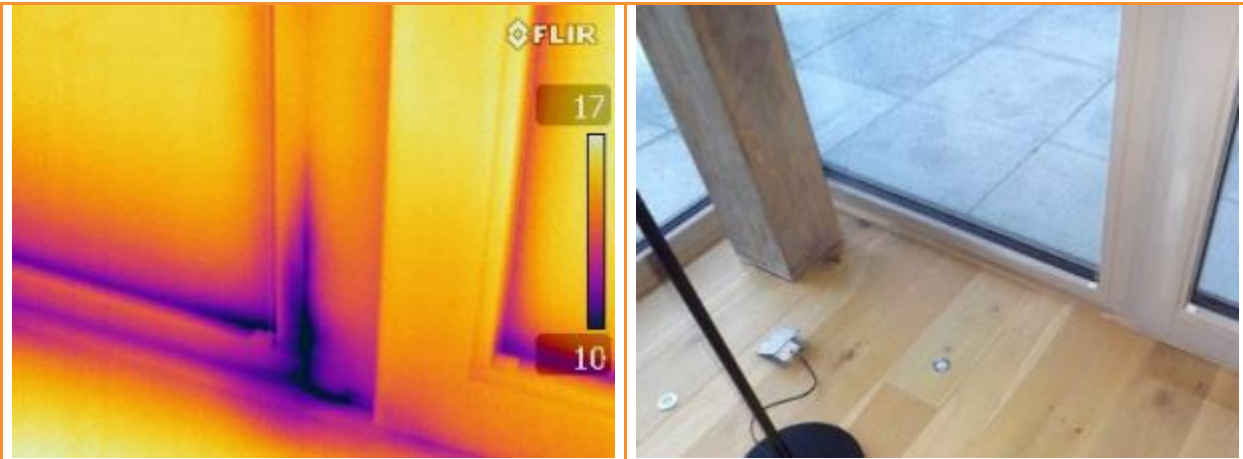
3.05: Internal thermographic image whilst house is depressurised showing leakage through frame next to bottom corner of window in lounge.

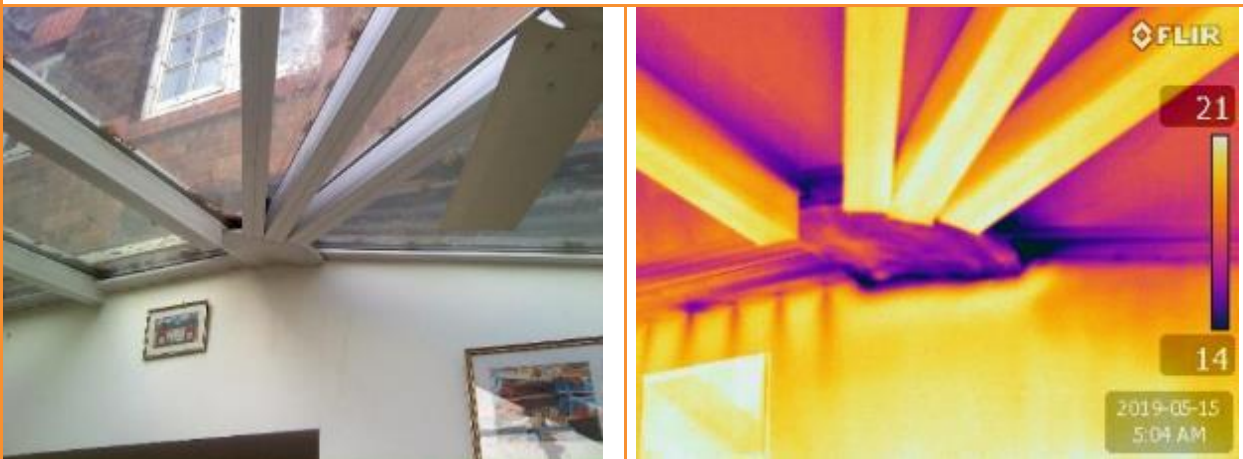
3.06: Internal thermographic image whilst house is depressurised showing leakage around joint in conservatory roof, also leakage through vents along the side adjoining house.

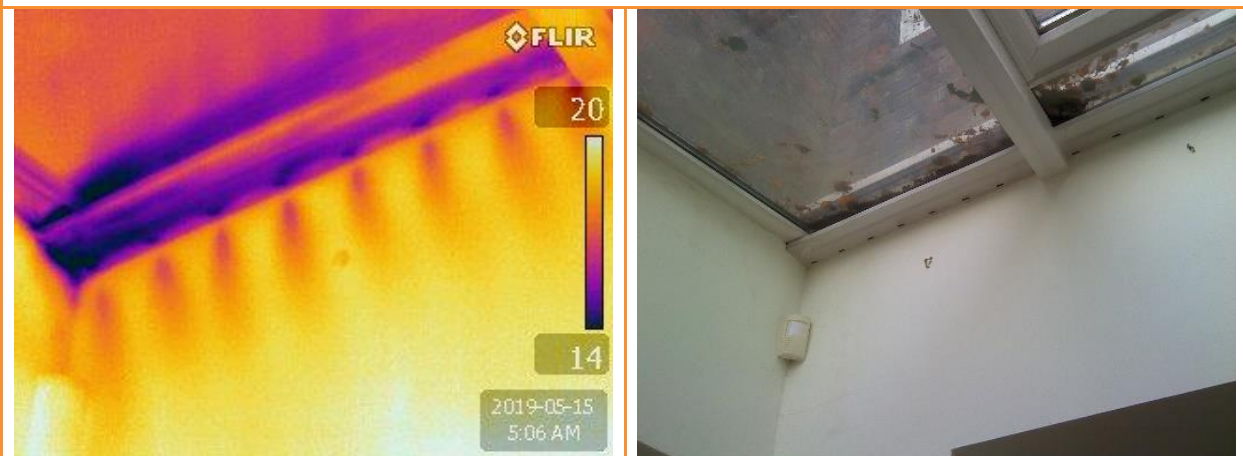
3.07: Close-up internal thermographic image whilst house depressurised, showing leakage through vents in conservatory frame

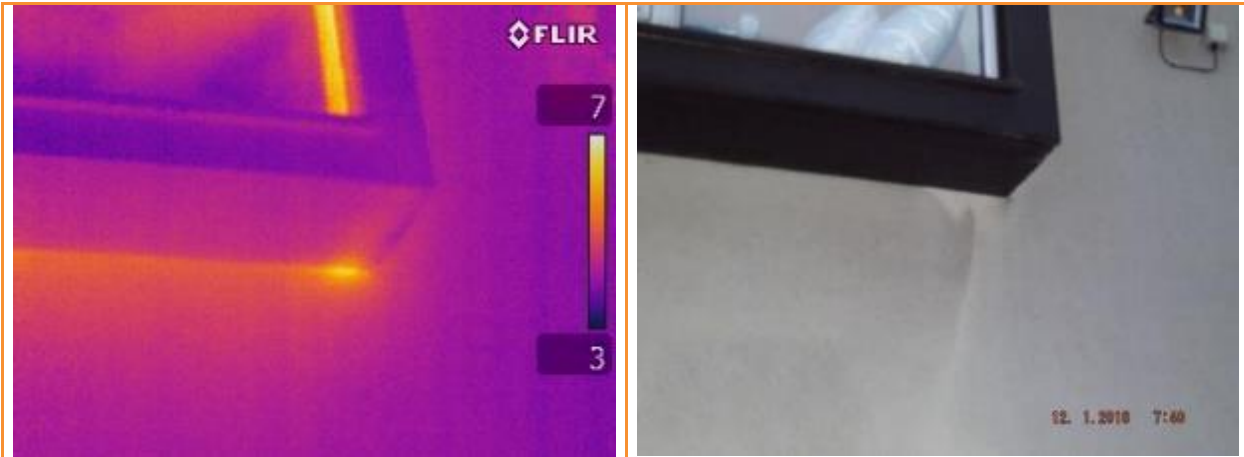
3.08: External thermographic image whilst house is pressurised showing leakage through defect on underside of projecting window

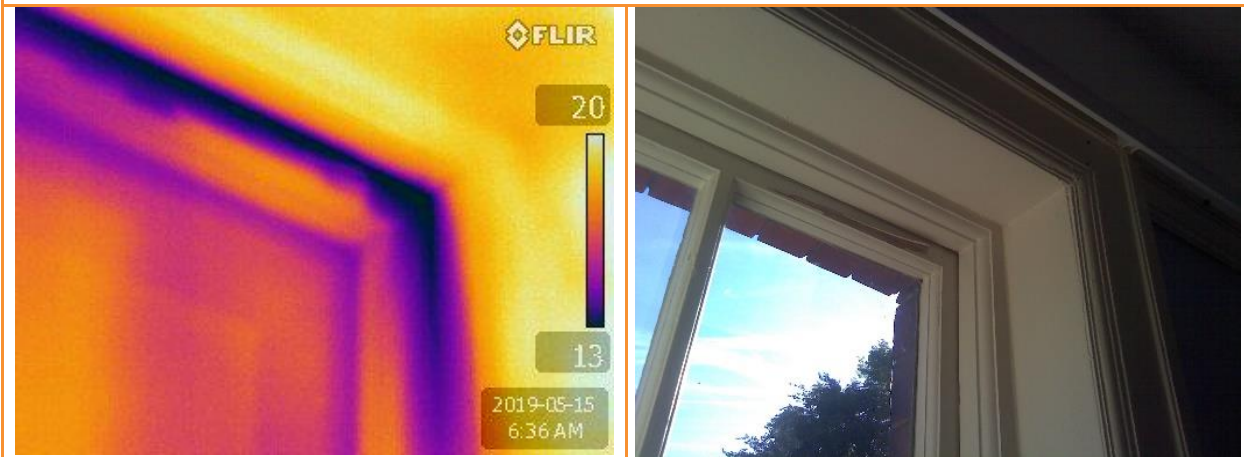
3.09: Internal thermographic image whilst house depressurised, showing substantial leakage at the top of poorly fitting bathroom window, first floor rear

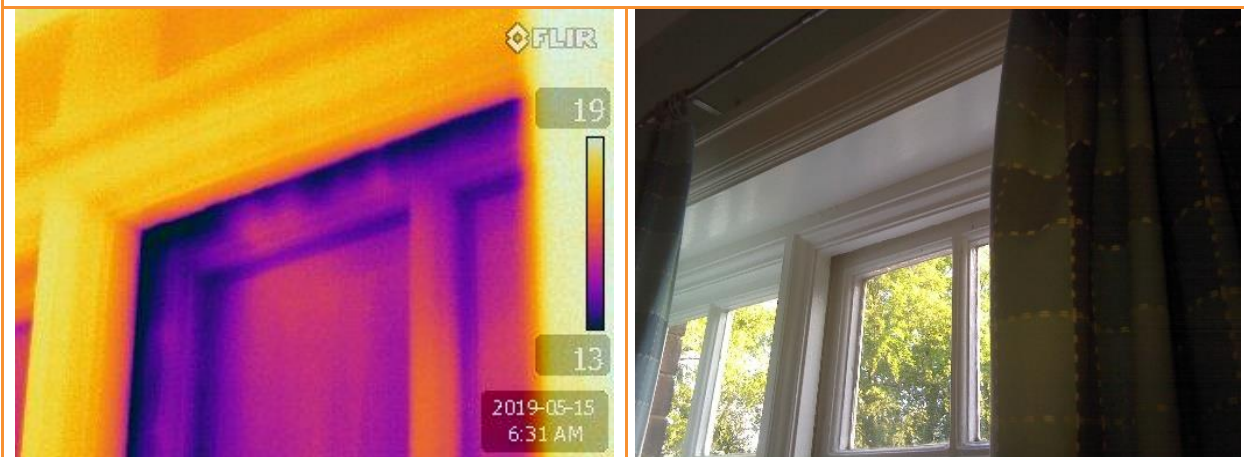
3.10: Internal thermographic image whilst house depressurised, showing substantial leakage at the top of poorly fitting bathroom window, first floor rear

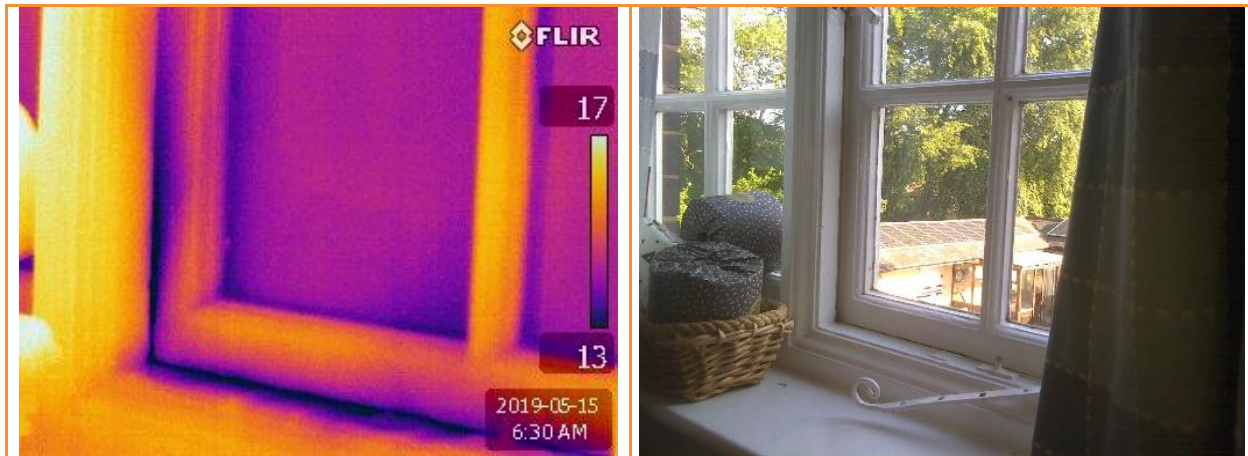
3.11: Internal thermographic image whilst house depressurised, showing substantial leakage across the base of a poorly fitting bathroom window, first floor rear

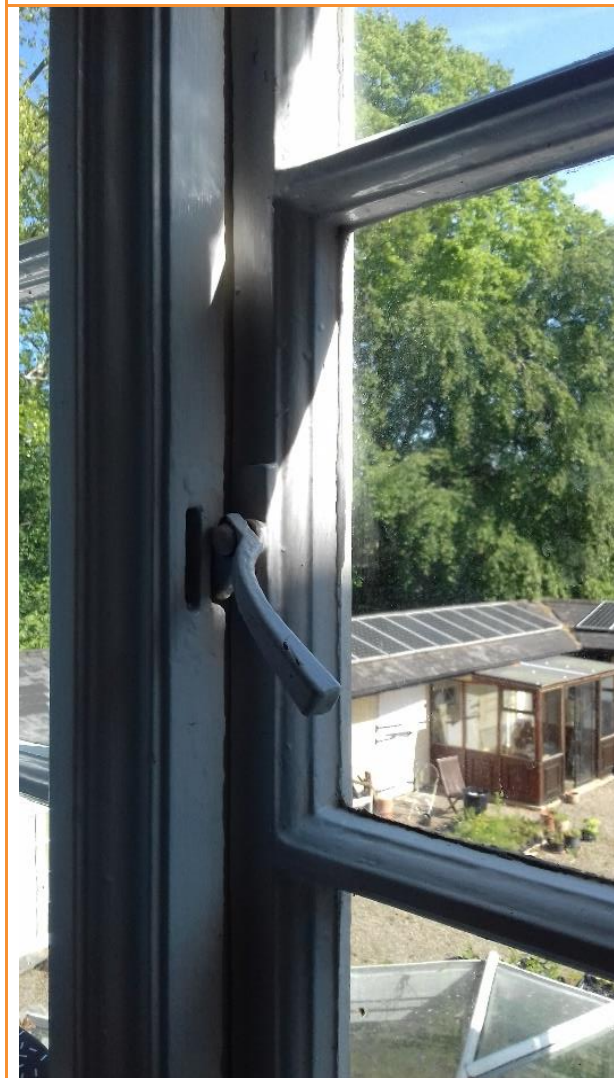
3.12: Photograph of bathroom window where substantial leakage was found during depressurisation because the window could not be closed fully

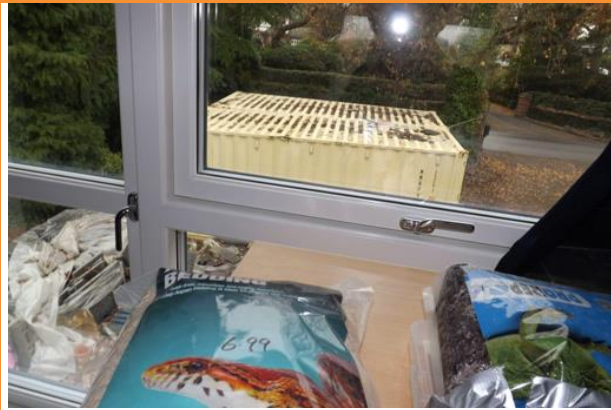
3.13: Leakage around handle to window where draughtsealing is ineffective

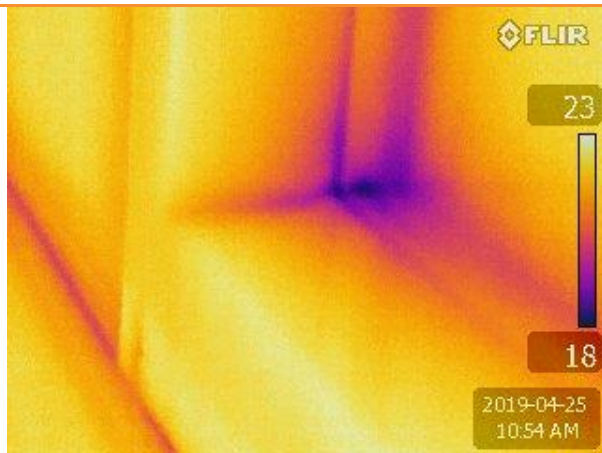
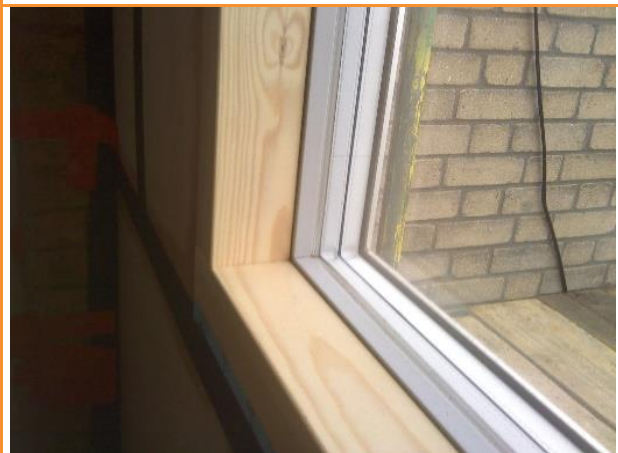
3.14: Thermographic image showing significant leakage in the corner of a new window

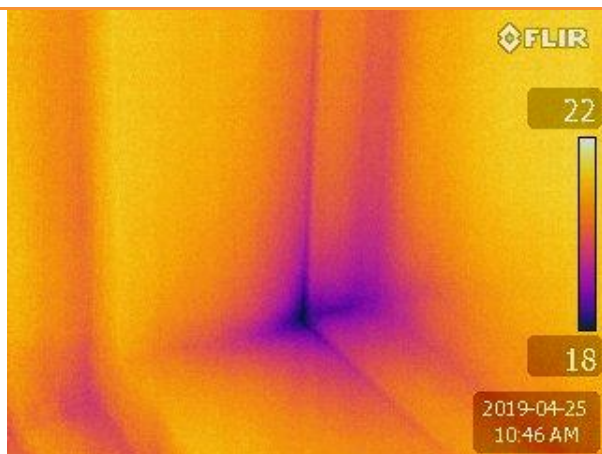
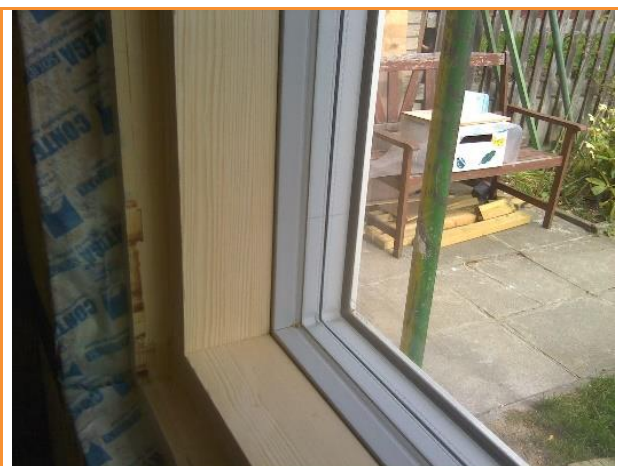
3.15: Thermographic image showing significant leakage in the corner of another new window

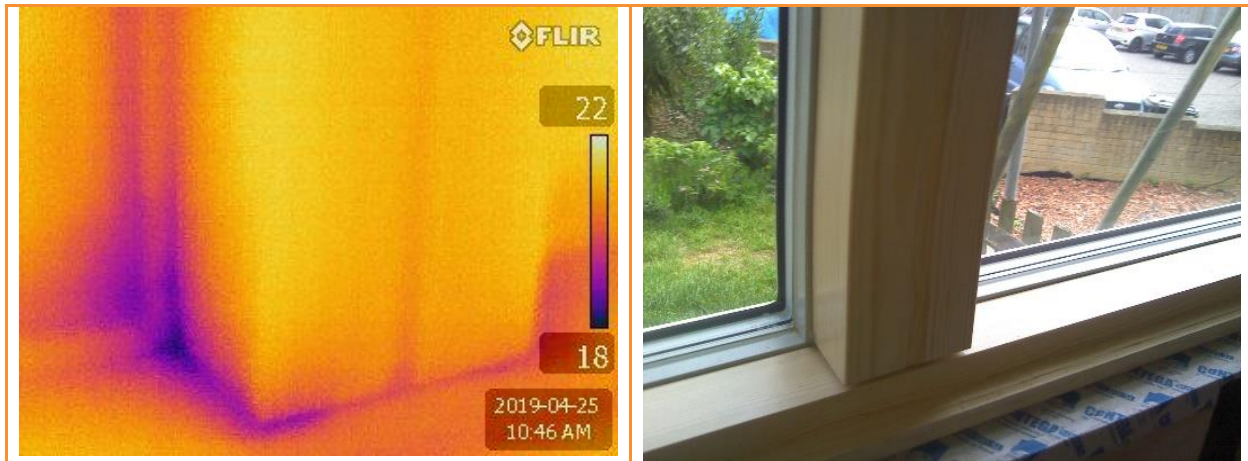
3.16: Thermographic image showing significant leakage at the timber joint in the centre of a large new window

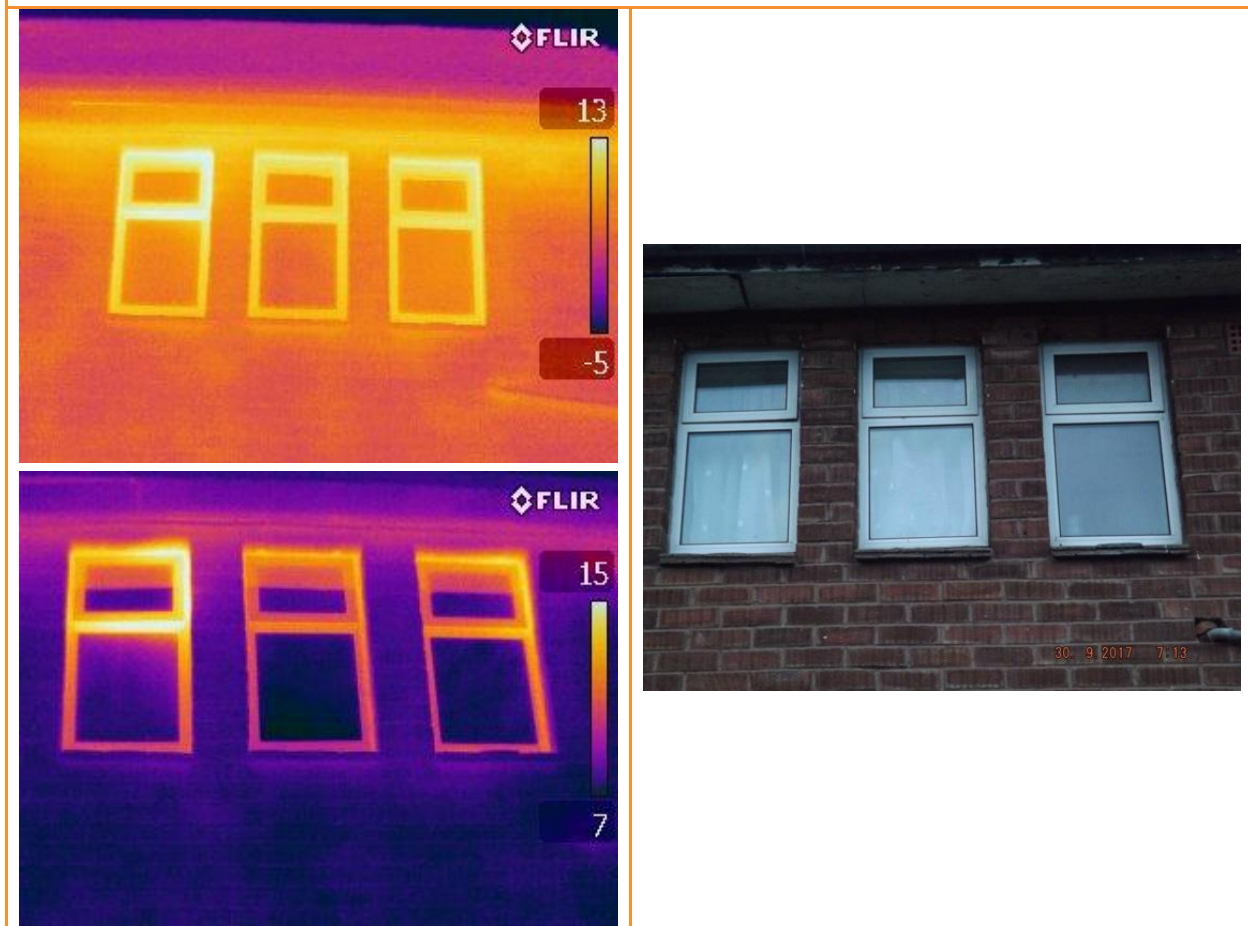
3.17: Thermographic image of stairs and WC windows, first floor, before pressure differential applied (top) and after pressure differential applied (bottom)

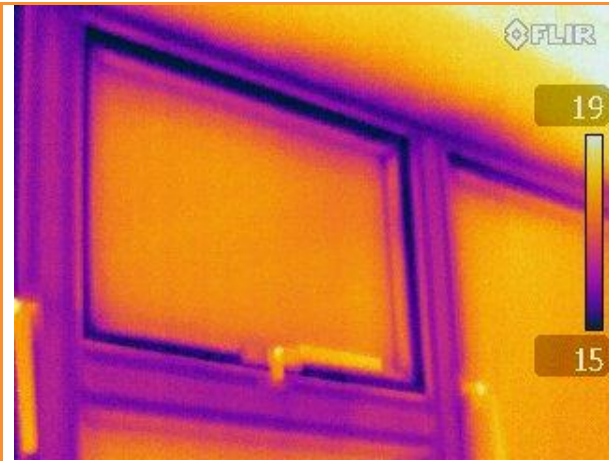
3.18: Thermographic image showing leakage on living room windows

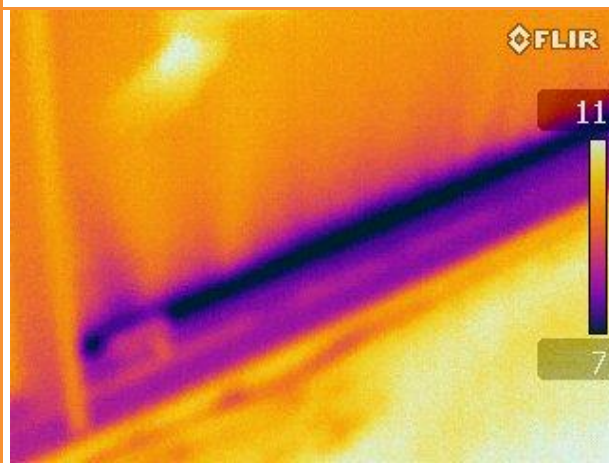
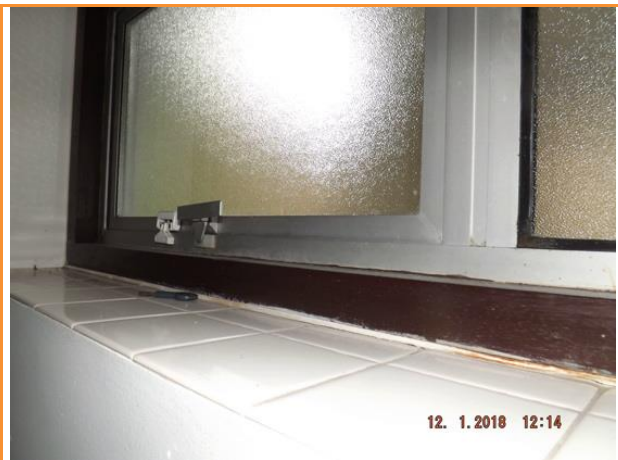
3.19: Thermographic image showing substantial leakage at base of cloakroom window

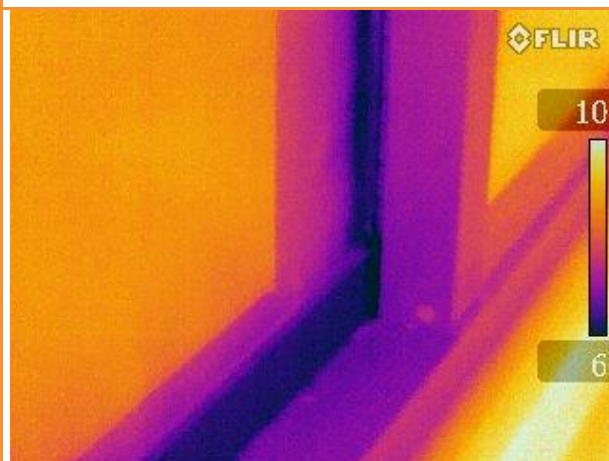
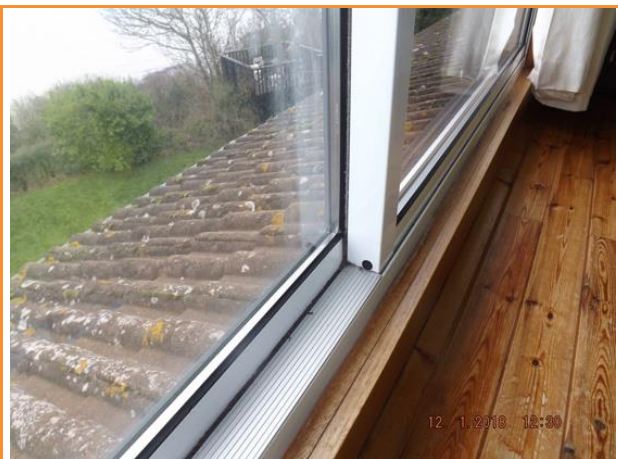
3.20: Thermographic image showing substantial leakage on top floor rear window
