Common Leakage Sites no.4

Building Fabric Leakage 4: Through doors – particularly double doors

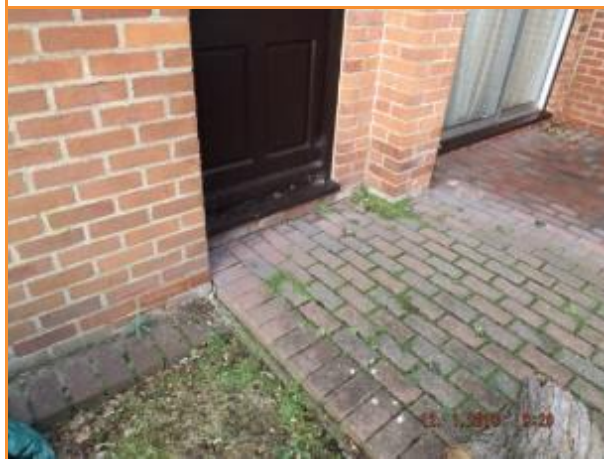
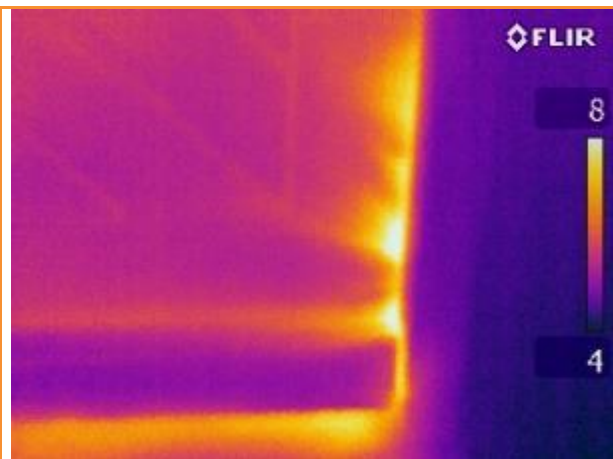
4.1: Major leakage along the side of external door whilst house is pressurised.

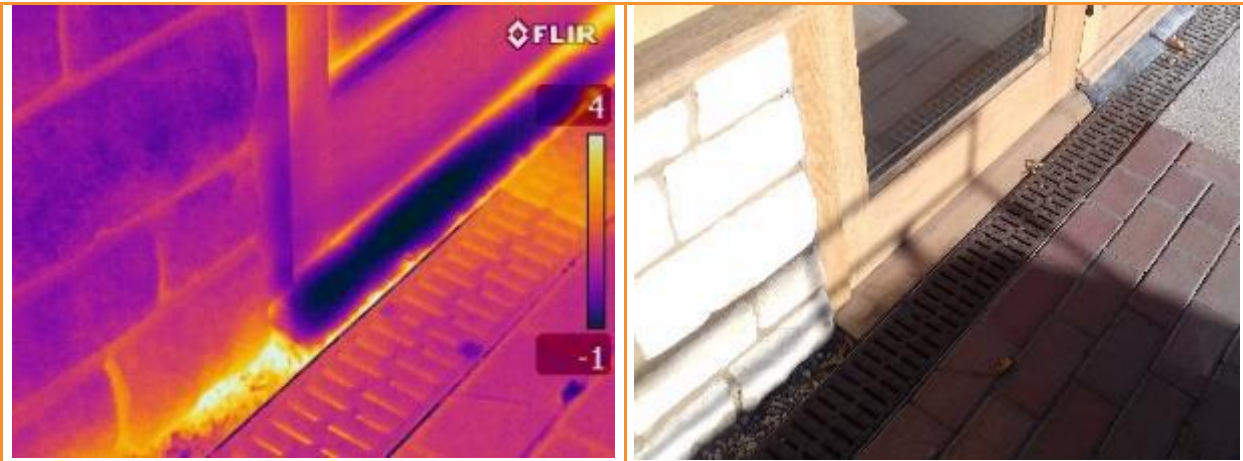
4.2: External thermographic image whilst building is pressurised, showing leakage at side of ground floor doorway.

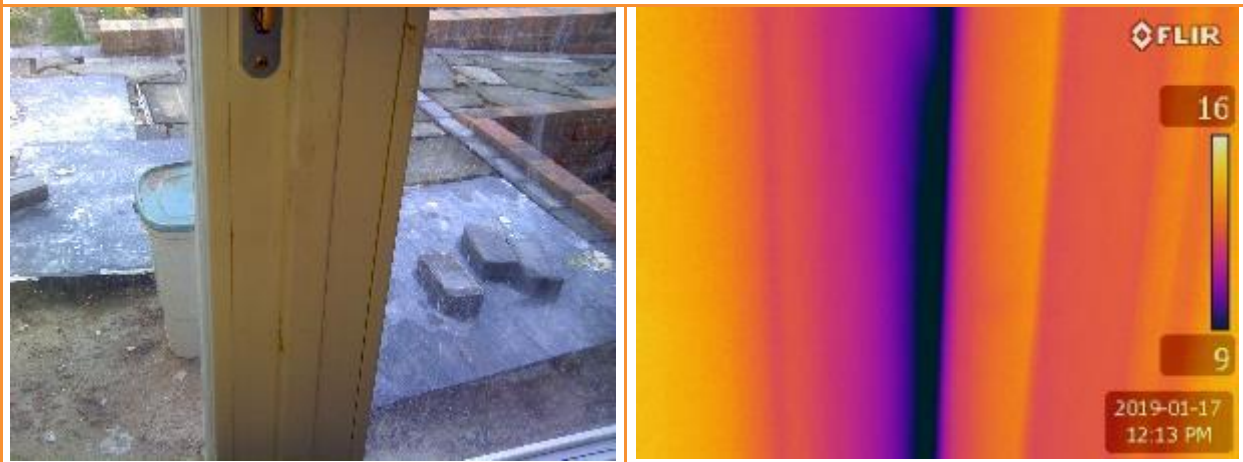
4.3: Internal thermographic image whilst house is depressurised showing leakage on meeting rail of French windows where draughtseals are ineffective.

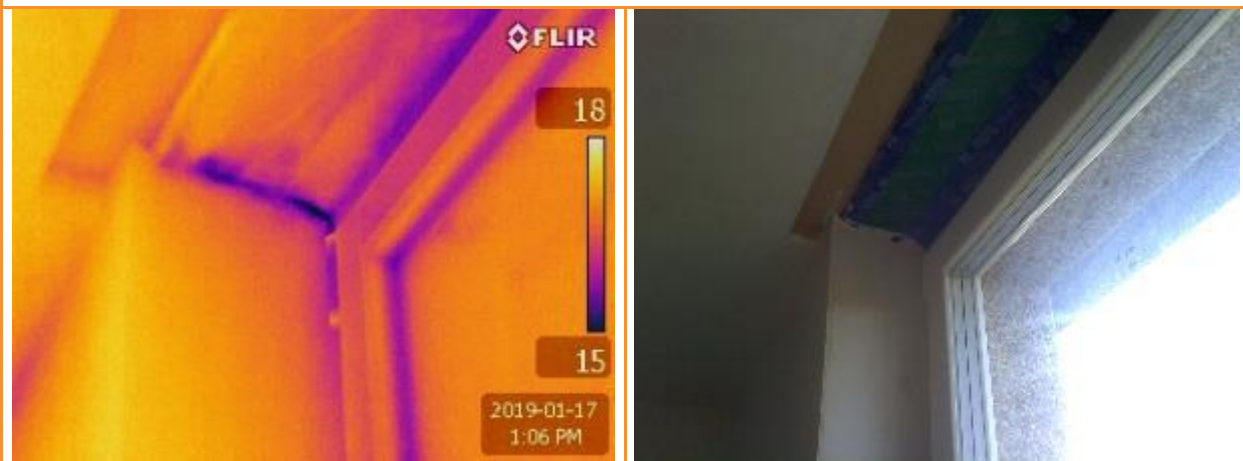
4.4: Internal thermographic image whilst house is depressurised showing leakage at top of large sliding doors.

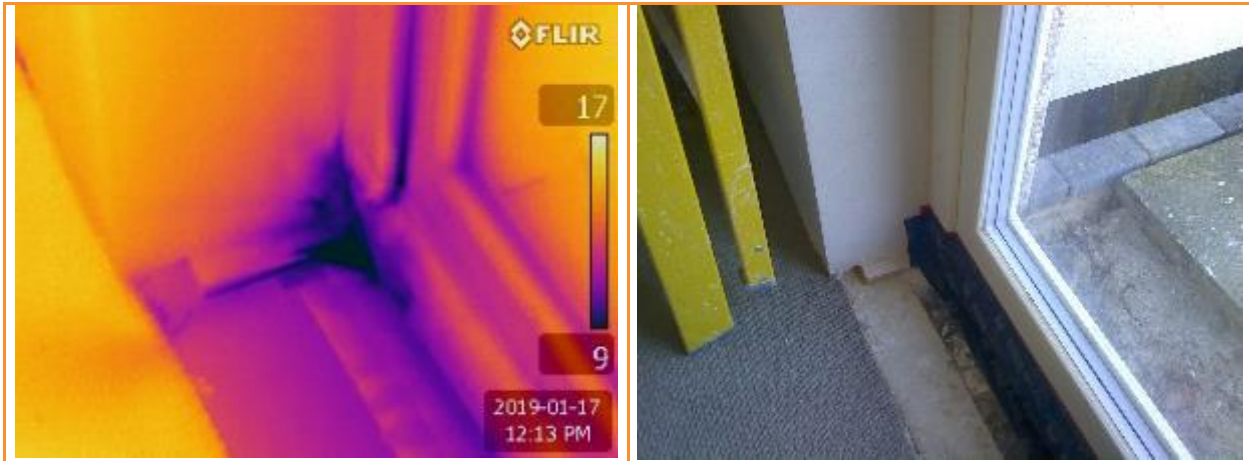
4.5: Internal thermographic image whilst house is depressurised showing leakage at bottom of French windows where sealing is incomplete.

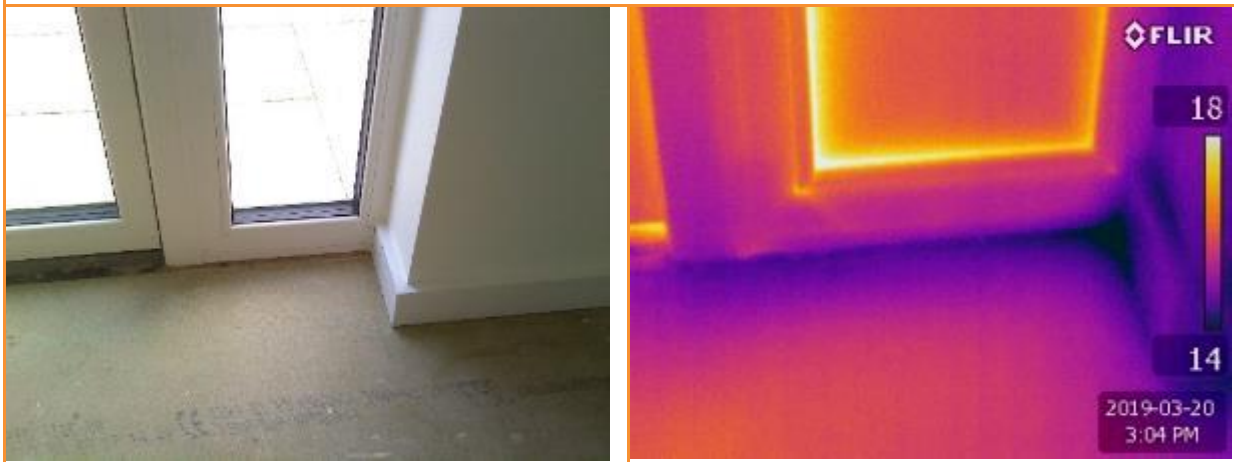
4.6: Internal thermographic image whilst house is depressurised showing leakage at base and right side of rear door.

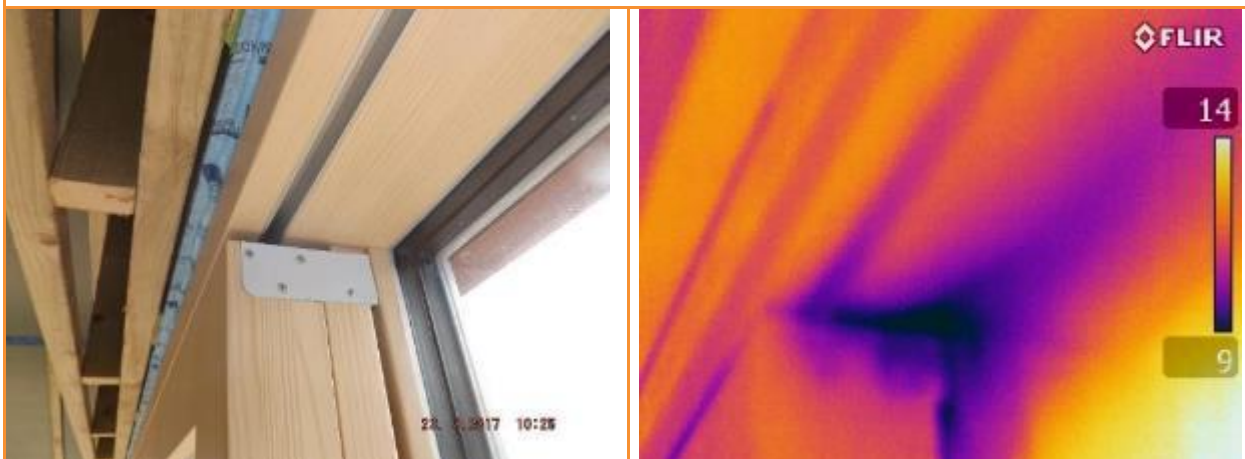
4.7: Internal thermographic image whilst newbuild house is depressurised showing leakage at head of large sliding door.

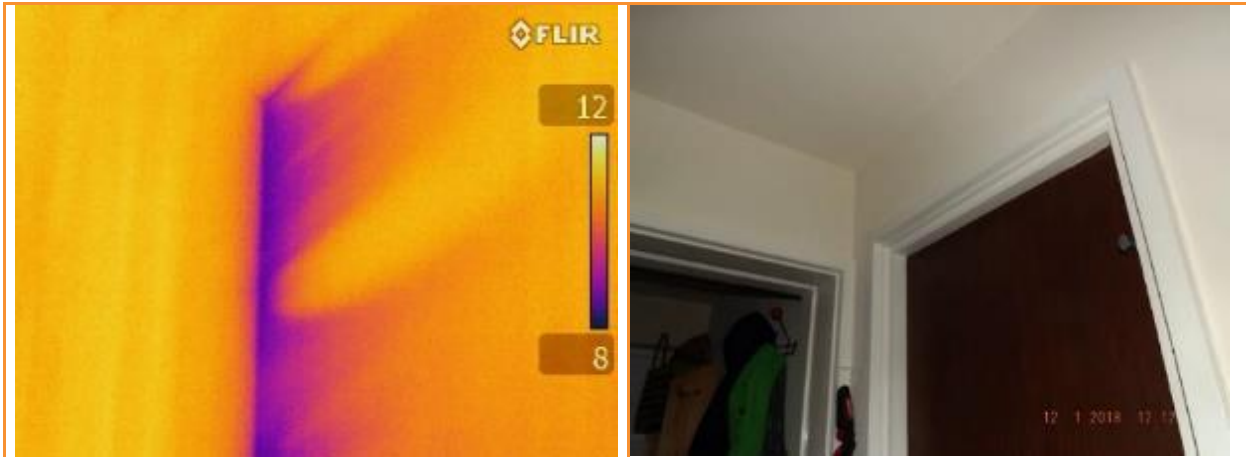
4.8: Internal thermographic image whilst house is depressurised showing leakage on side of internal door to unheated garage.

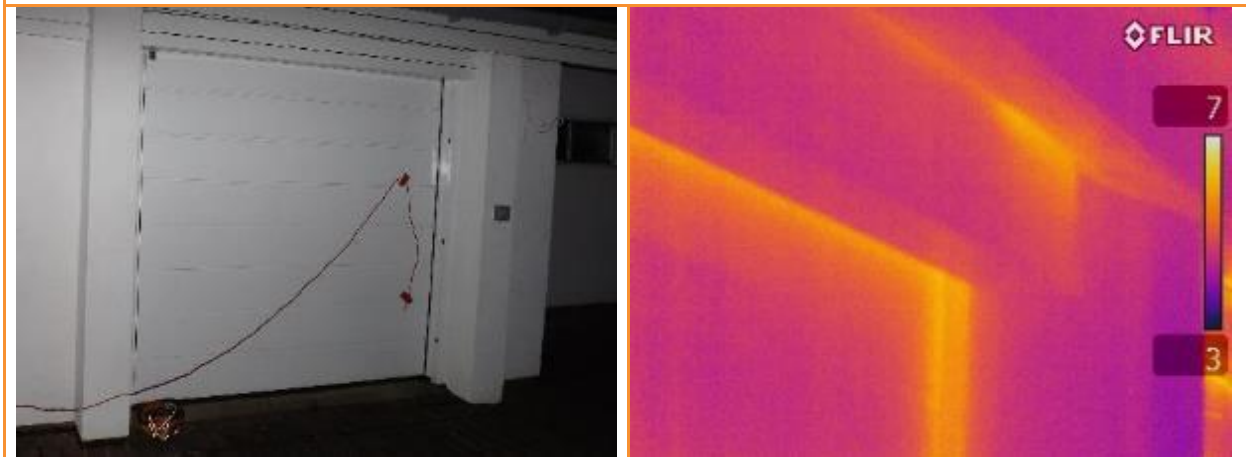
4.9: External thermographic image whilst house is pressurised showing leakage at side & top of garage door, connected through internal doorway to interior of house.

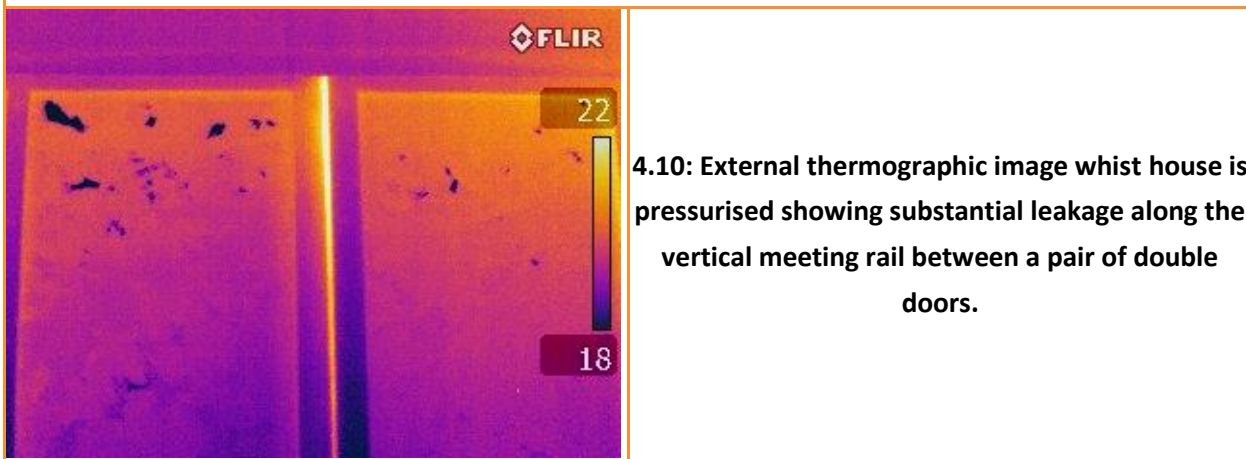
4.10: External thermographic image whilst house is pressurised showing substantial leakage along the vertical meeting rail between a pair of double doors.

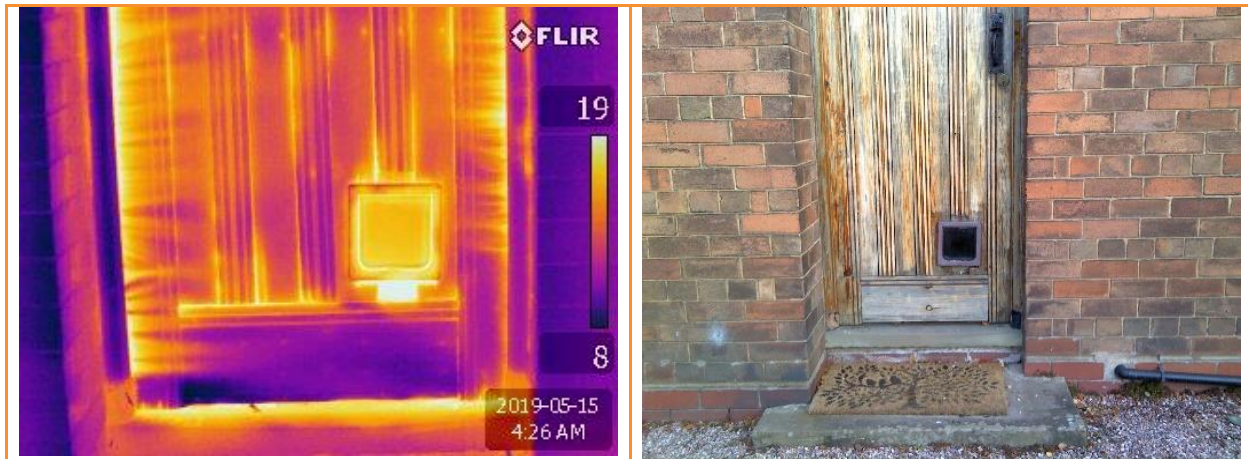
4.11: External thermographic image whilst house pressurised showing leakage around the side door, both through the gap beneath the door but also at the sides and through the joints in the wooden door itself

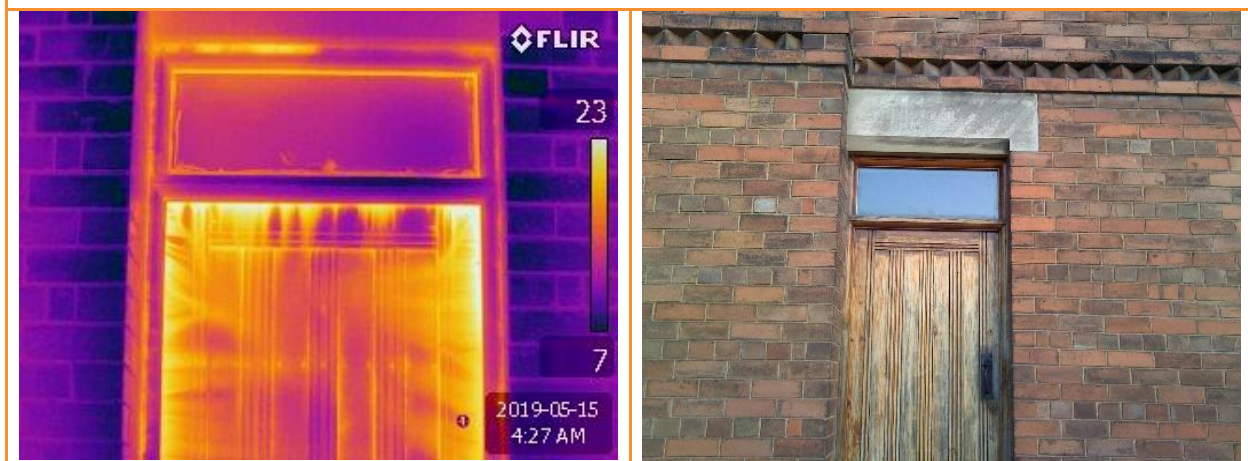
4.12: External thermographic image whilst house pressurised showing leakage around the side door, both at the top and sides of the door, but also across the top of the glazed panel above the door

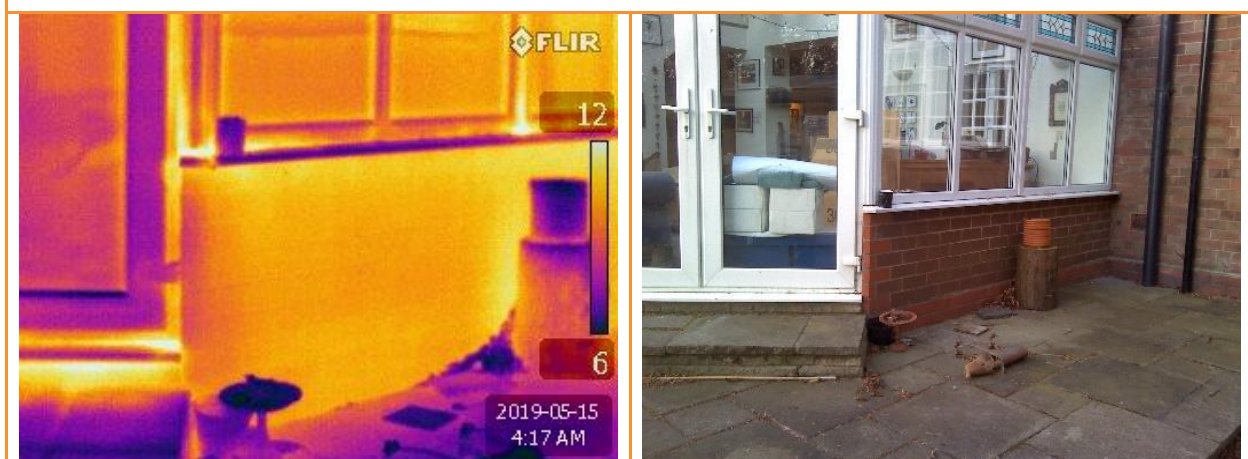
4.13: External thermographic image whilst house pressurised, showing substantial leakage at base of conservatory doors. Also, in several places along the top of the stub wall

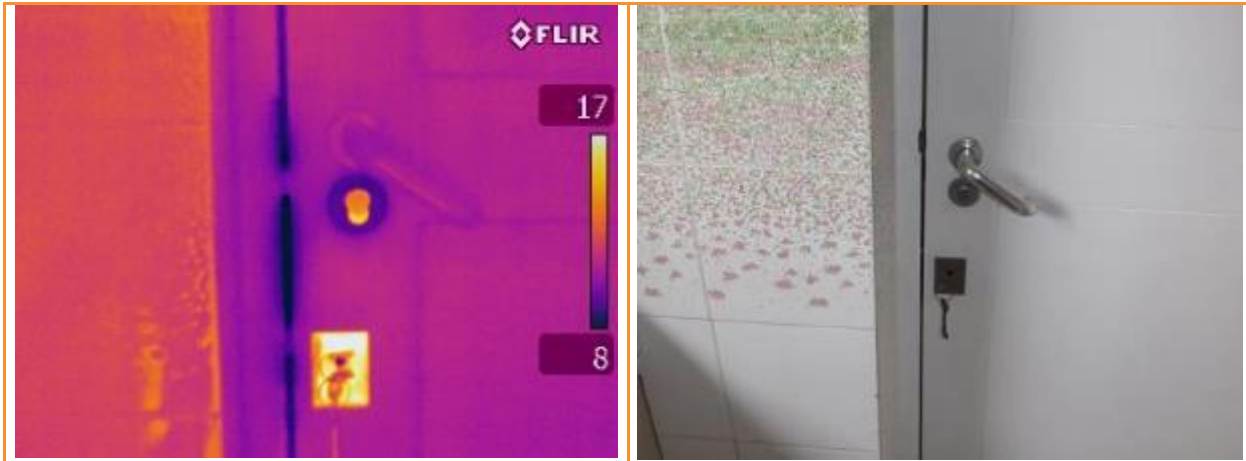
4.14: Internal thermographic image whilst house is depressurised showing leakage along the side of lock on external kitchen door.

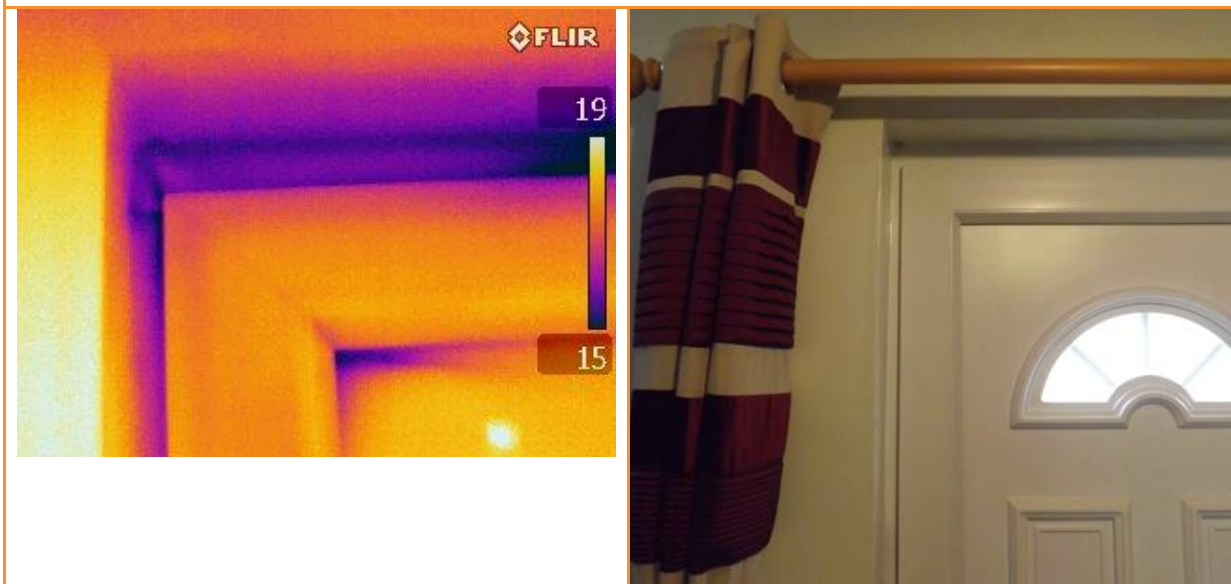
4.15: Thermographic image of leaks at inside top left of front door

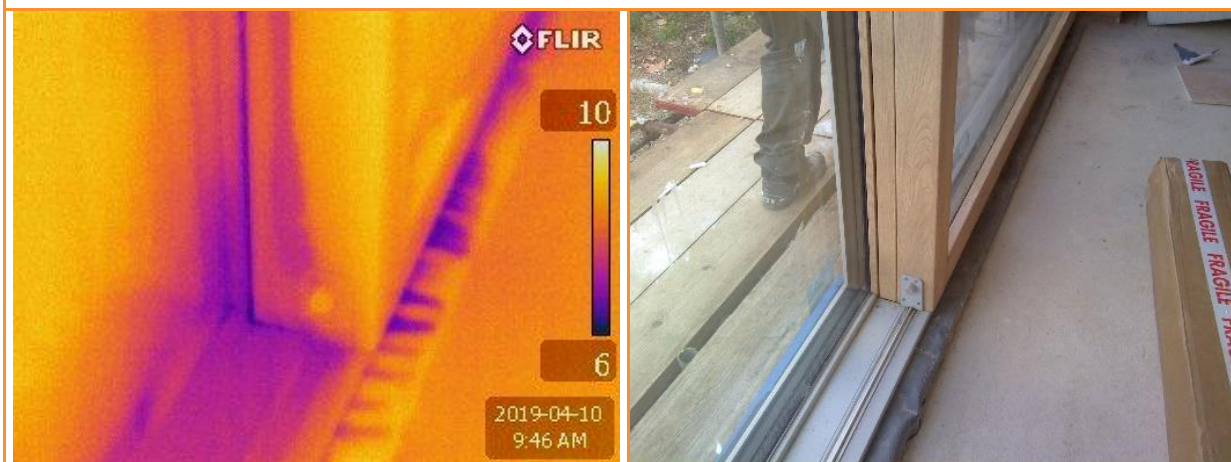
4.16: Thermographic image showing numerous leakage locations beneath the threshold of the first set of large sliding doors, also along the vertical meeting rail, particularly at its base

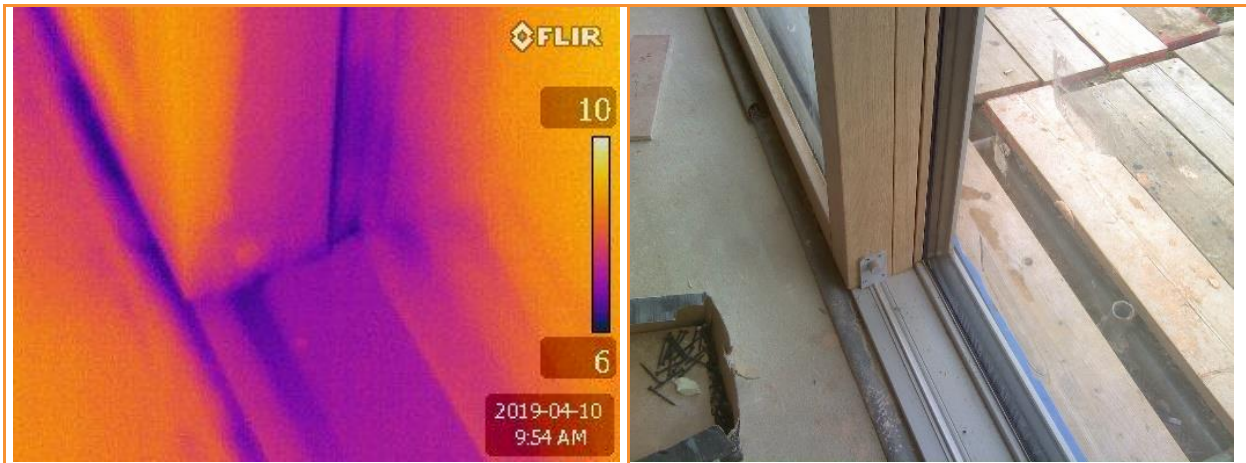
4.17: Thermographic image showing leakage beneath the threshold of the second set of large sliding doors, also along the vertical meeting rail, again particularly at its base

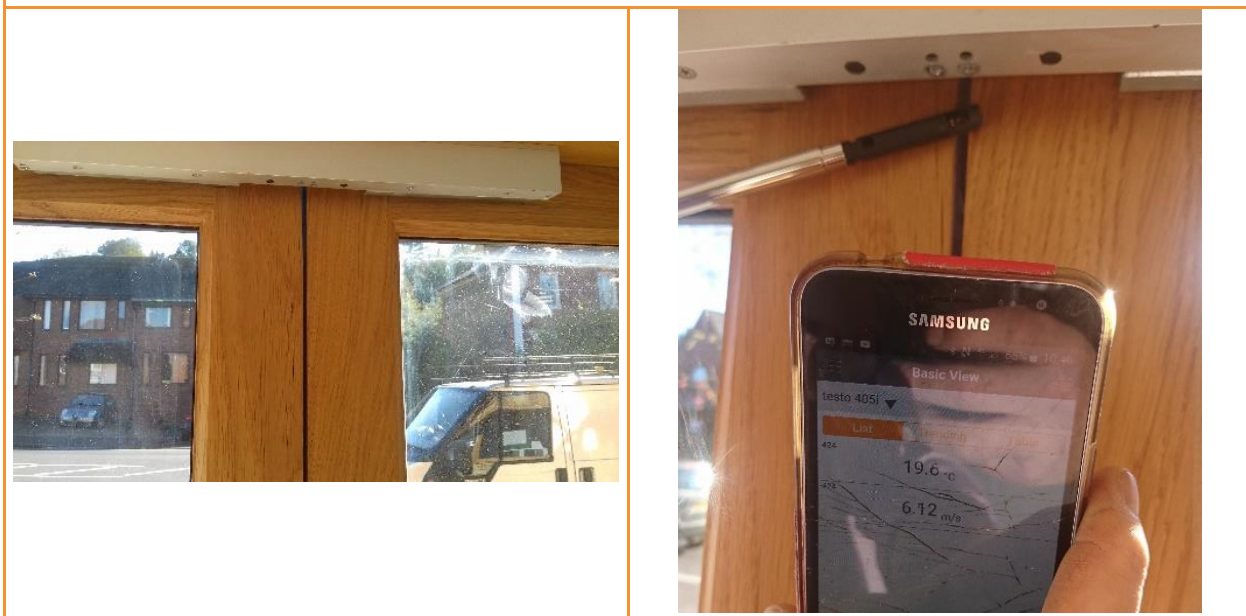
4.18: Close up of leaky gap at top of main entrance doors, with detail showing air velocity of 6.12m/s air movement recorded through gap at top of front doors using a hot wire anemometer

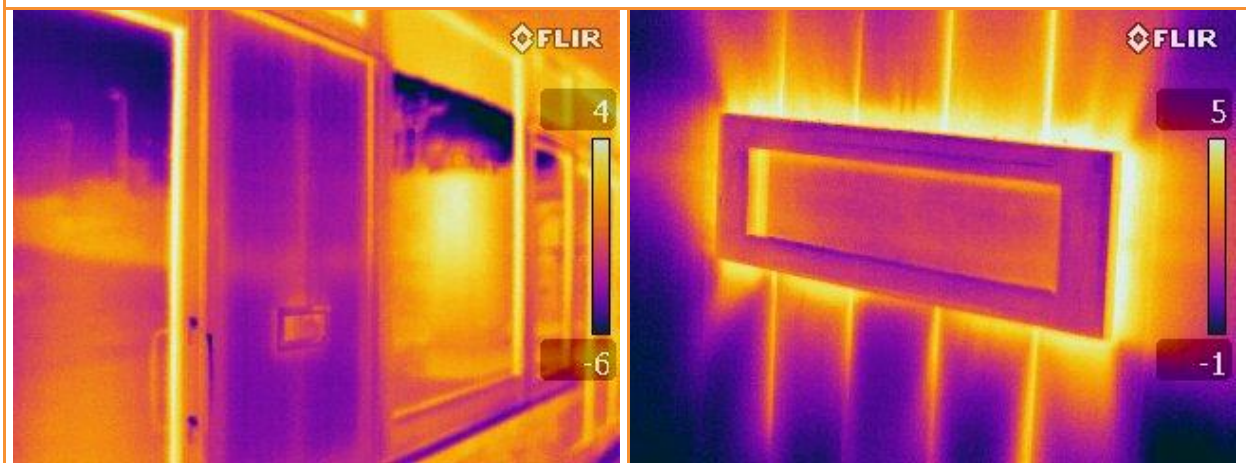
4.19: Thermographic image showing heat loss on letter box before building pressurised (left), then showing dramatically worsened leakage after building pressurised (right)

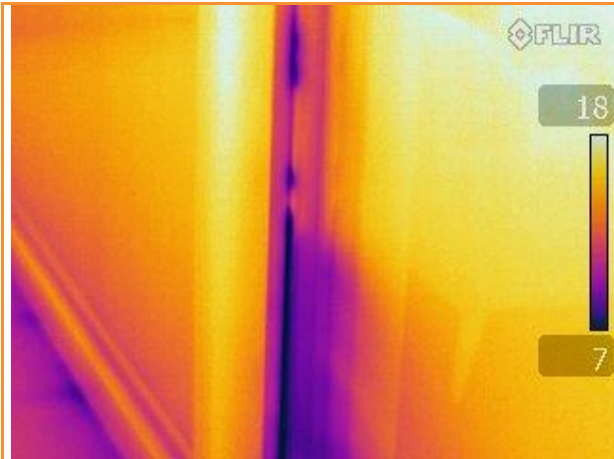
4.20: Thermographic image showing substantial leakage on lower portion of overlap of rear sliding doors

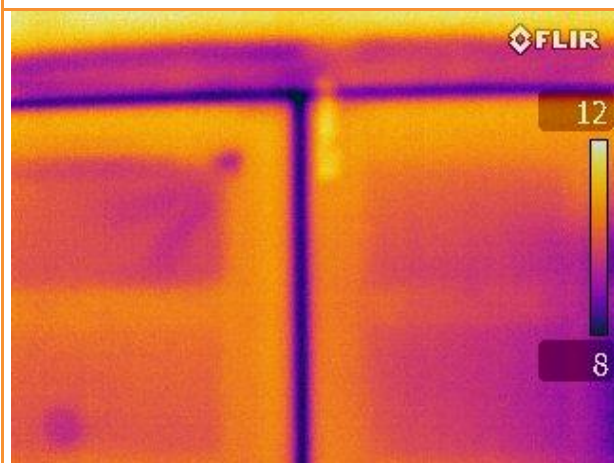
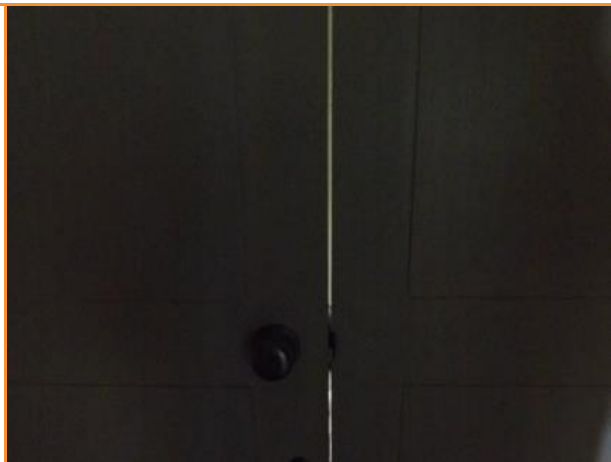
4.21: Thermographic image showing leakage at top of front door, also between door leaves

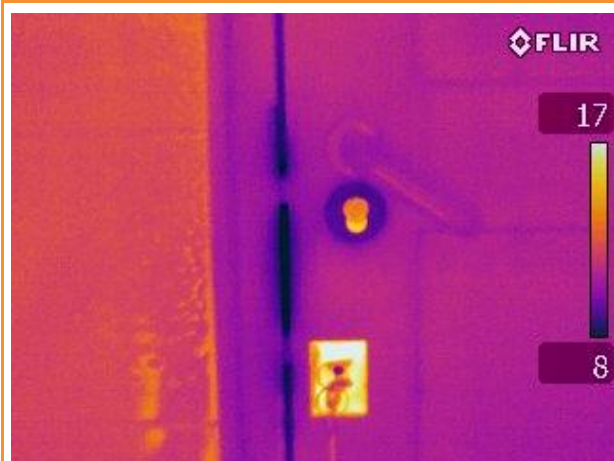
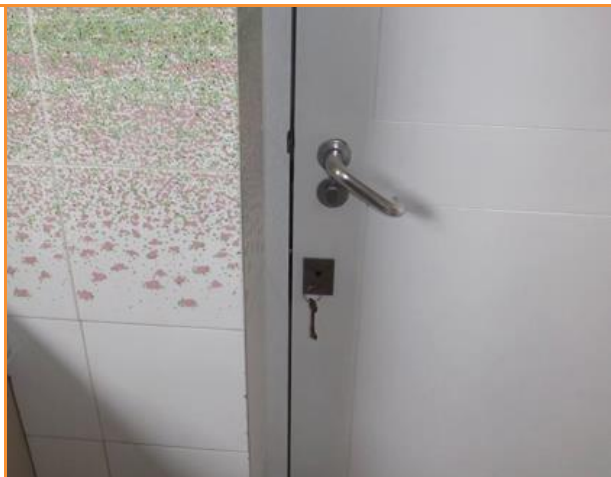
4.22: Thermographic image showing leakage beside kitchen door lock during depressurisation
