Common Leakage Sites no.5

Building Fabric Leakage 5: Beneath doors and doorframes

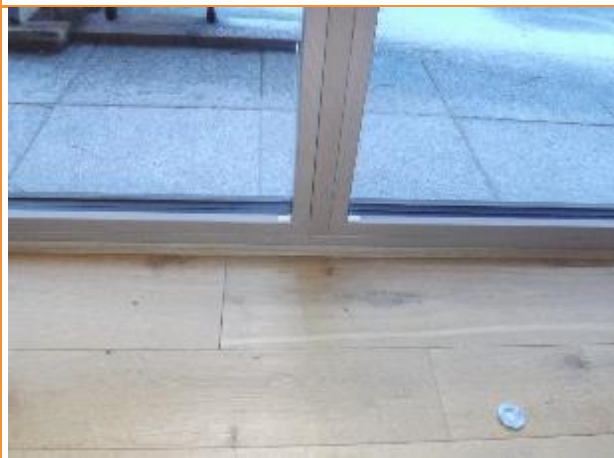
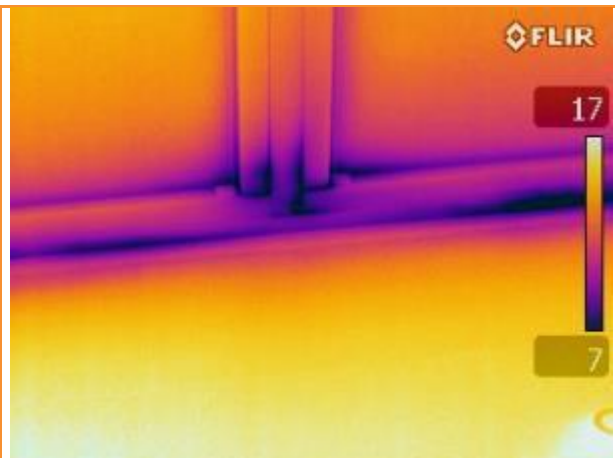
5.01: Internal thermographic image whilst existing house depressurised. Leakage across bottom of glazed door in lounge.

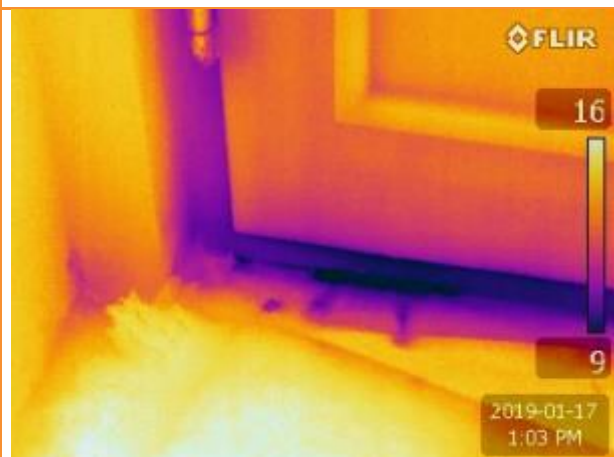
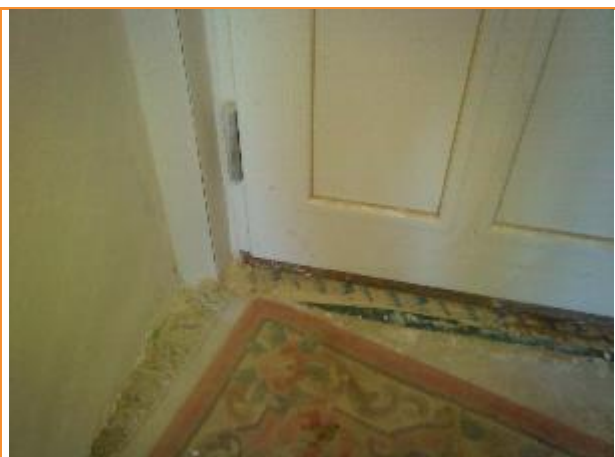
5.02: Internal thermographic image whilst house is depressurised showing leakage at base of front door.

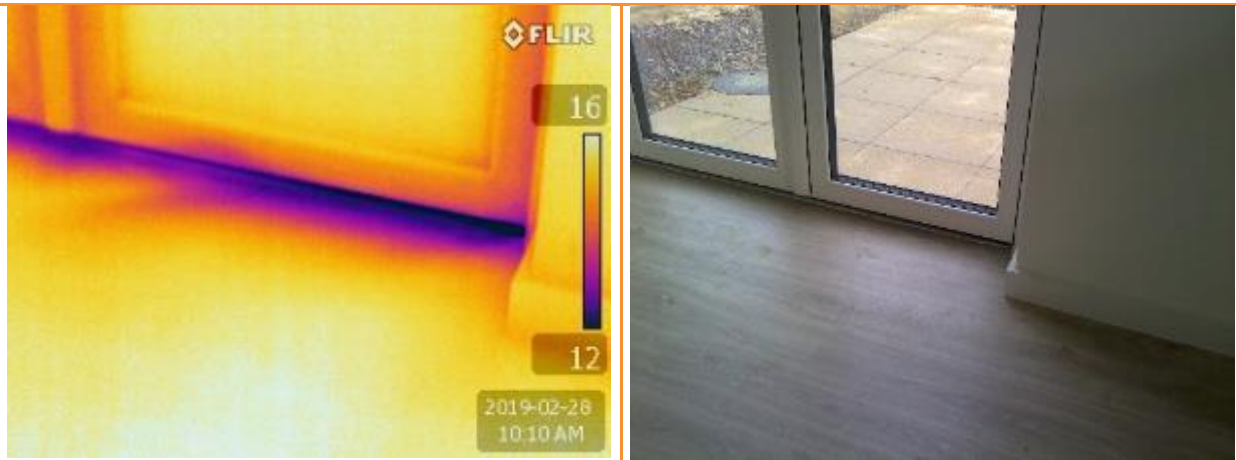
5.03: Internal thermographic image whilst house is depressurised showing leakage across the bottom of French windows.

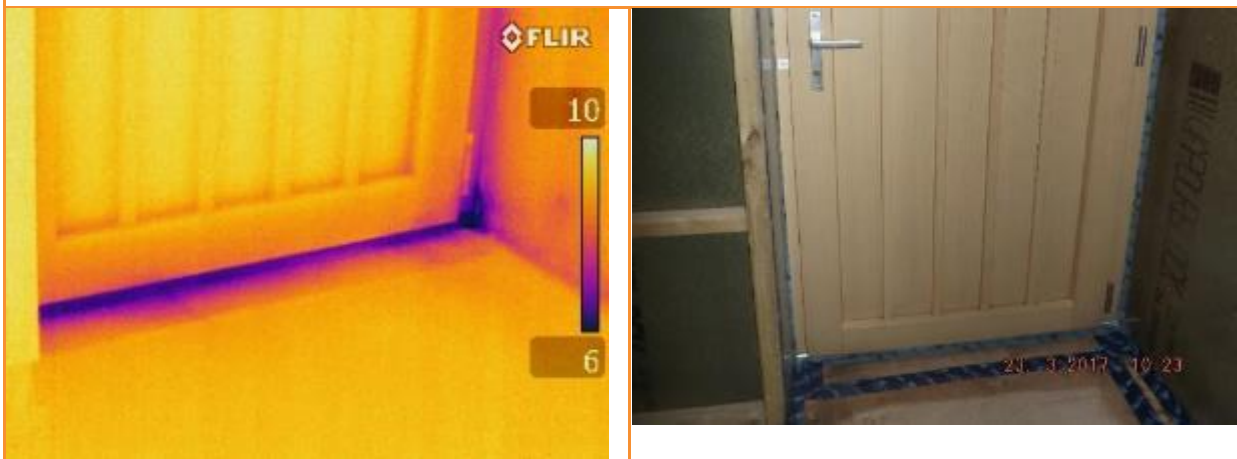
5.04: Internal thermographic image whilst house is depressurised showing leakage across base of internal door to garage, particularly at corner.

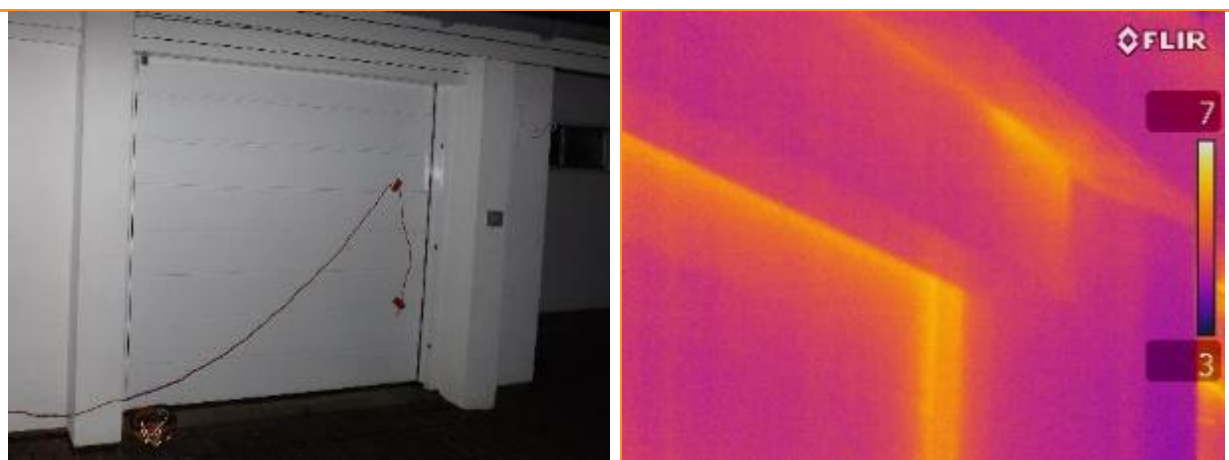
5.05: External thermographic image whilst house is pressurised showing leakage at side & top of garage door.

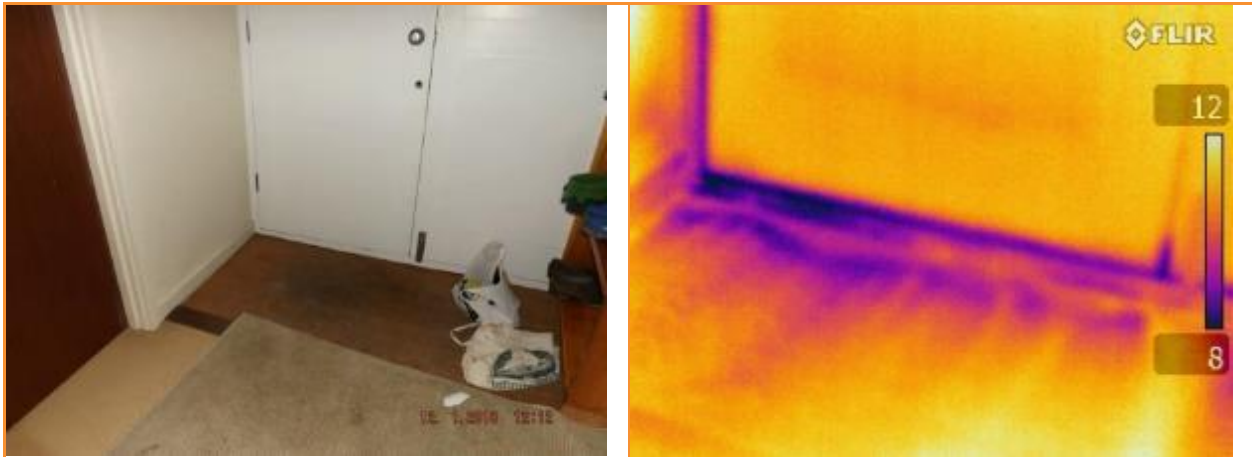
5.06: Internal thermographic image whilst house is depressurised showing leakage along base of front entrance door.

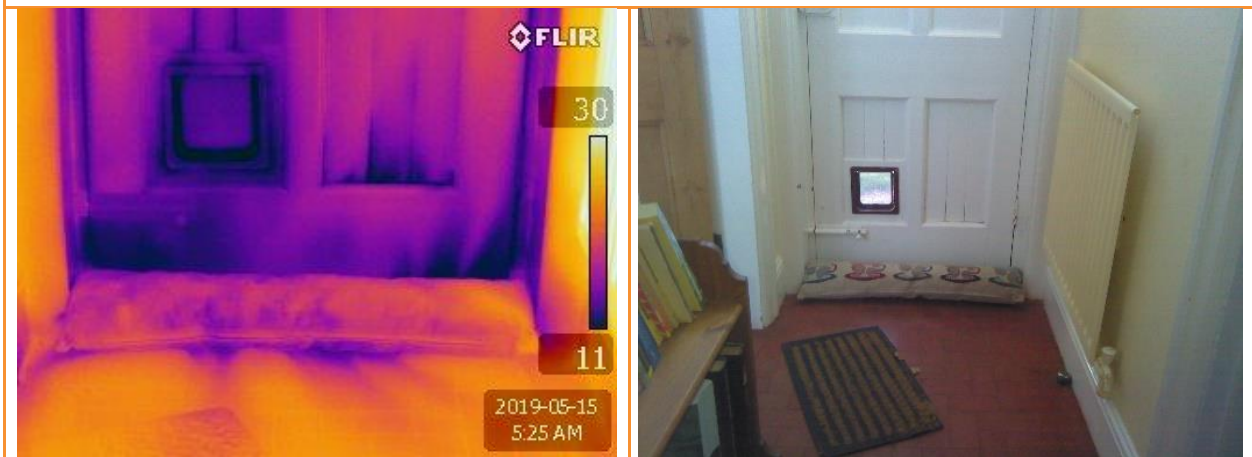
5.07: Internal thermographic image whilst house depressurised, showing substantial leakage on base of side door, also around cat flap, through the panels of the door and beneath the threshold

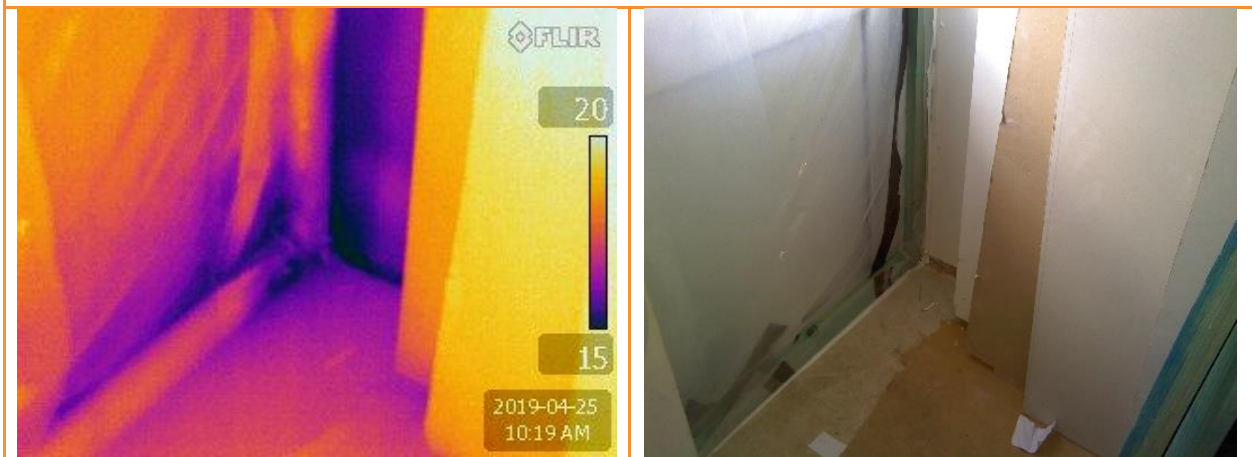
5.08: Thermographic image showing substantial leakage at the bottom corner and side of the existing rear door, which has yet to be replaced

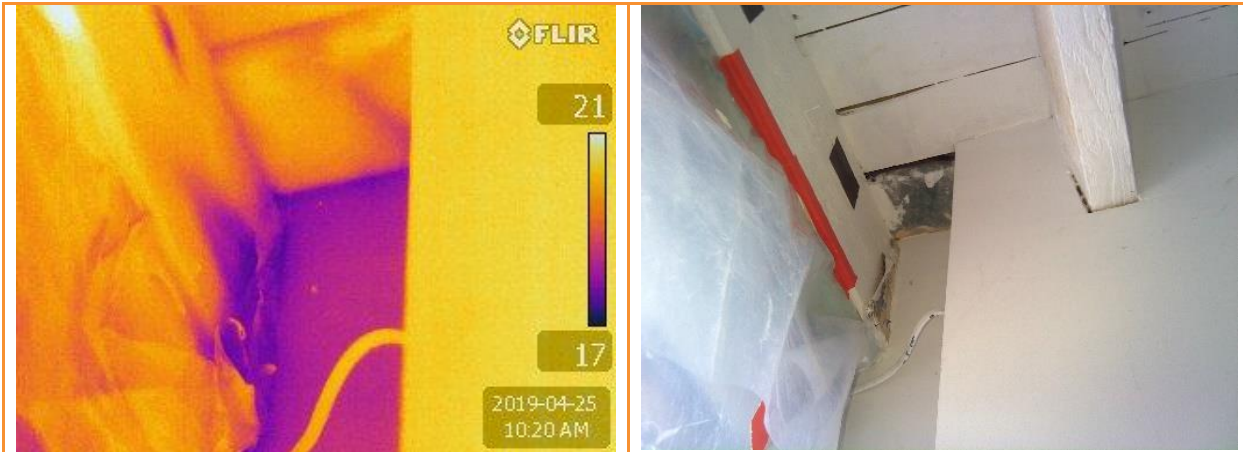
5.09: thermographic image showing substantial high-level leakage at the side of the existing rear door. Unclear if the fundamental problem is an issue with the door or with the external façade beside the door

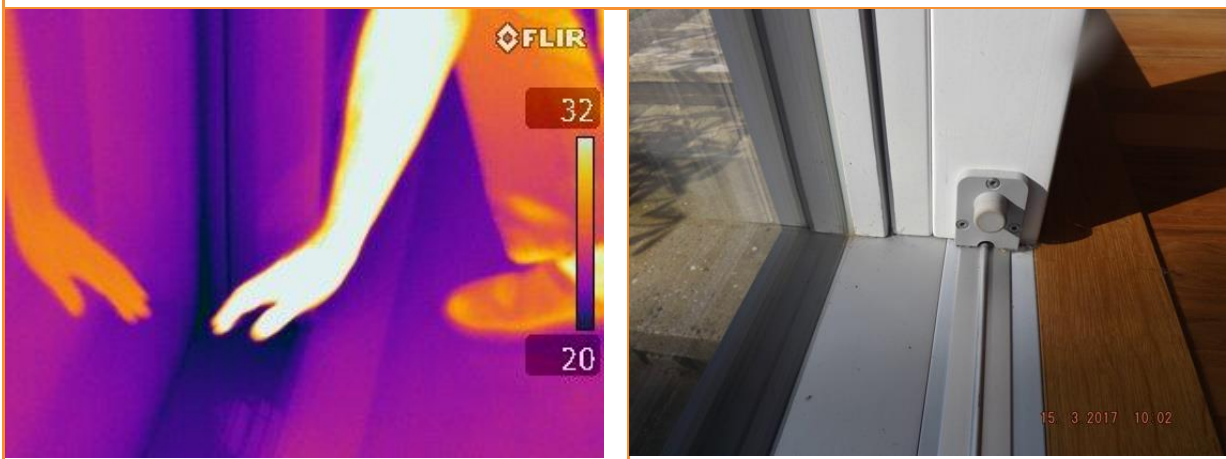
5.10: Thermographic image showing checking for leakage at base of large sliding doors

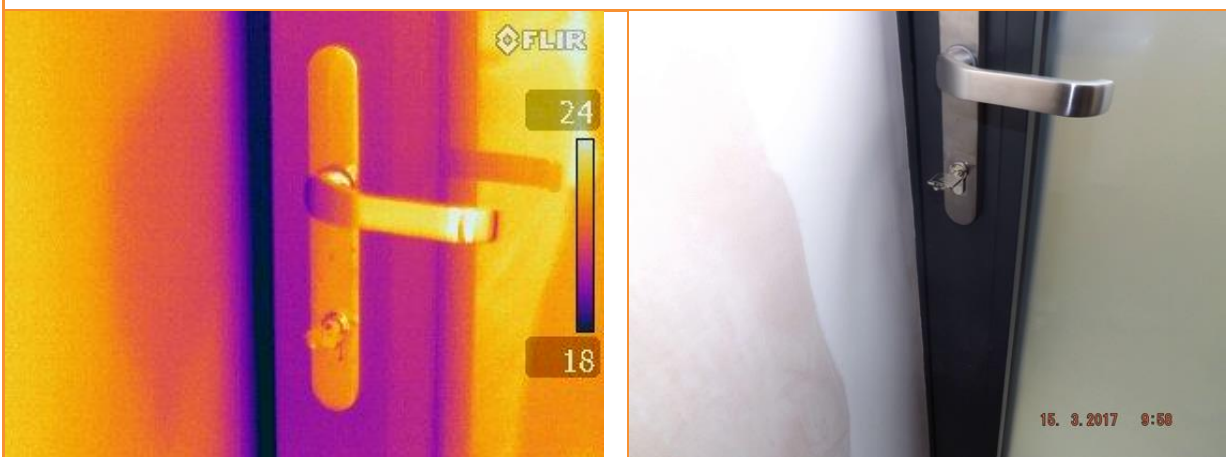
5.11: Thermographic image showing cold bridging down side of door and minor leakage on lock

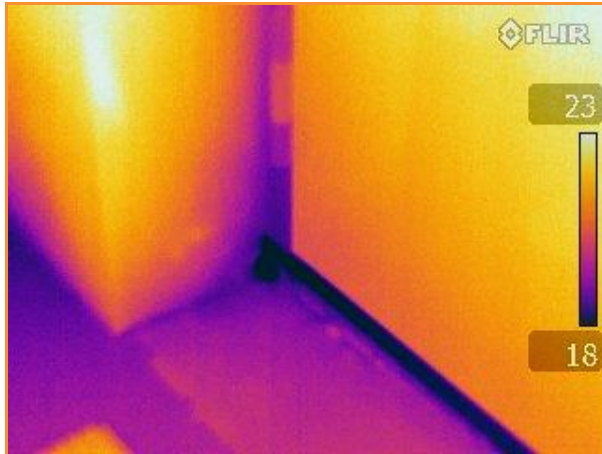
5.2: Thermographic image showing leakage across base of front doorway, particularly in lower left corner

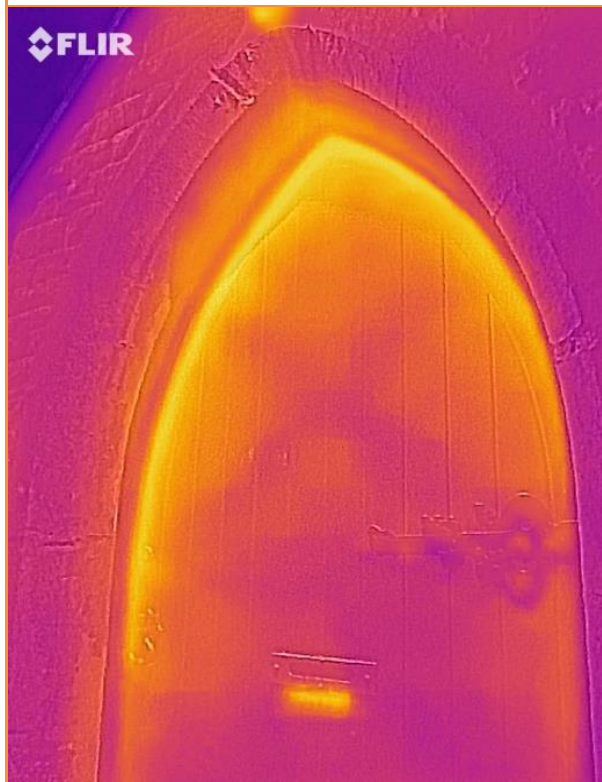
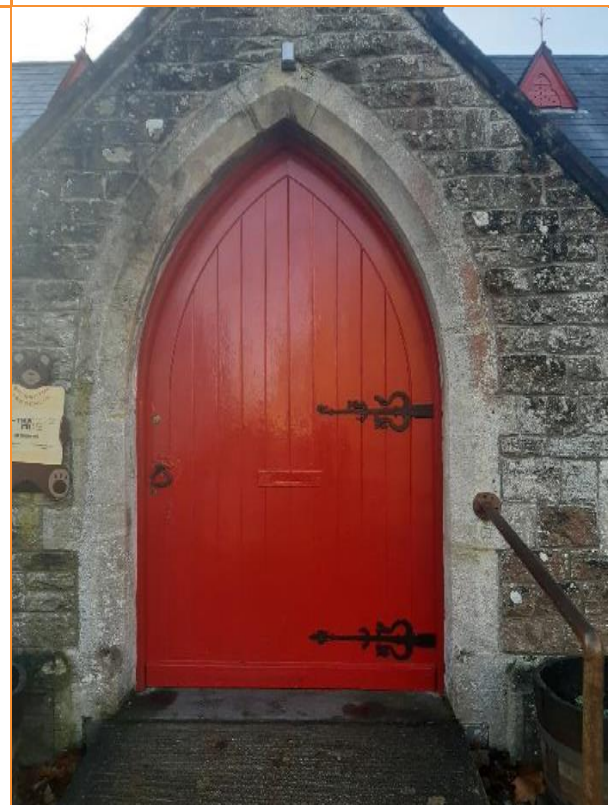
5.13: External thermographic image whilst building pressurised, showing substantial warm air (yellow) escaping the building around main entrance. The letterbox is clearly also leaky and at the very top of the image there appears to be leakage around the connection to the external light

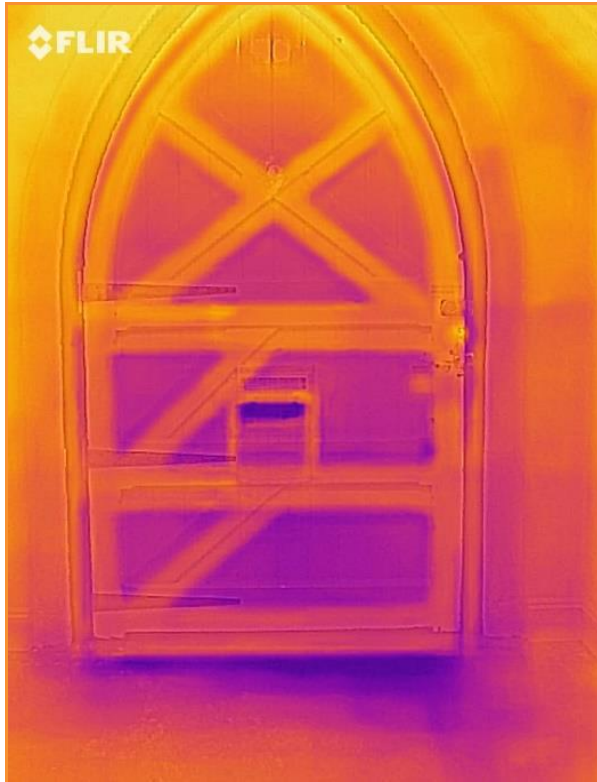
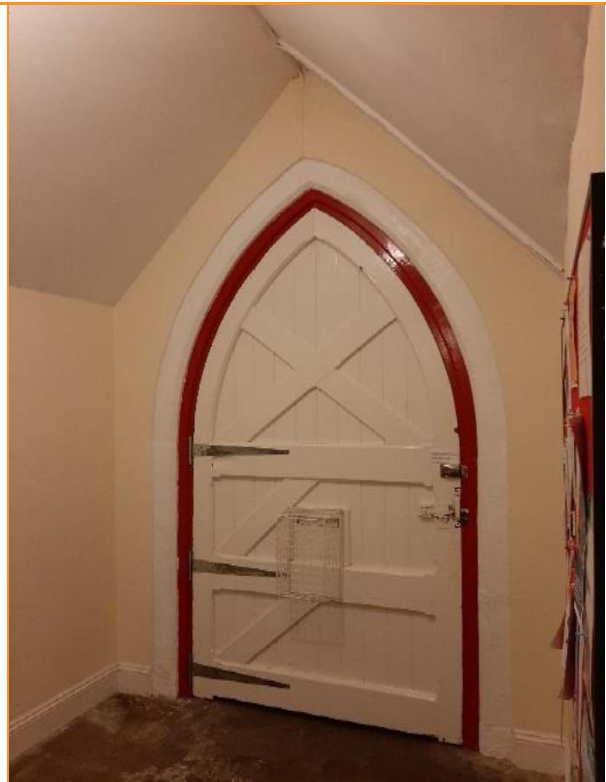
5.14: Internal thermographic image whilst building depressurised, showing substantial cold air (blue) entering the building across the base of the main entrance door, also through the letterbox

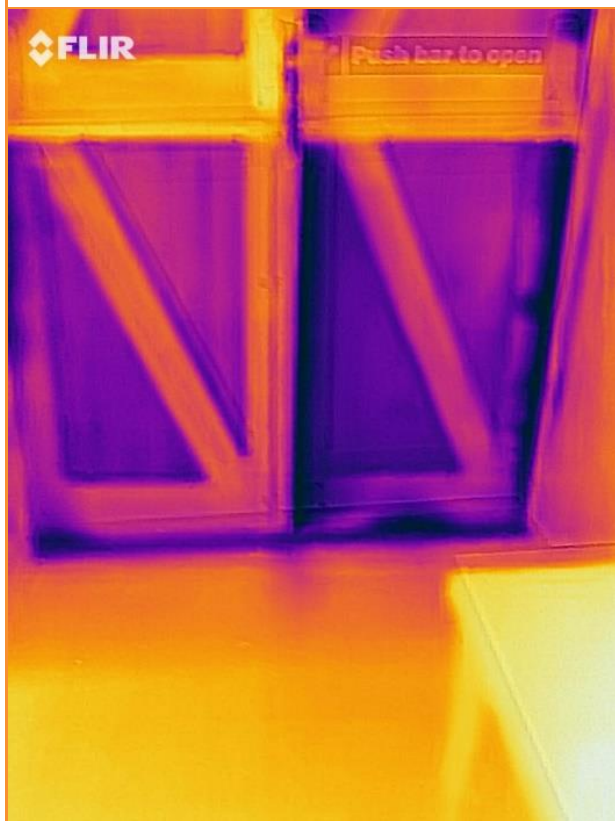
5.15: Internal thermographic image while building depressurised showing substantial leakage of cold air (black) in numerous locations on fires escape door in main hall

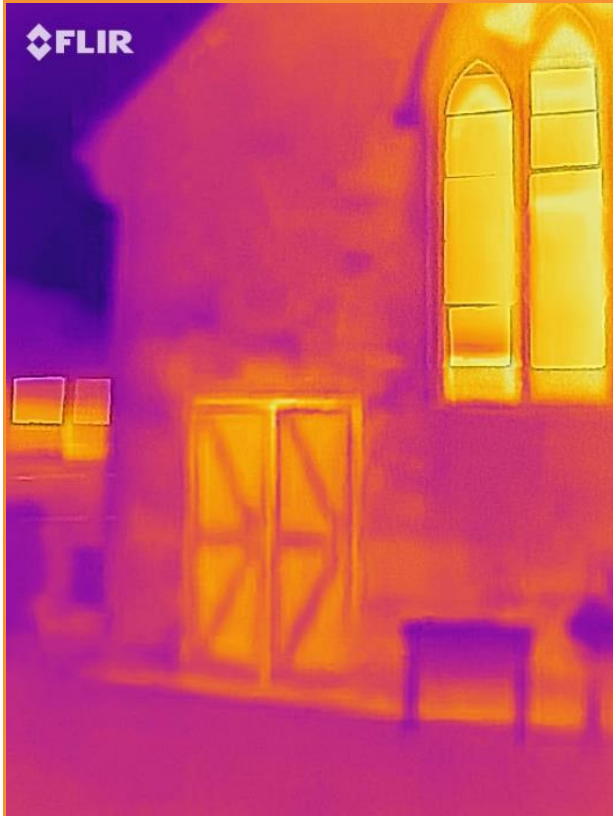
5.16: External thermographic image while building is pressurised showing leakage of warm air (yellow) at side and top of fire escape doorway from main hall

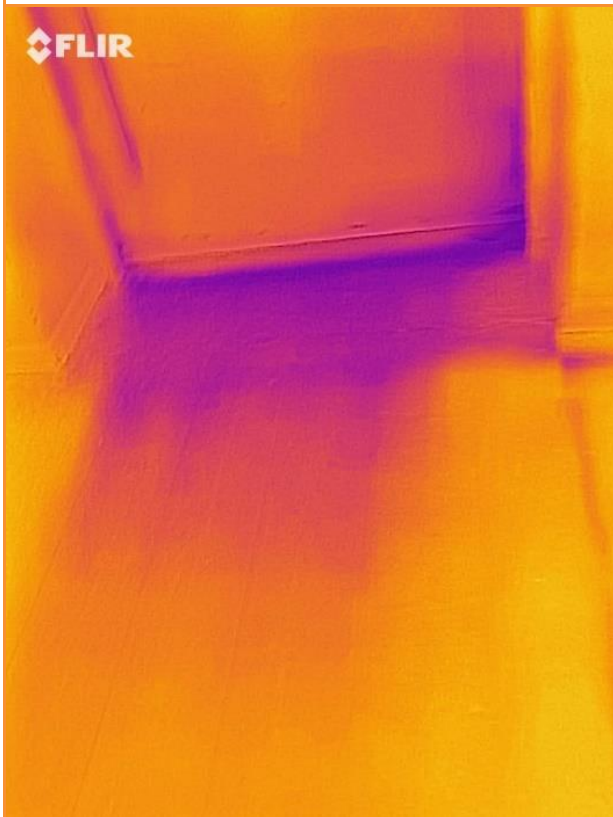
5.17: Internal thermographic image while building depressurised showing leakage of cold air (blue/black) underneath the external door from the kitchen

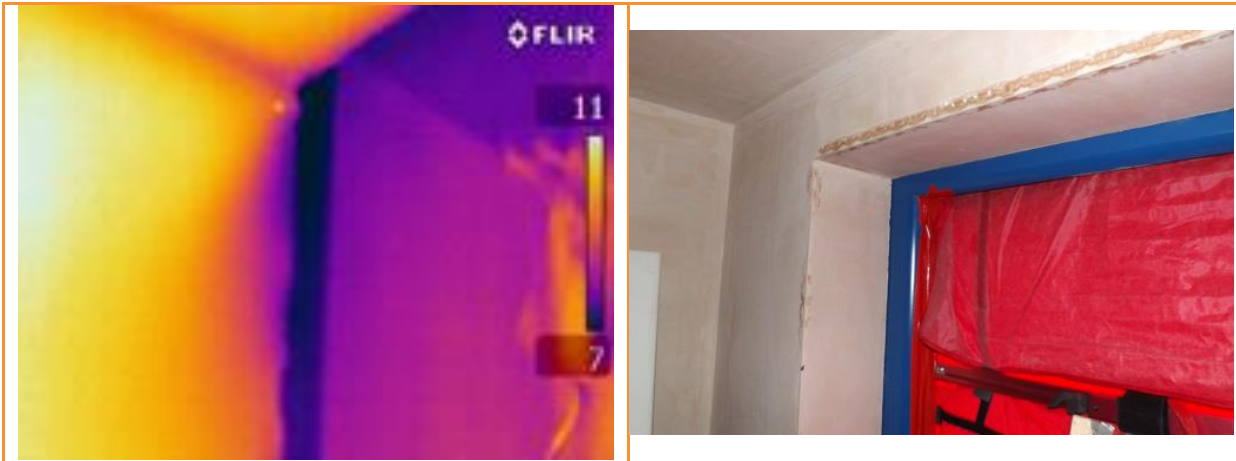
5.18: Thermographic image of cold section formed by leakage along vertical edge of door frame

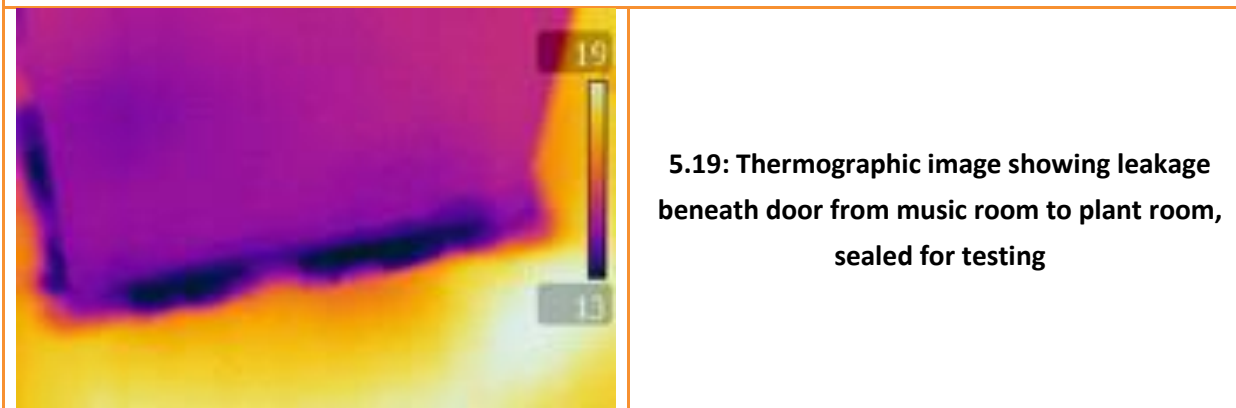
5.19: Thermographic image showing leakage beneath door from music room to plant room, sealed for testing

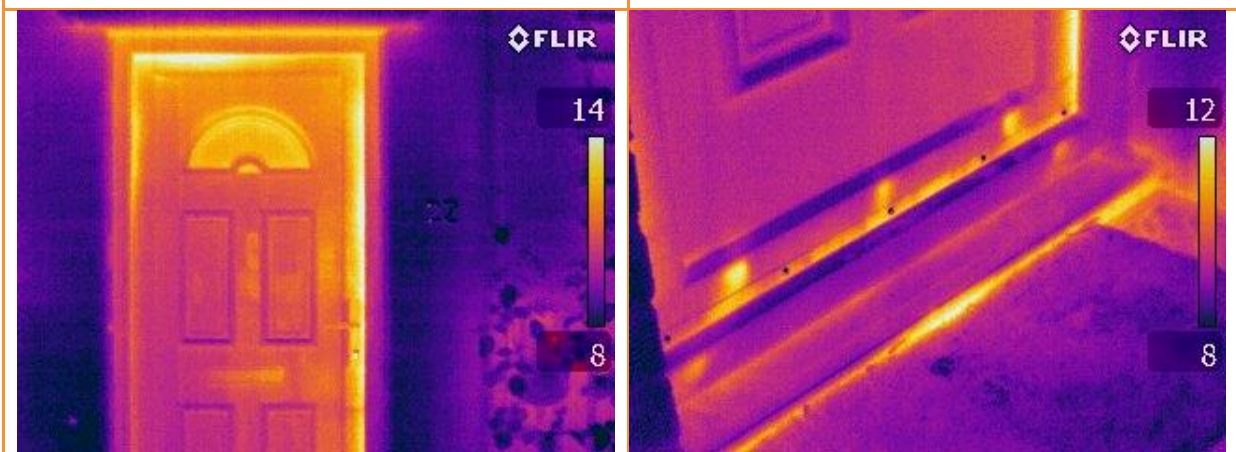
5.20: Thermographic images showing leakage on front door as house pressurised and close up showing cold spots and leakage at base of front door

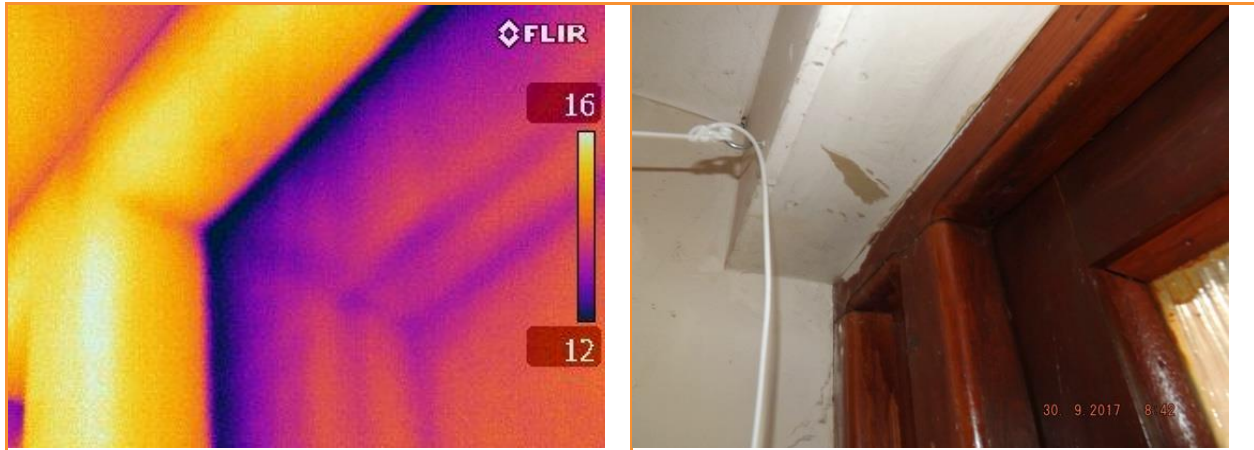
5.21: Thermographic image of leakage on top corner of rear door

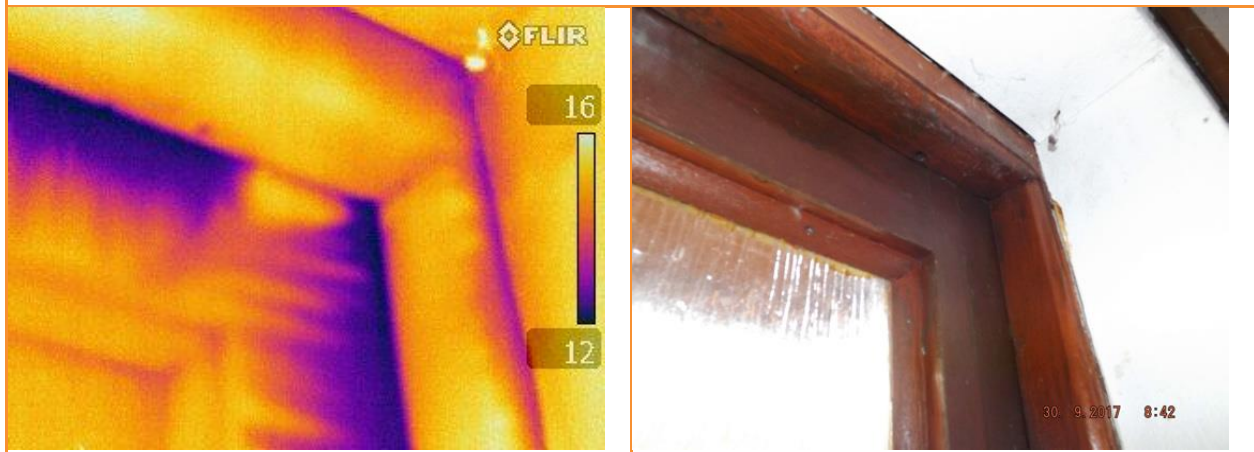
5.22: Thermographic image of leakage on top corner of rear door to lean-to extension

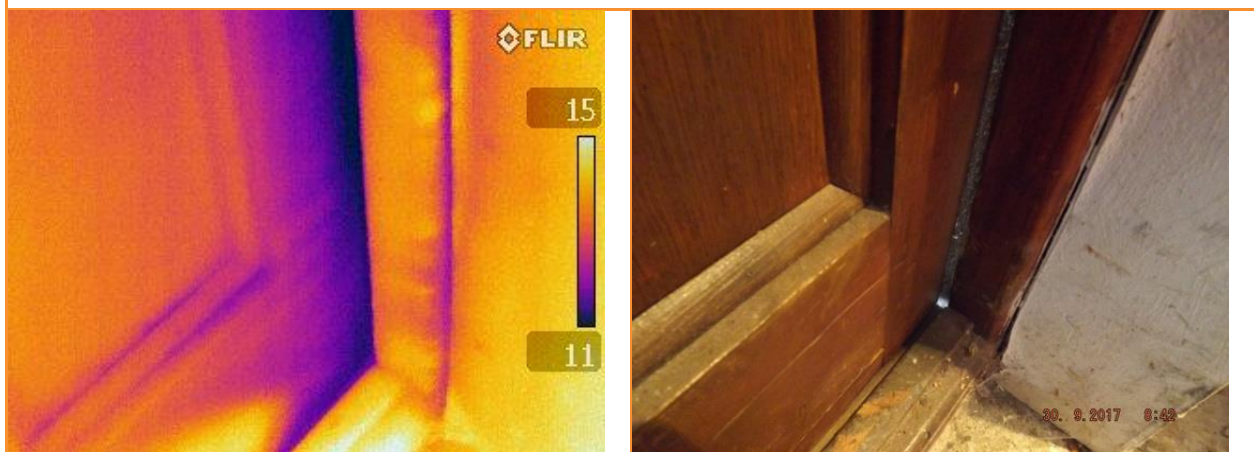
5.23: Thermographic image of leakage on bottom corner of rear door to lean-to extension

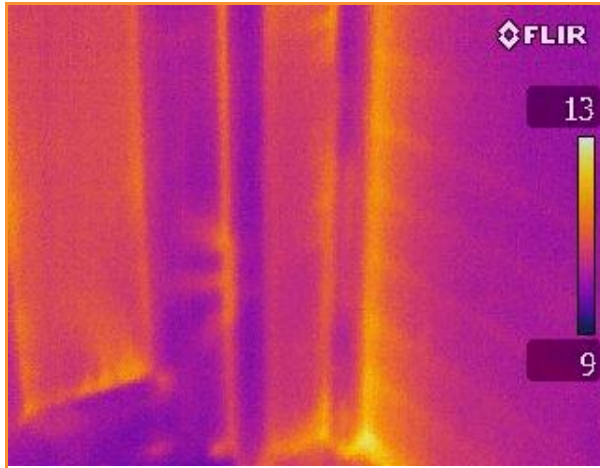
5.24: Thermographic image showing significant leakage around rear door frame to extension, and also where base of extension wall joins to main house

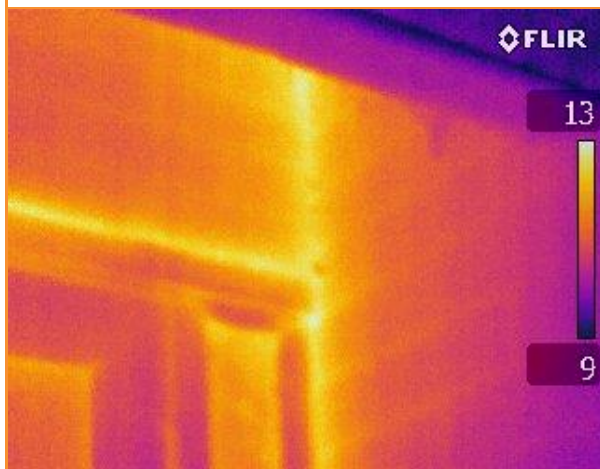
5.25: Thermographic image showing leakage across top of lintel and where edge of extension wall joins to main house

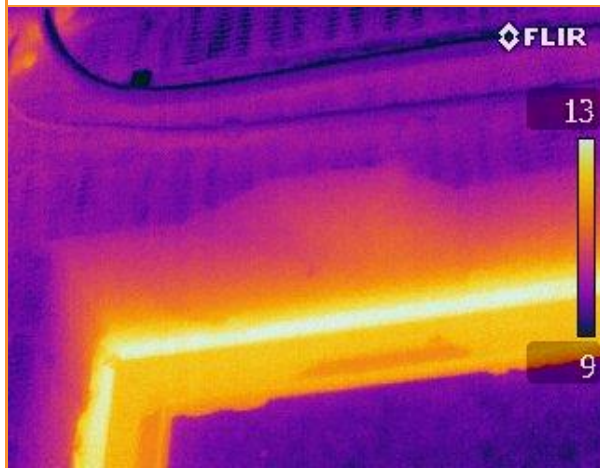
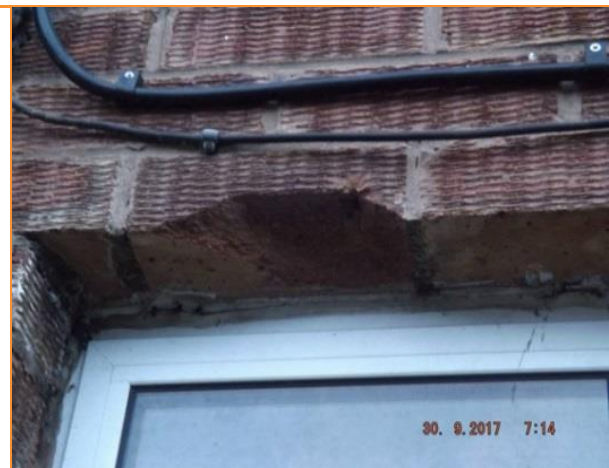
5.26: Thermographic image showing warmer temperature where brickwork is damaged, and leakage around window frame

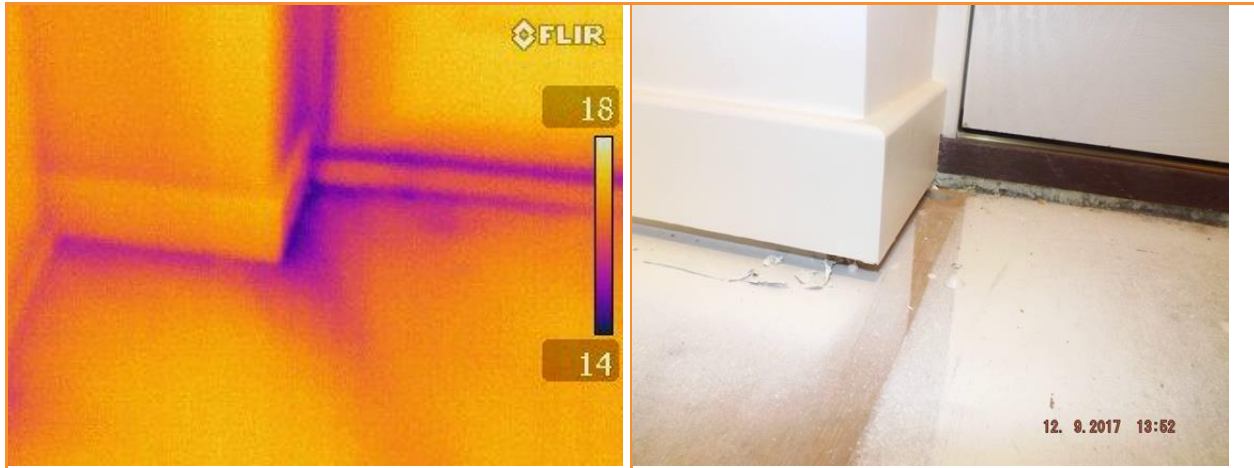
5.27: Thermographic image showing leakage at side of door threshold on front door

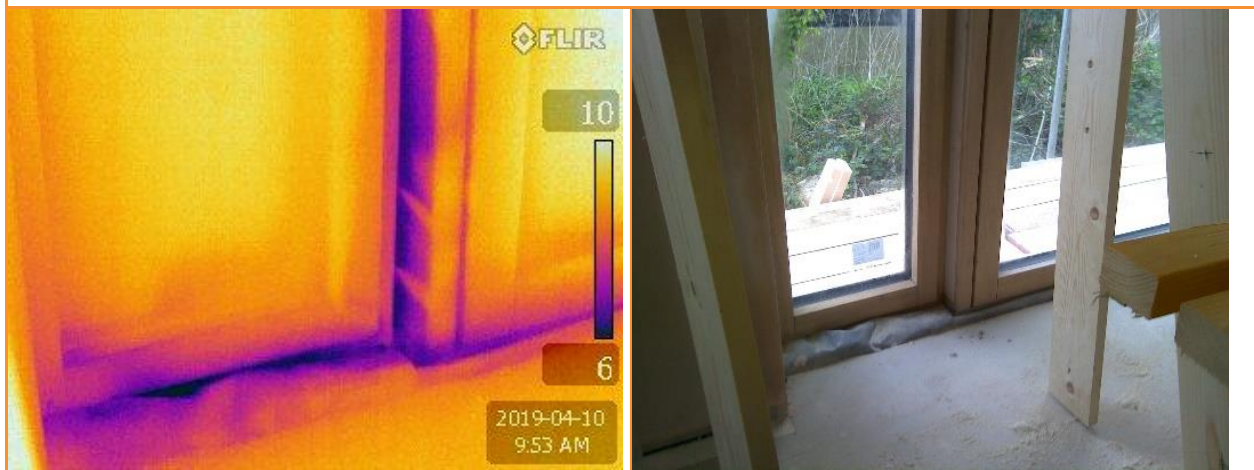
5.28: Thermographic image showing substantial leakage around the external door from the lounge area

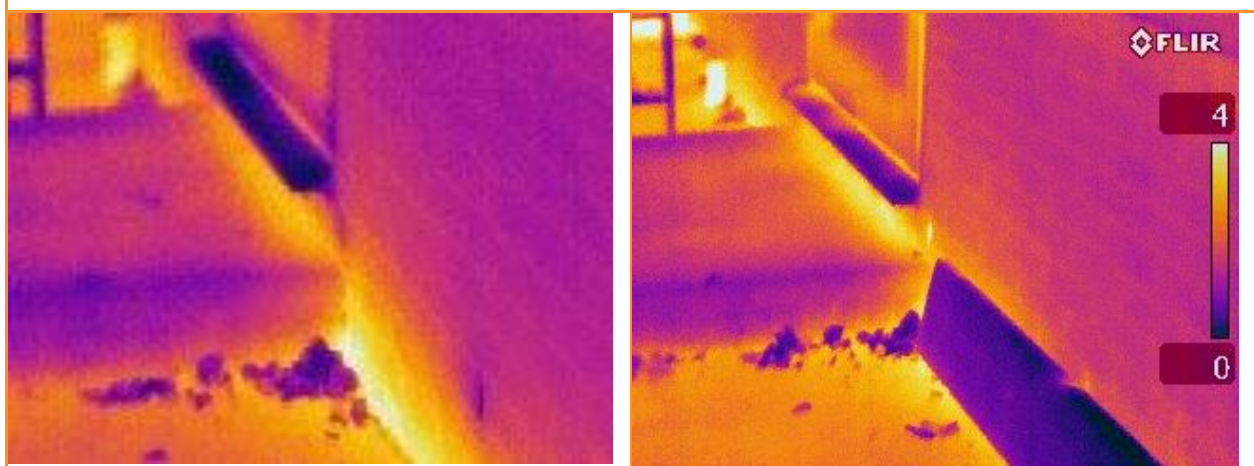
5.29: Thermographic image showing some heat loss beneath side door threshold before building pressurised (left), and then showing much more heat loss under threshold and on bottom & side of door after pressurisation (right)

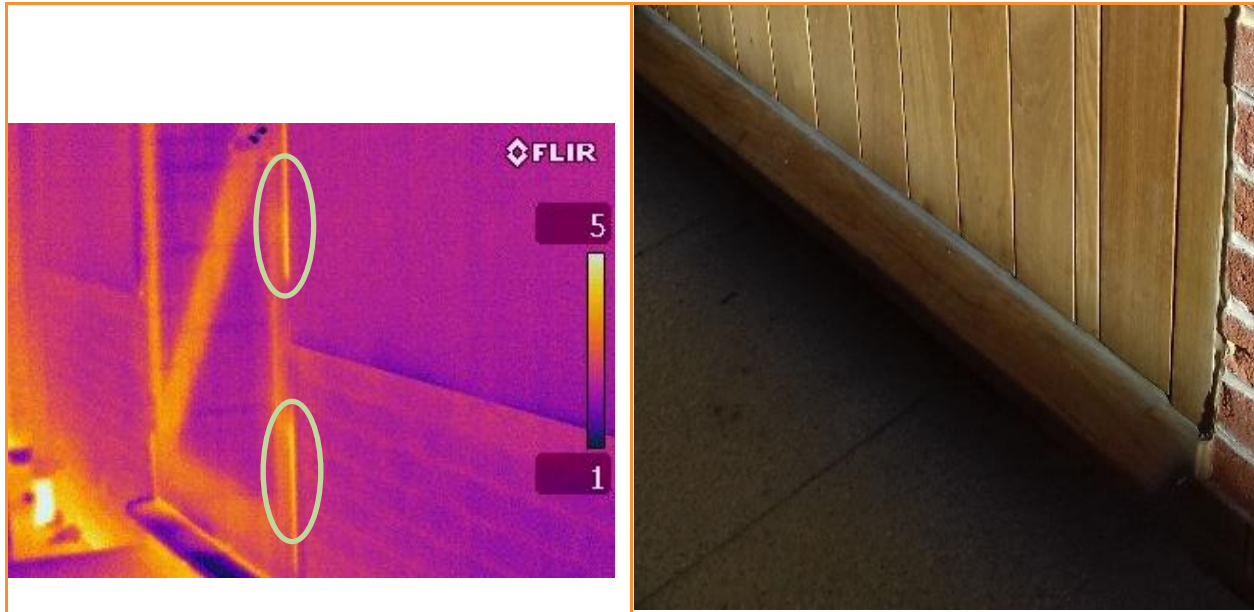
5.30: Thermographic image of side door, with frame visible and clear air leakage at two particular locations on the vertical edge - also beneath both door & threshold

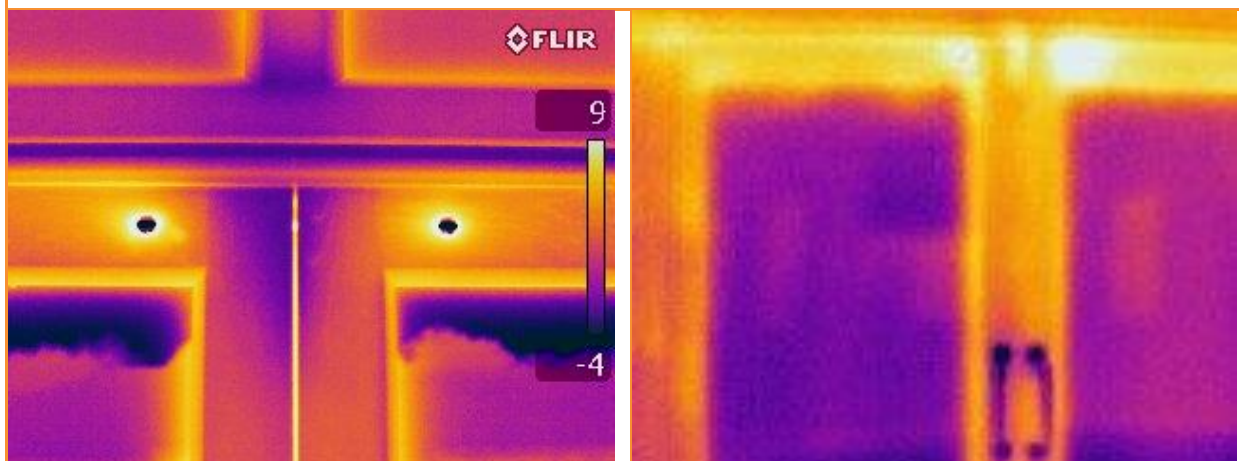
5.31: Thermographic image showing leakage at top of gap between front doors, before building pressurised (left), then after building pressurised showing increased leakage at top of double doors (right)

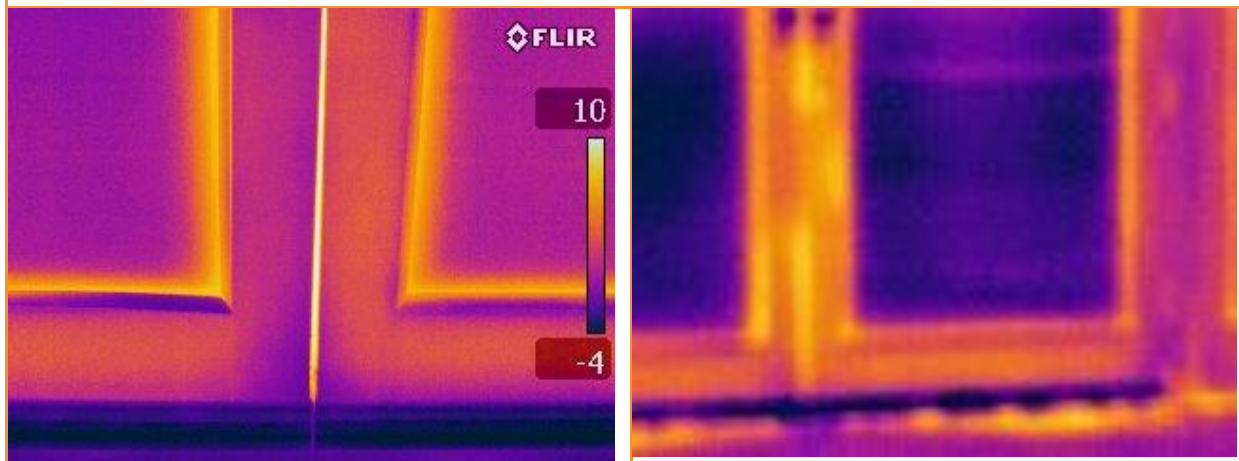
5.32: Thermographic image showing leakage at bottom of gap between front doors, before building pressurised (left), and after building pressurised showing increased leakage between doors but particularly beneath threshold

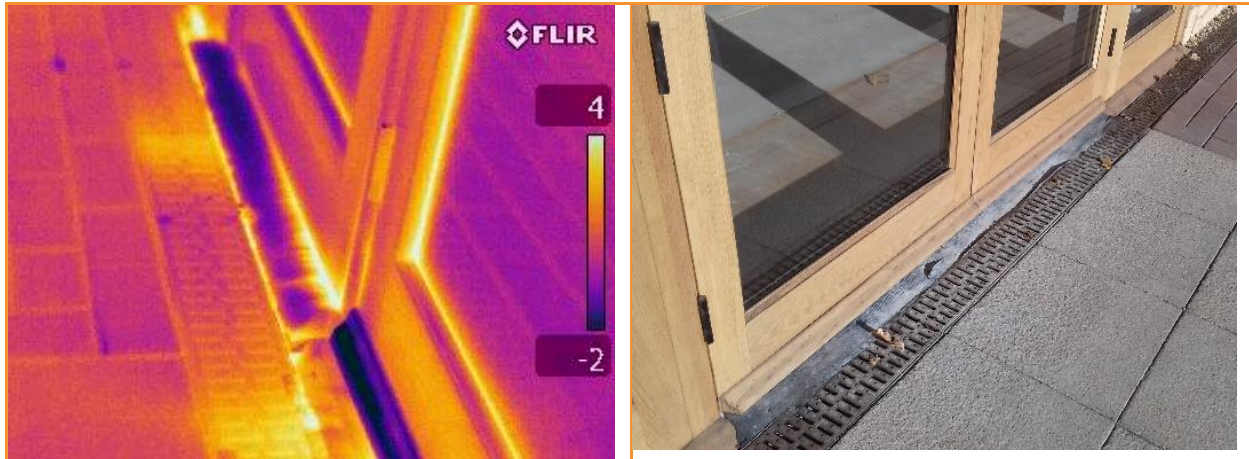
5.33: Thermographic image whilst building pressurised showing major leakage on front door threshold

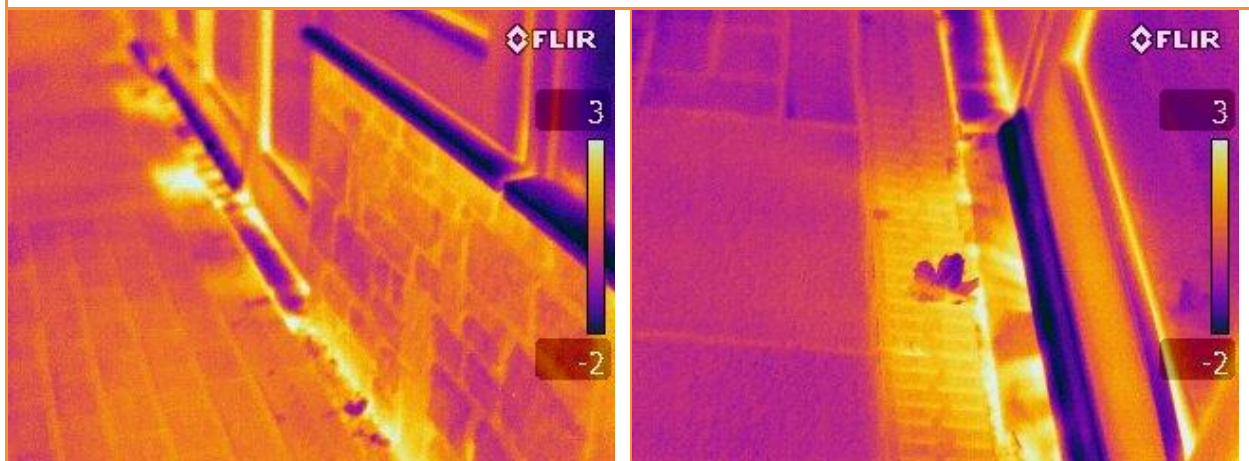
5.34: Thermographic image along front façade of building when pressurised, showing heat loss at edge similar to that before pressure applied, but major heat loss under door frame and beneath threshold (left), then close-up view of edge of threshold; classic “plumes of warmth” showing hot air escaping when building pressurised (right)

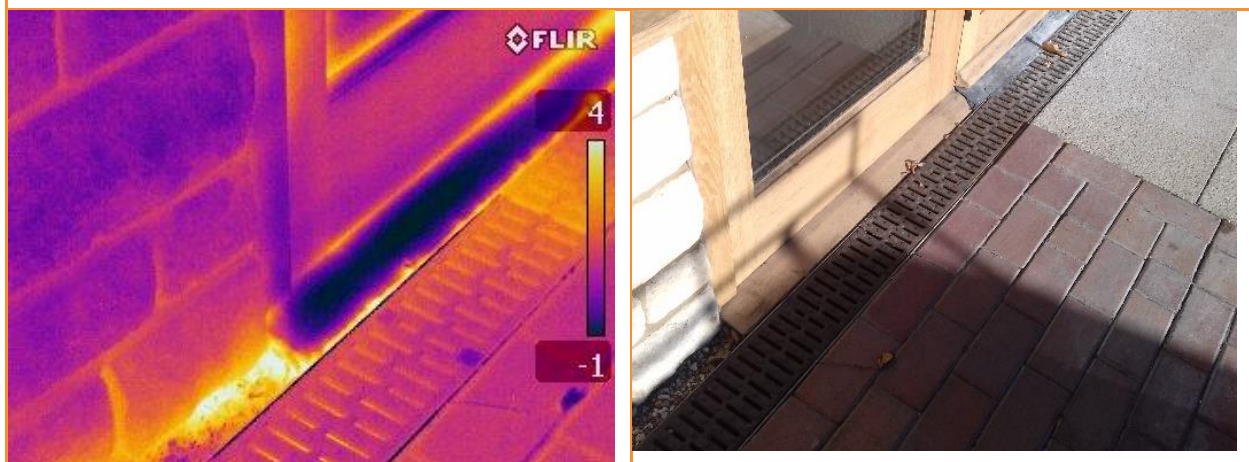
5.35: Thermographic image whilst building pressurised showing substantial leakage at side of front double doors at low level

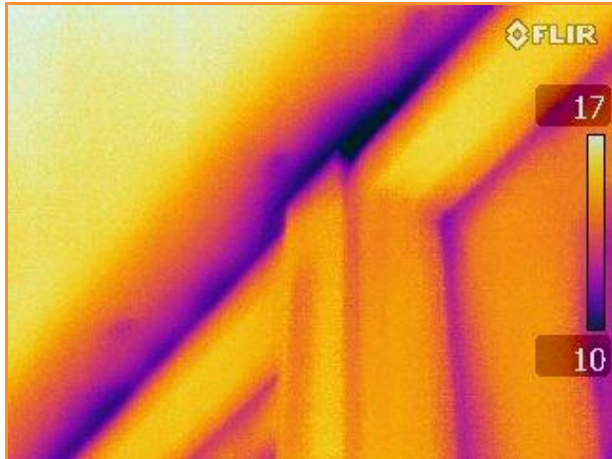
5.36: Thermographic image of major leakage at top of double doors whilst depressurising

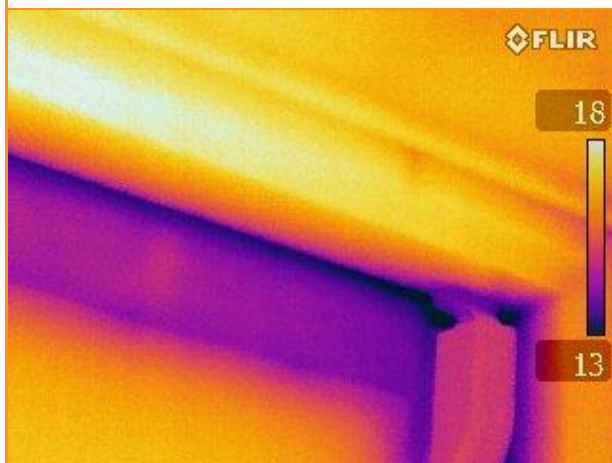
5.37: Thermographic image of major leakage across top of side door whilst depressurising

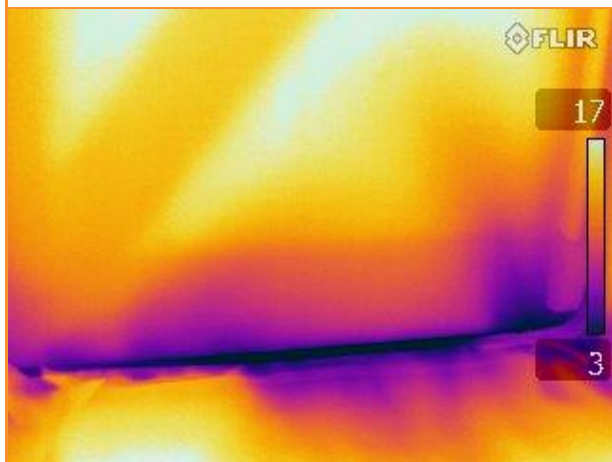
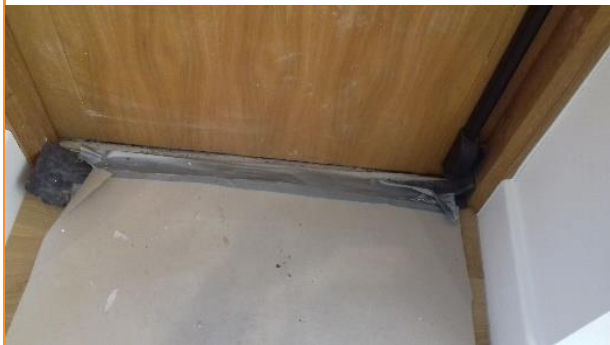
5.38: Thermographic image of major leakage under base of side door whilst depressurising

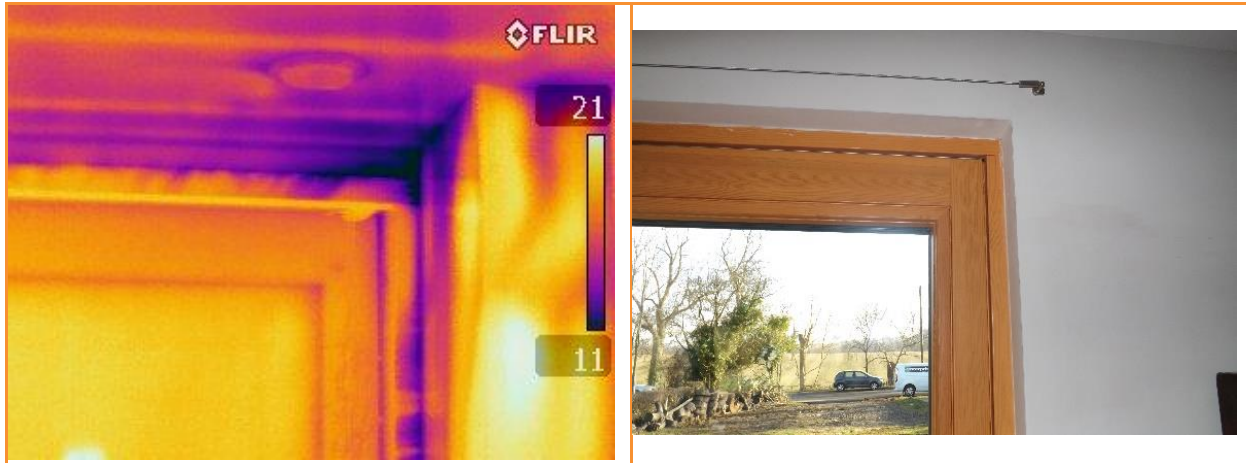
5.39: Thermographic image showing substantial leakage at corner of double doors
