Common Leakage Sites no.5

Building Fabric Leakage 5: Beneath doors and doorframes

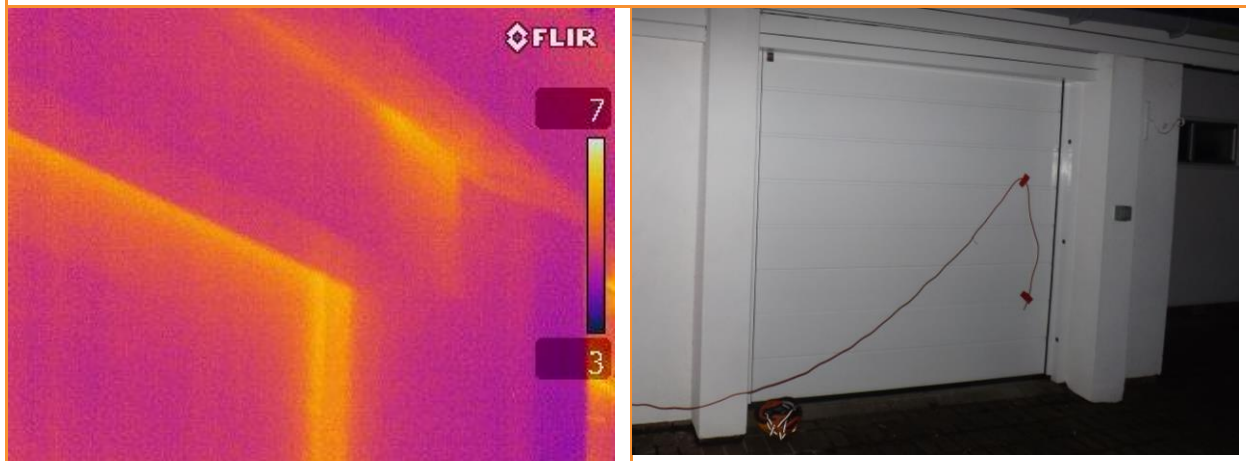
5.40: Thermographic image showing leakage under pressurisation at side & top of garage door, also along section of eaves junction to top of wall

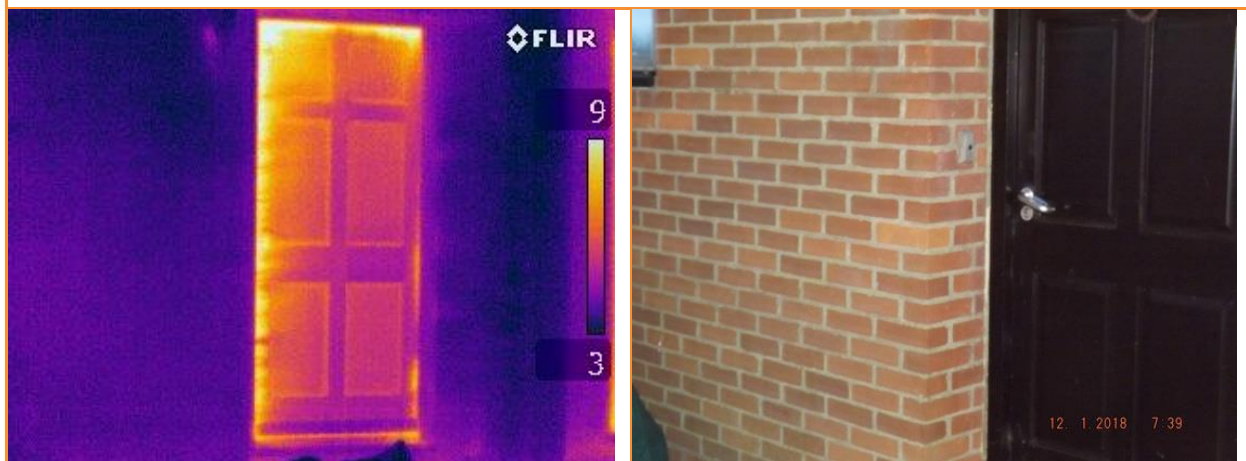
5.41: Thermographic image showing leakage around back door during pressurisation

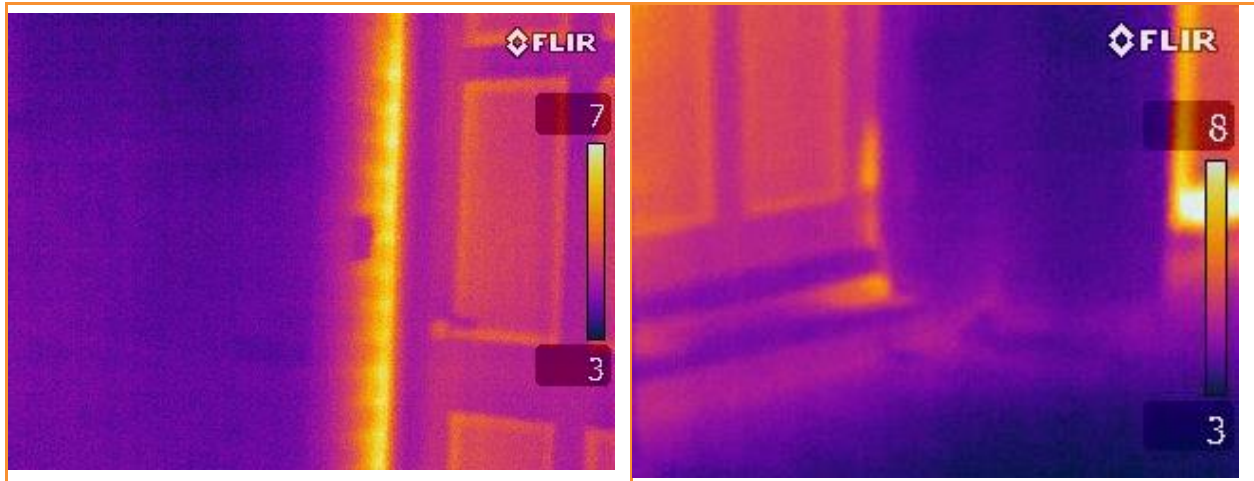
5.42: Thermographic images showing close-up of leakage at side and base of back door

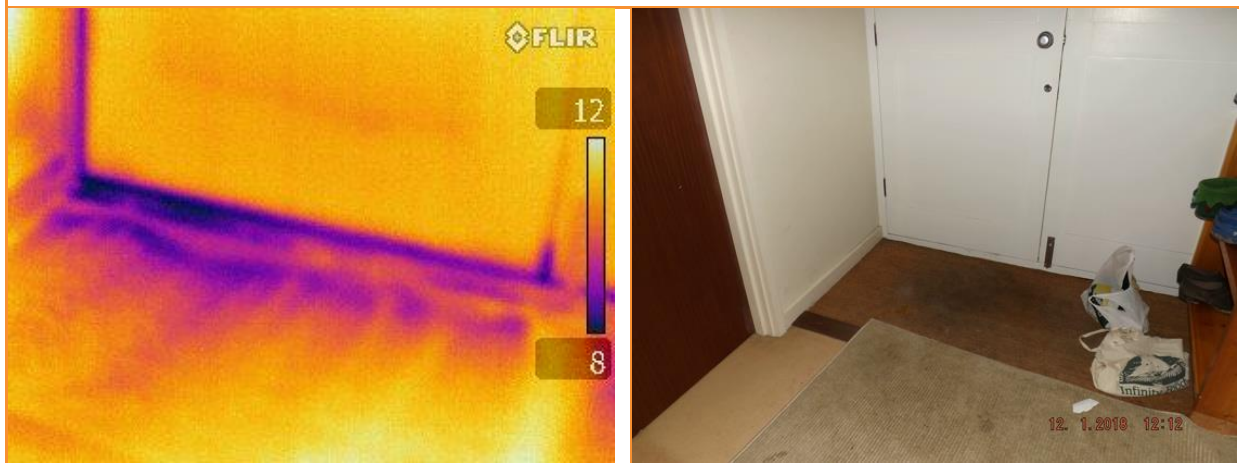
5.43: Thermographic image showing substantial leakage at base of front entrance doorway

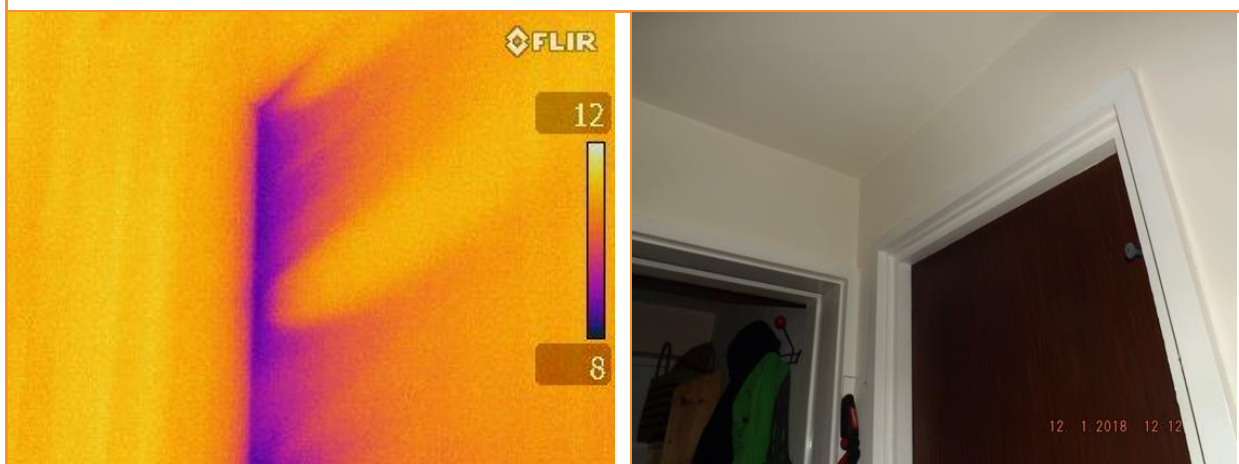
5.44: Thermographic image showing substantial leakage on upper side of internal garage door

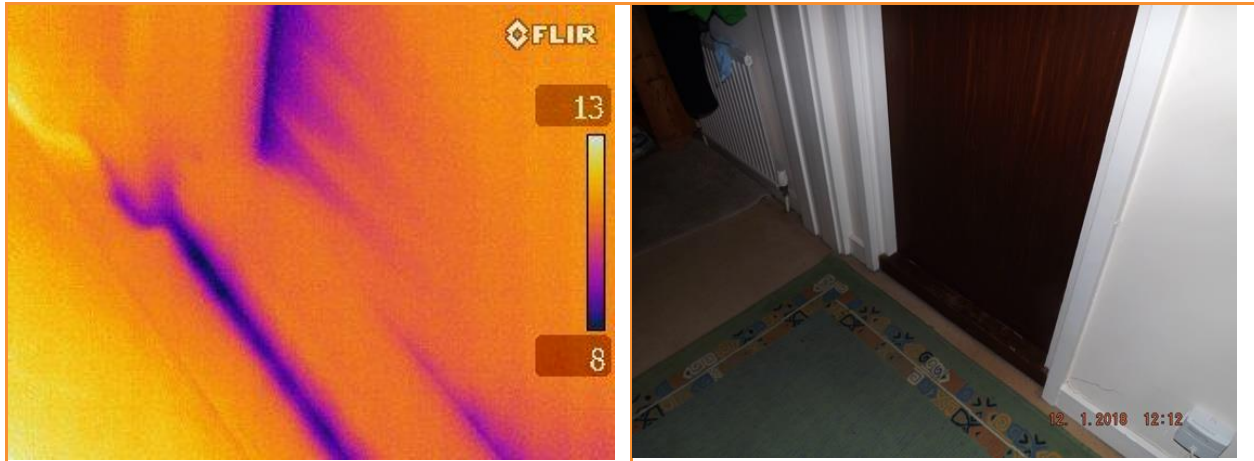
5.45: Thermographic image showing substantial leakage at lower side and beneath threshold

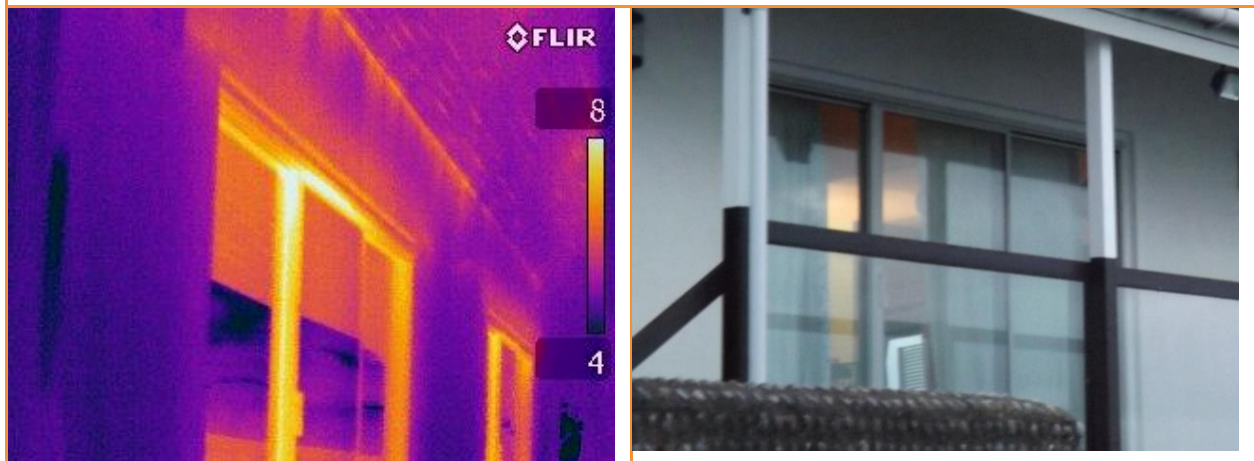
5.46: Thermographic image showing leakage along lintel above rear lounge doors. Also, leakage at side & top of sliding door

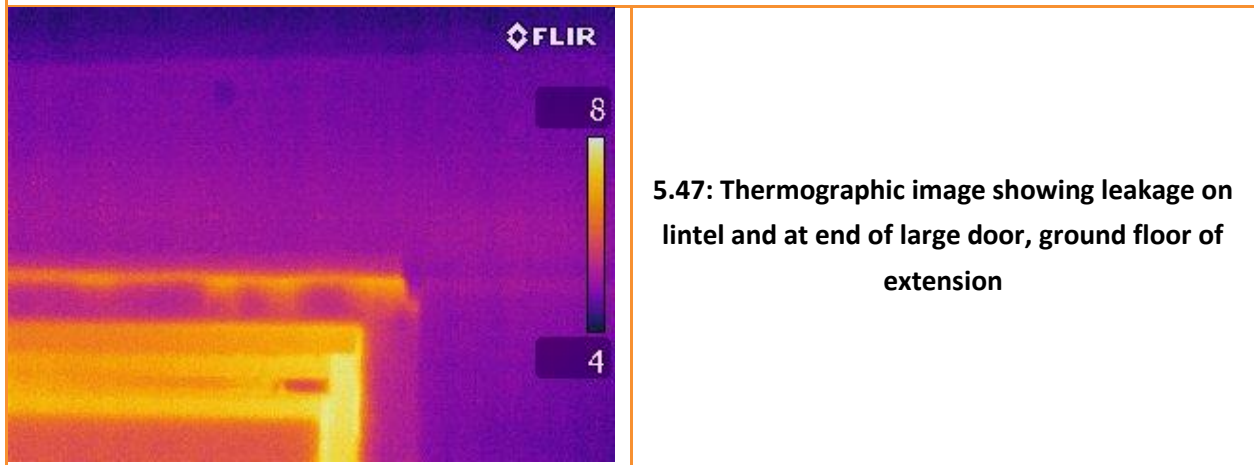
5.47: Thermographic image showing leakage on lintel and at end of large door, ground floor of extension
