## Common Leakage Sites No.11

**Through gaps behind plasterboard on dabs or hollow studwork walls.**

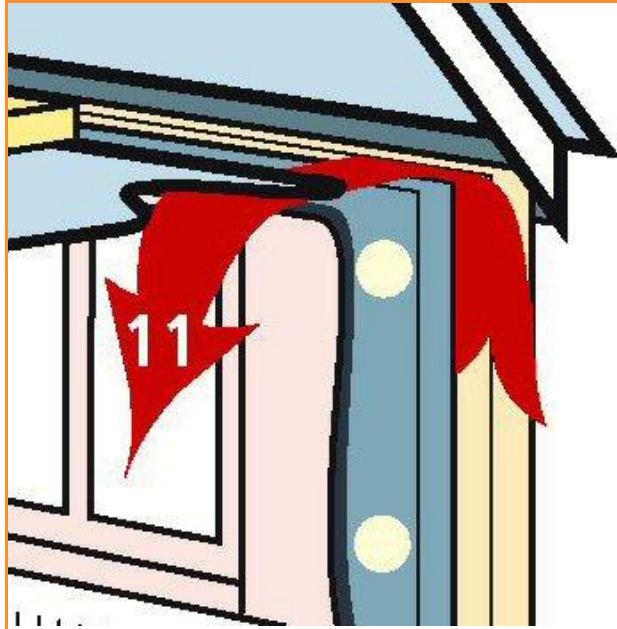
In this instance air is leaking from the wall cavity into the room via gaps behind dot-and-dab plasterboard, or hollow studwork walls. Often occurs through electricity sockets and light switches, and cable TV and similar media outlets are commonly very poor.

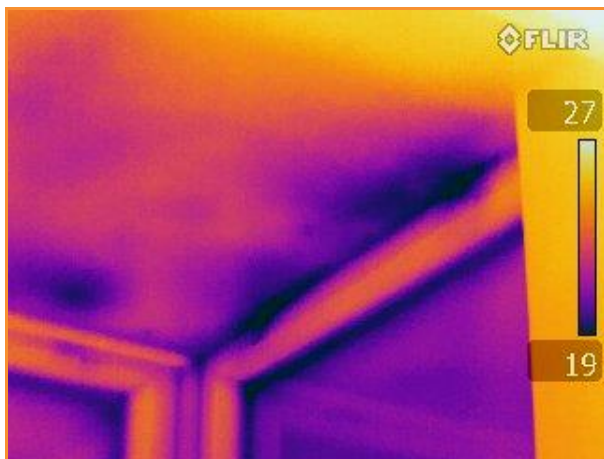
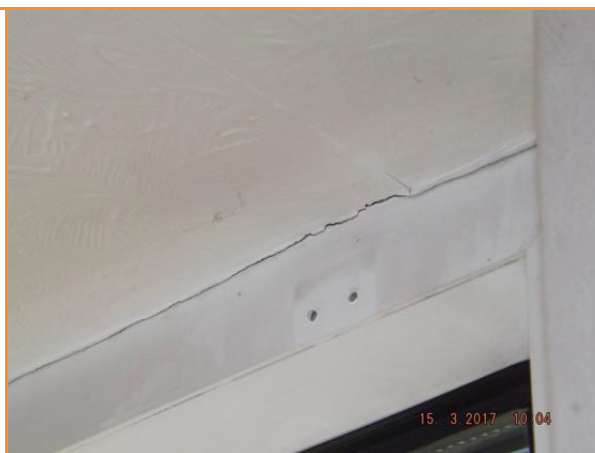
**11.02: Thermographic image showing leakage at side of bay window**

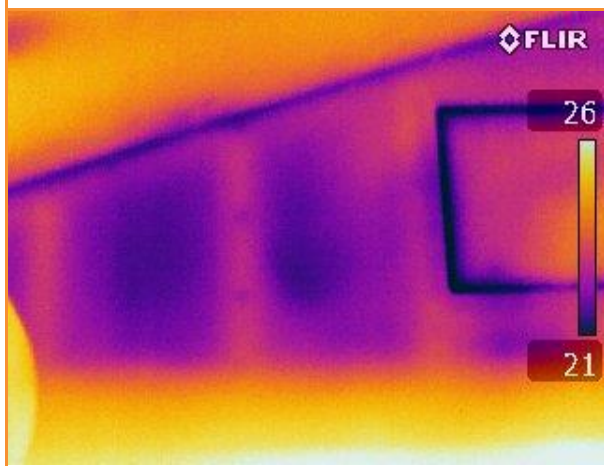
**11.03: Thermographic image of internal wall to cold loft above rear extension showing cold bridges where no insulation fitted between vertical timber studs**
