Airtightness Testing Report

St Sidwell's Point Paris Street, Exeter, EX1 2JB

On behalf of: Kier Construction

Reference: P3819-11

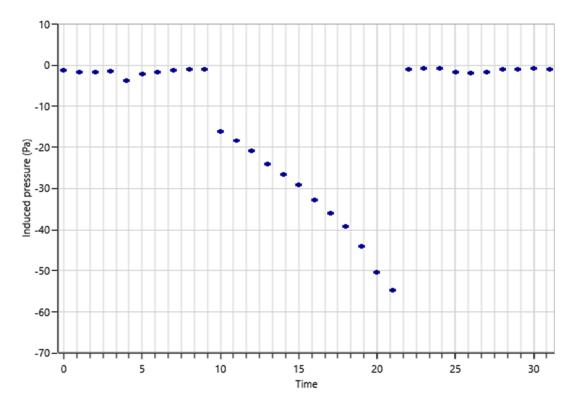
Reading	1	2	3	4	5	6	7	8	9	10	11	12
Induced Pressure [Pa]	-17.7	-19.9	-22.4	-25.7	-28.2	-30.7	-34.5	-37.7	-40.8	-45.5	-51.9	-56.4
Total flow, Q _r [m ³ /h]	1466.0	1594.6	1738.7	1893.2	2049.1	2192.1	2317.5	2459.0	2613.2	2844.5	3044.1	3249.0
Corrected flow, Q _{env} [m ³ /h]	1374.8	1495.4	1630.5	1775.4	1921.6	2055.7	2173.2	2305.9	2450.5	2667.4	2854.6	3046.7
Error [%]	-0.3%	-0.2%	0.2%	-0.8%	0.7%	1.7%	-0.7%	-0.8%	0.0%	1.1%	-0.9%	0.0%

G1: Graph of imposed pressure differentials, Depressurisation, St Sidwell's Point:

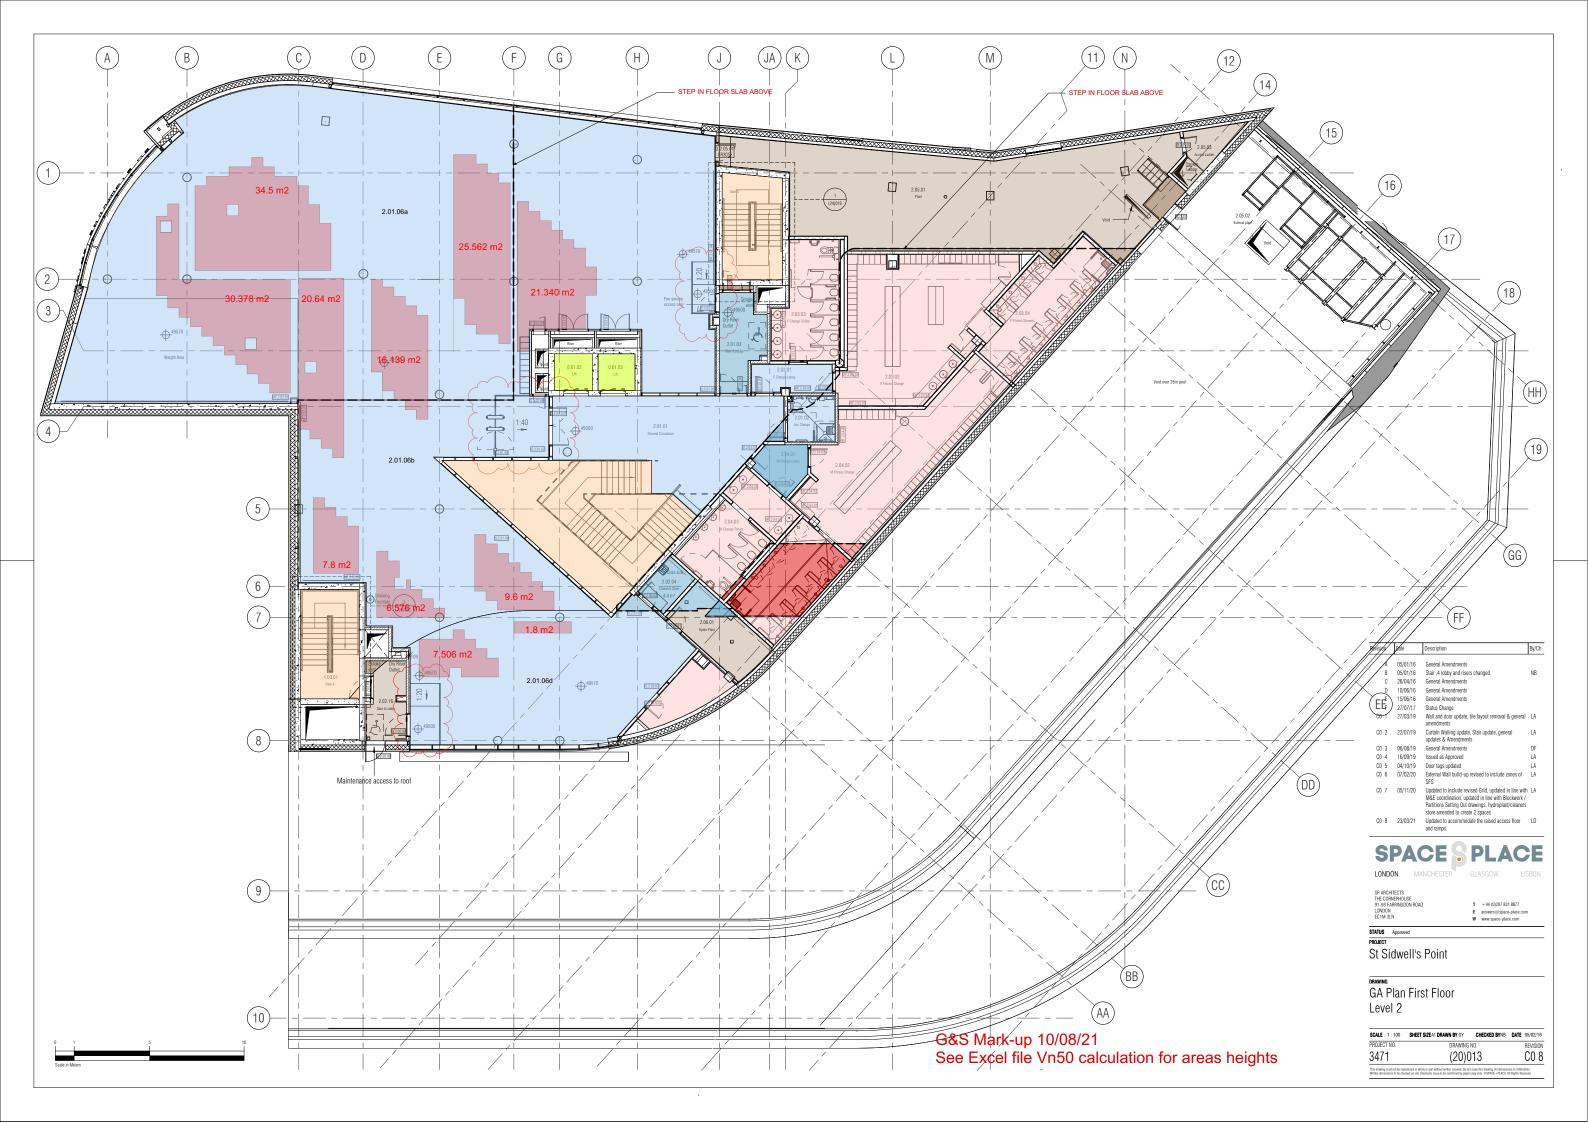
SSP Ceiling Height Reference Sheets (5 pages)

Refer to GSA mark-ups for height references (colour co-ordinated)
