Common Leakage Sites no.7

Between sections of suspended floors, usually timber.

Building Fabric Leakage 7: Between sections of suspended floors, usually timber. Also through hollow intermediate floors.

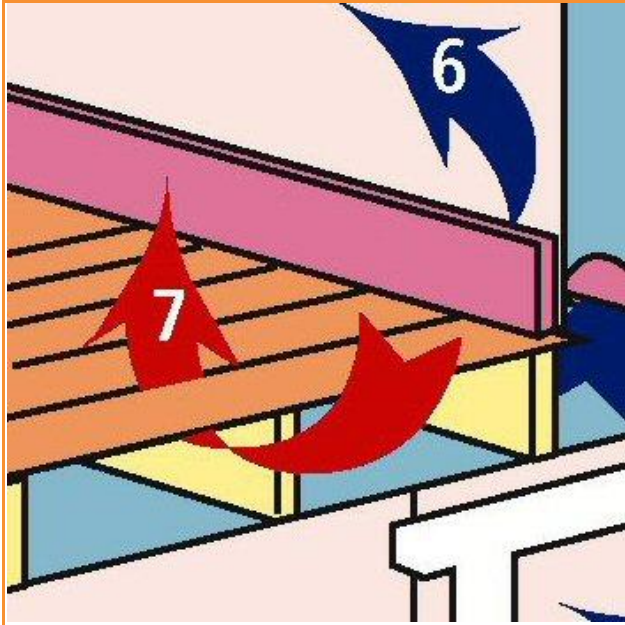
In this instance air is leaking from an unheated floor void into the room where the floorboards are suspended and have not been sealed.

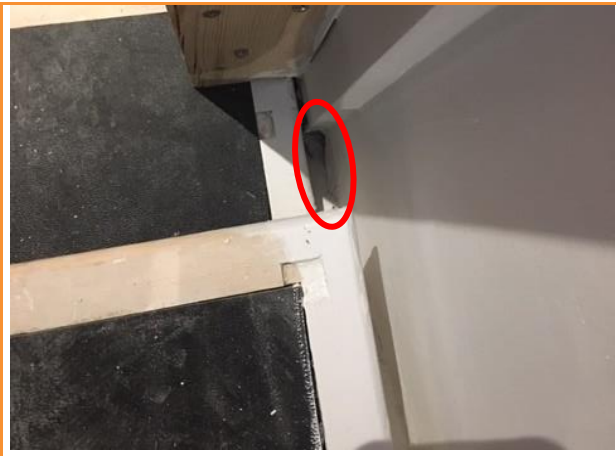
7.02: Leakage found at the side of the lowest step of internal stairs in an existing flat whilst it was depressurised
