Report on the Preliminary Air Leakage Testing of two maisonettes in Erneley Close, Manchester, being refurbished to the EnerPHit standard, in compliance with ATTMA TSL1 (2010)

Site address: Erneley Close, Longsight, Manchester M12 5RB

JALDAS5084/R1

14th & 15th January 2014

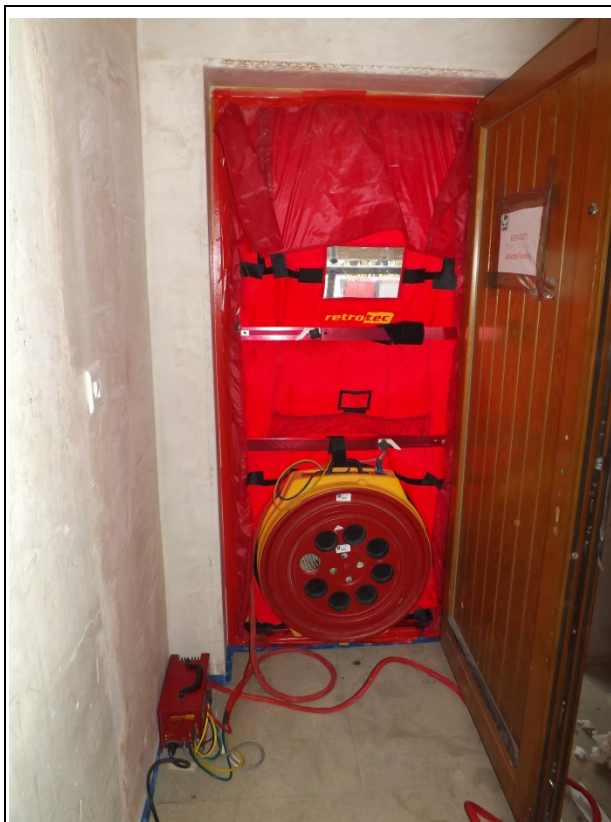
P3) Test equipment mounted in front doorway

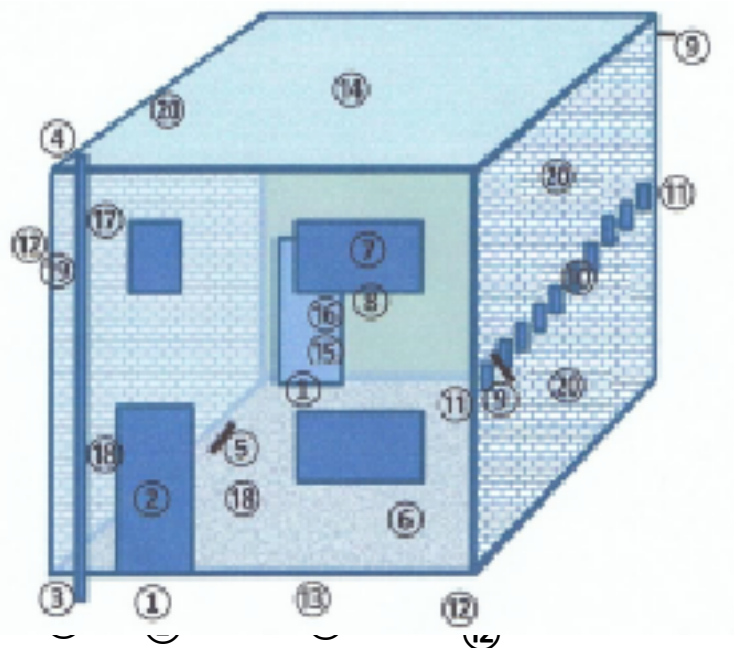
Referring to the above diagram, the following actual and potential leakage sites are:

- 1) Associated with the thresholds beneath both the front and back doors, where the sealing between the structural foam and the adjacent surfaces appears to be problematic;
