Common Leakage Sites No.12

Building Fabric Leakage 12: Through masonry walls

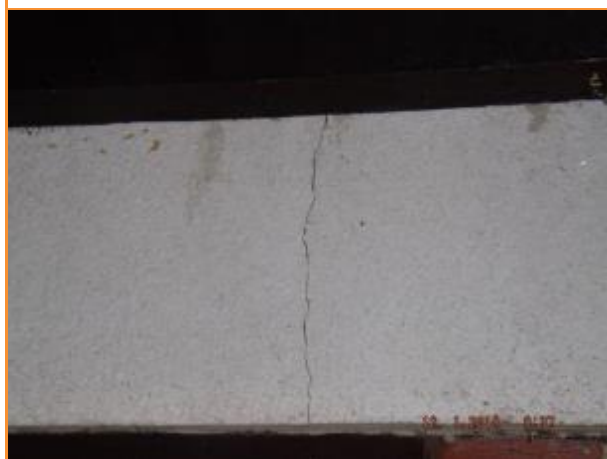
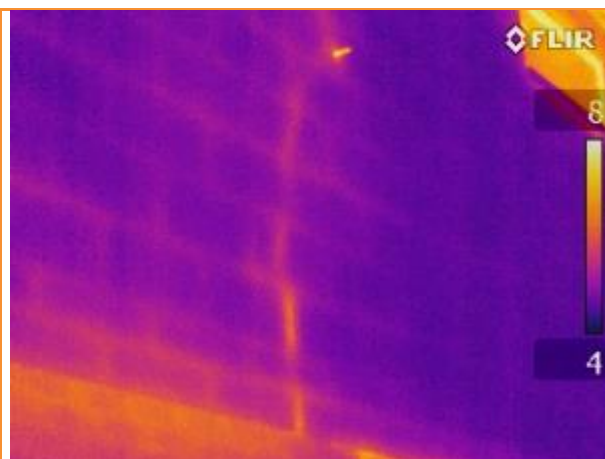
12.01: External thermographic image whilst house is pressurised showing heat escaping through crack in render, also underlying block pattern visible.
