## Common Leakage Sites no.2

### **Beneath inner window sills and around window frames.**

**Building Fabric Leakage 2: Beneath window cills and around window frames**

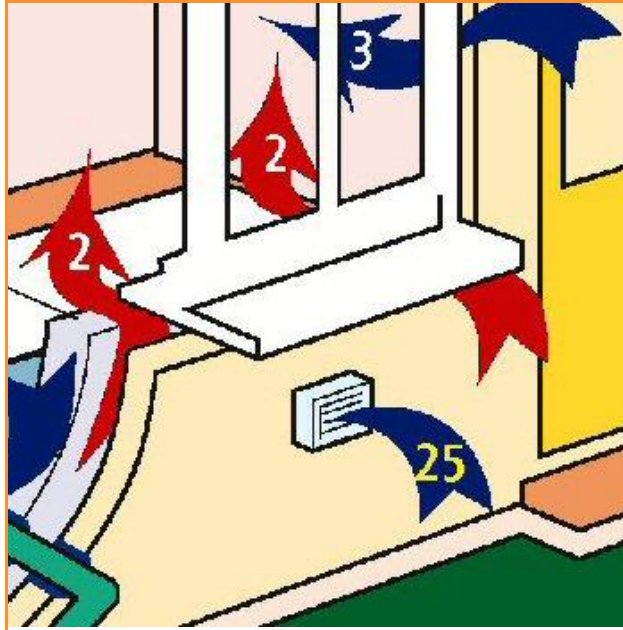
In this instance air is leaking either from an unheated wall cavity or direct from the outside into the room through gaps around the windows. This may be where replacement windows have been badly sealed back to the surrounding building fabric. Alternatively, leakage may be due to building movement, or perhaps moisture damage to timber windows, so that the sealing has failed around older windows.
