Common Leakage Sites no.3

Building Fabric Leakage 3: Through windows joints and/or hollow window frames

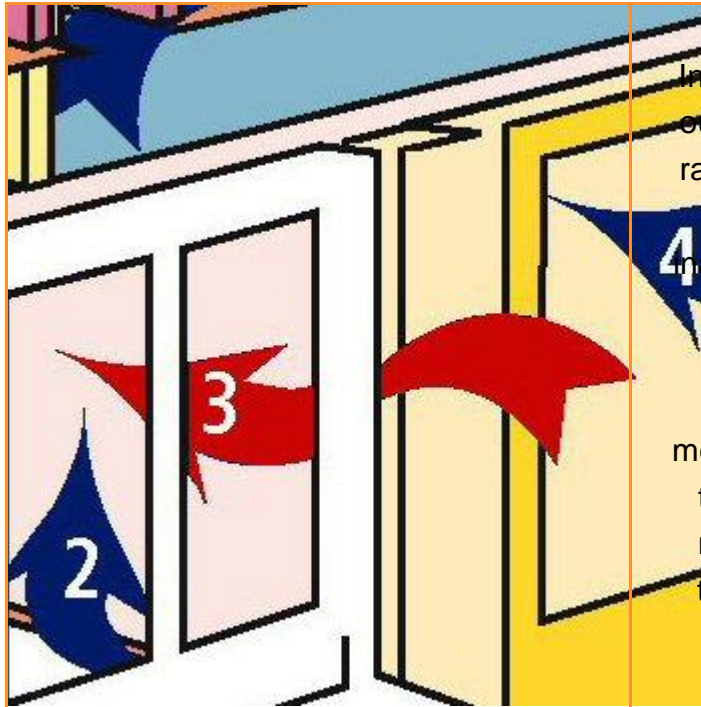
Through windows and/or hollow window frames.

In this instance air is leaking from the outside through the window unit itself rather than around the unit. This may be due to poor build quality, inadequate sealing of the glass panes or bad design, but is particularly prevalent in modern sealed unit windows where the locking mechanism penetrates the frame, and through keyholes. It has also been noted that the trickle vents fitted to these modern units frequently leak very badly, even when closed.
