Common Leakage Sites no.4

Building Fabric Leakage 4: Through doors – particularly double doors

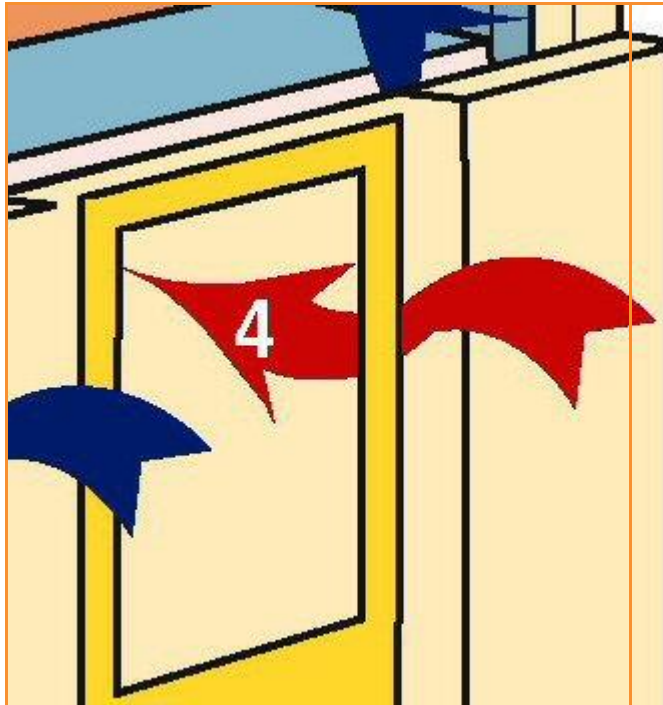
Through doors – particularly double doors.

In this instance air is leaking from outside through the fabric of the door itself, or in the case of double doors, through an inadequate seal where the doors meet. Doors with inset glass or wooden panels may leak around the joins or panel edges, but also letterboxes, keyholes and catflaps are known to be particularly common sources of very bad leaks. It has also been noted that the trickle vents fitted to modern sealed units such as patio doors frequently leak very badly, even when closed.
