Common Leakage Sites no.5

Building Fabric Leakage 5: Beneath doors and doorframes

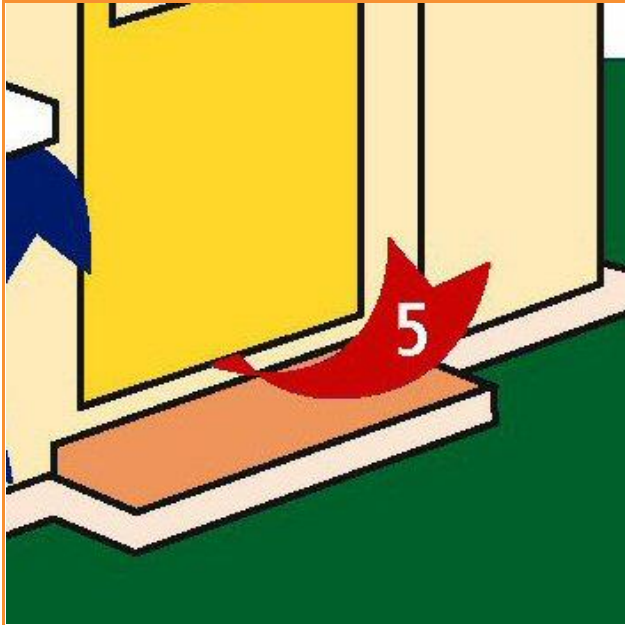
Beneath and around doors and doorframes.

In this instance air is leaking from the outside or an adjacent unheated space around the door itself or perhaps between the door frame and the adjacent wall, due to either bad fitting or inadequate sealing. It is not uncommon to see a door that has been cut marginally too short with a noticeable gap underneath it, allowing substantial airflow through the gap.
